# **61 Baker Street - Listed Building Consent**

## **1.Design and Access Statement**

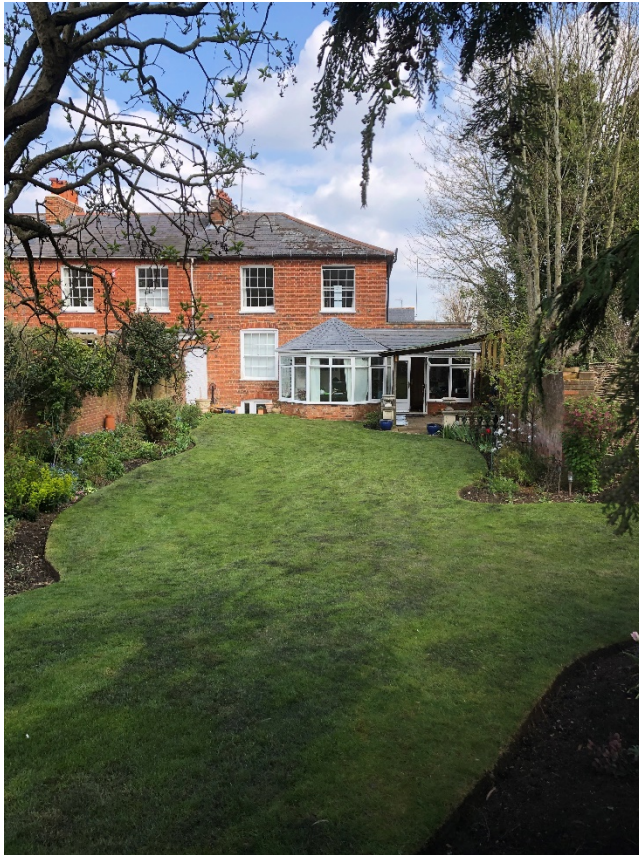
##### **Rear view of 61 Baker Street**

The sills are either original or more probably replacements (at least 35 years ago) and two of those (dining room and bedroom) at the rear (southside) of the property are now badly rotten and need replacement. I initially sought to repair them by filling but the wood is badly rotten and simply absorbing more water. In heavy rain the bedroom window already leaks. Additionally one sash frame (bathroom window) has cracked and rotted and requires repair.

Our intention is to refurbish the 3 rear facing window frames to a standard that, once completed and painted, will be undiscernible.

We plan to cut out the rotten wood in the two sills (dining room and bedroom) and replace with hardwood. Once completed and painted the repairs will be undetectable. The one broken and rotten frame (bathroom) will be similarly repaired and made good.
