## Claim Assessment Report

**Our Reference:** IFS-AVI-SUB-19-0084937

**Policyholder:** Reading Spiritualist Church

**Risk Address:** 81 Baker Street, Reading, RG1 7XY

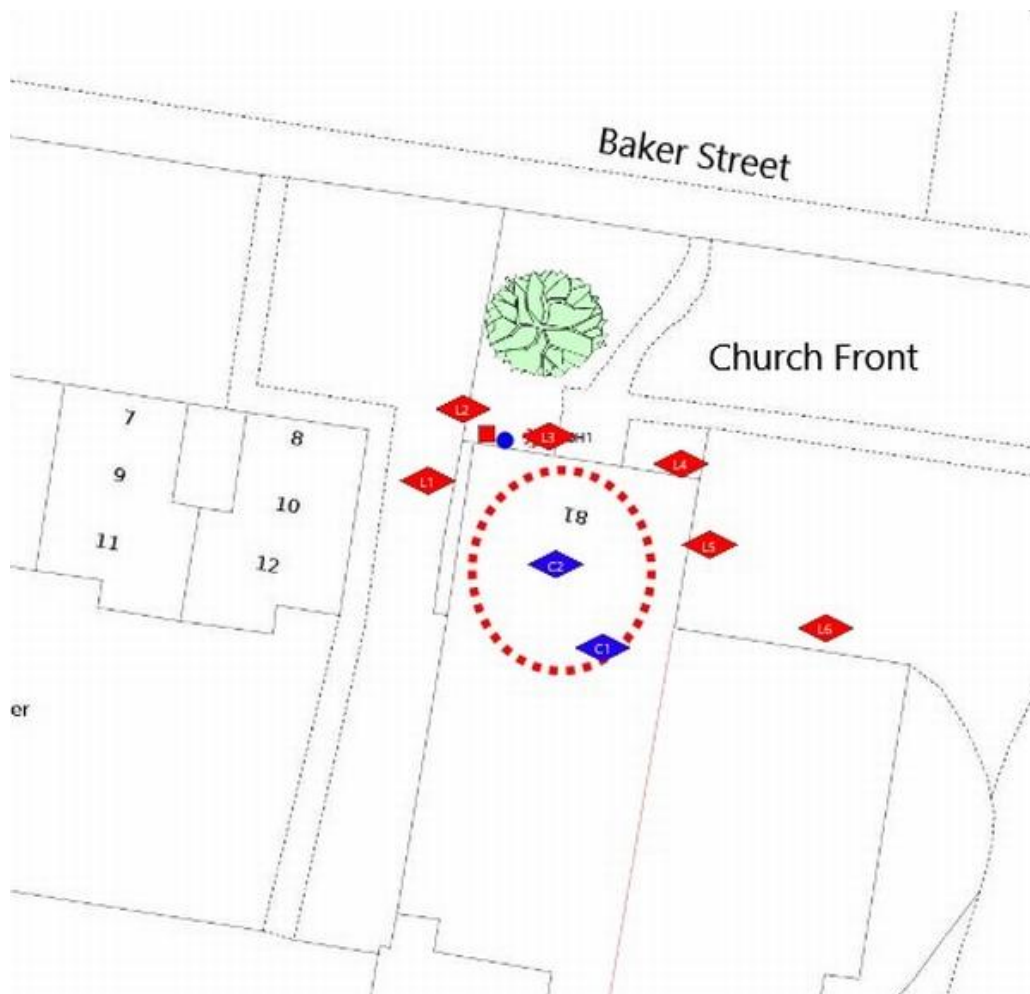
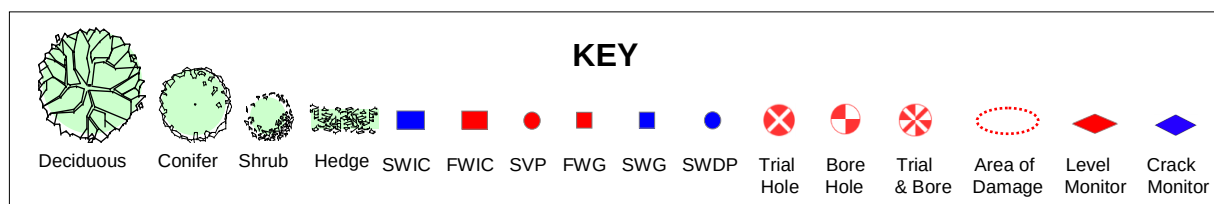
FIGURE 1 Site Plan

There is a large street tree to the front of the property which is likely to be the cause of most of the cracks evident in the building, both internal and external.
