# Arboricultural Consultancy for Aviva

| Insured | Mr Alan Carey | Address | 53 Crescent Road, Tilehurst, Reading, RG31 5AH | | |
| ES Ref | SA-244180 | Consultant | Lewis Fraser | Contact No. | 0330 380 1036 |
| Report Date | 21/06/2019 | | | | |

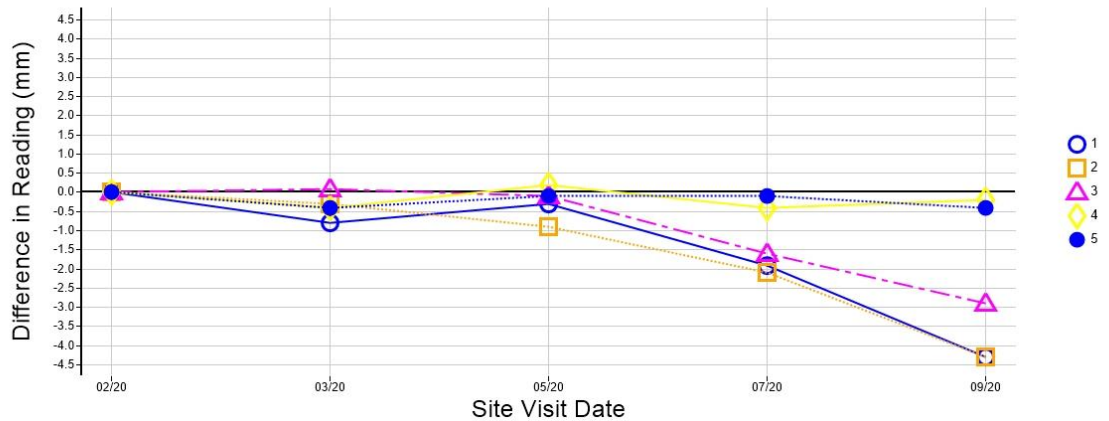
## Level Monitoring Difference Graphs

The following graphs display the progressive movement that each Level Monitoring Station recorded at each separate site visit date to give an overall look at how much the property is moving.

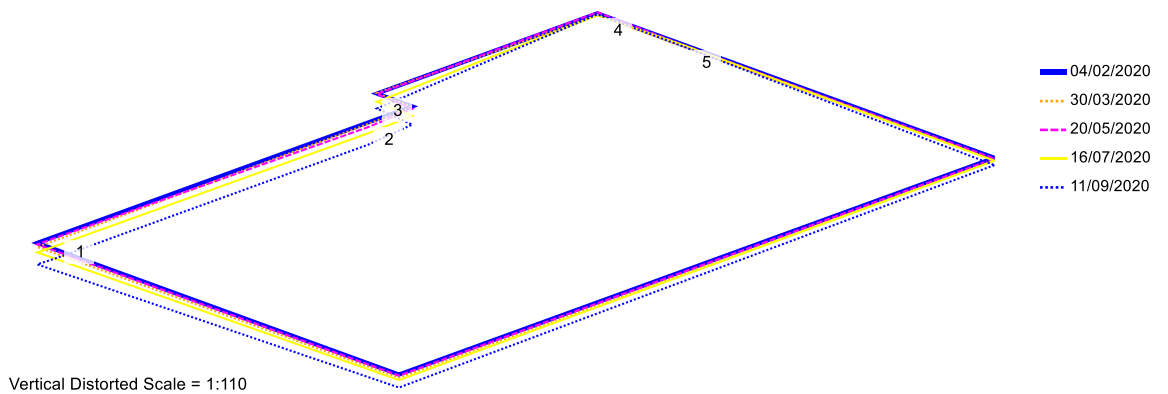
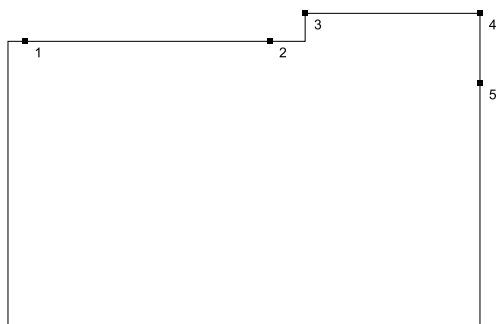
## Level Monitoring Displacement Map

The following image shows an isometric representation of the movement of the property, based on the Level Monitoring Stations that were installed.
