# Arboricultural Appraisal Report

## Subsidence Damage Investigation at:

The Lodge  
77 Chazey Road  
Caversham  
RG4 7DU

| MWA REF: | SUB191011-5898 |

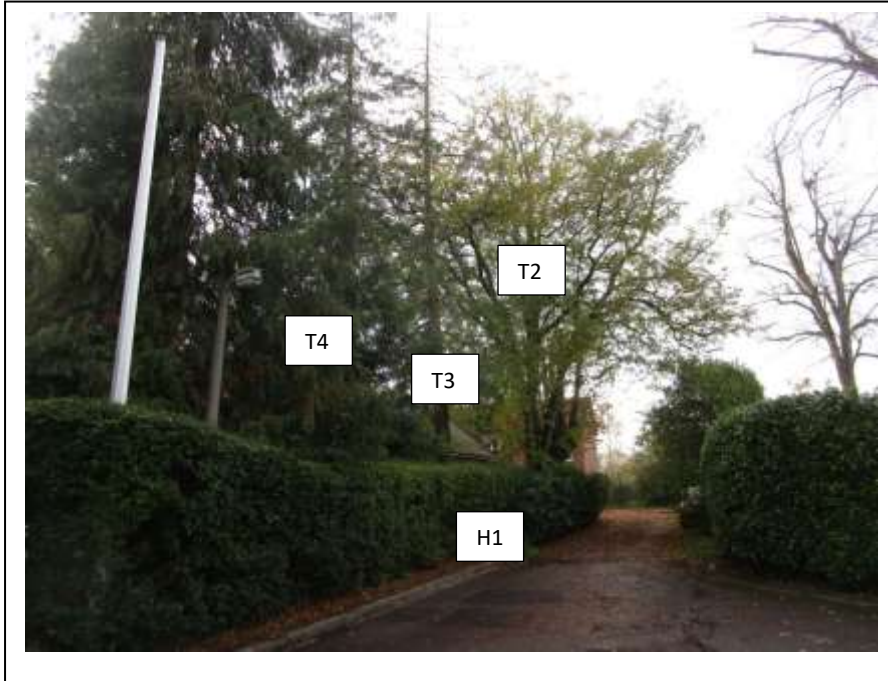
View of front boundary

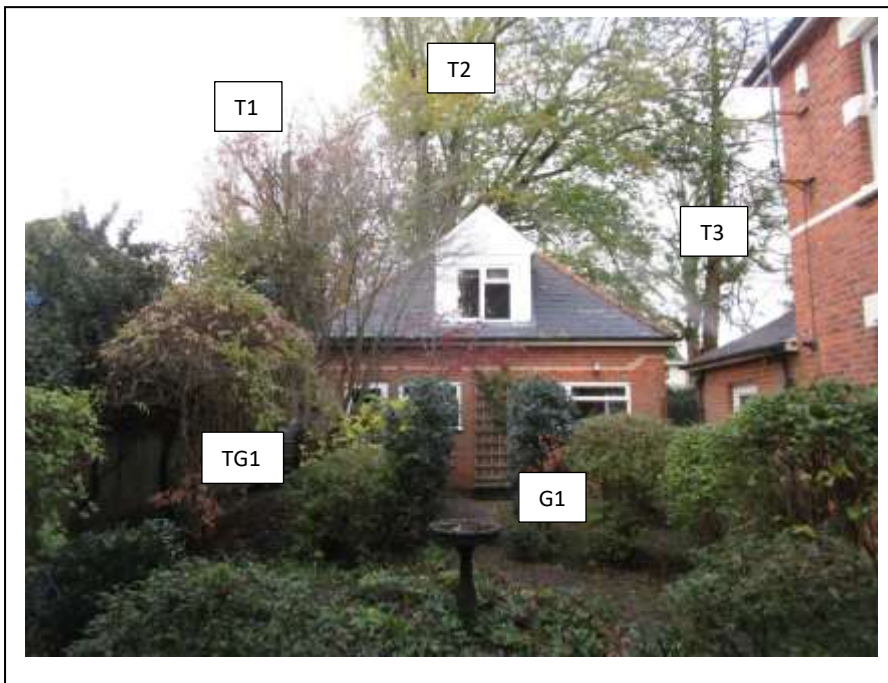
The current damage affects the front right corner of the garage with internal and external cracking to the walls and cracking along the centre of the floor slab. It was first noticed by the neighbour in December 2018.

View of garage from rear
