**93 Woodcote Road  
Caversham  
Reading  
Berkshire  
RG4 7EZ**

# **Preliminary Bat Roost Assessment**

**Ref: R2652/a**

**November 2020**

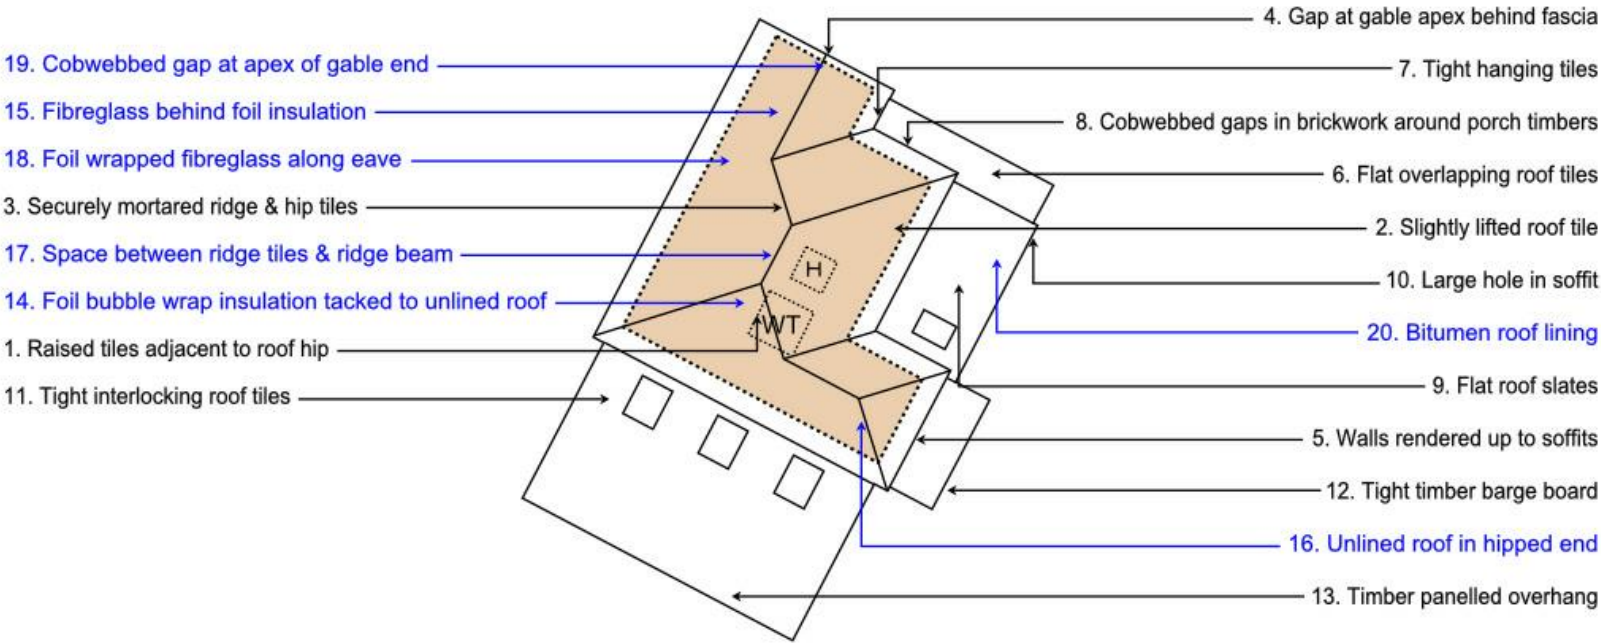
APPENDIX 2 – PRELIMINARY BAT ROOST ASSESSMENT FINDINGS

**3.2.5** No evidence of roosting bats was observed during the external inspection of the property.
