**19 Surley Row  
Emmer Green  
Reading  
Berkshire  
RG4 8PW**

# **Preliminary Bat Roost Assessment**

**Ref: R2634/a**

**October 2020**

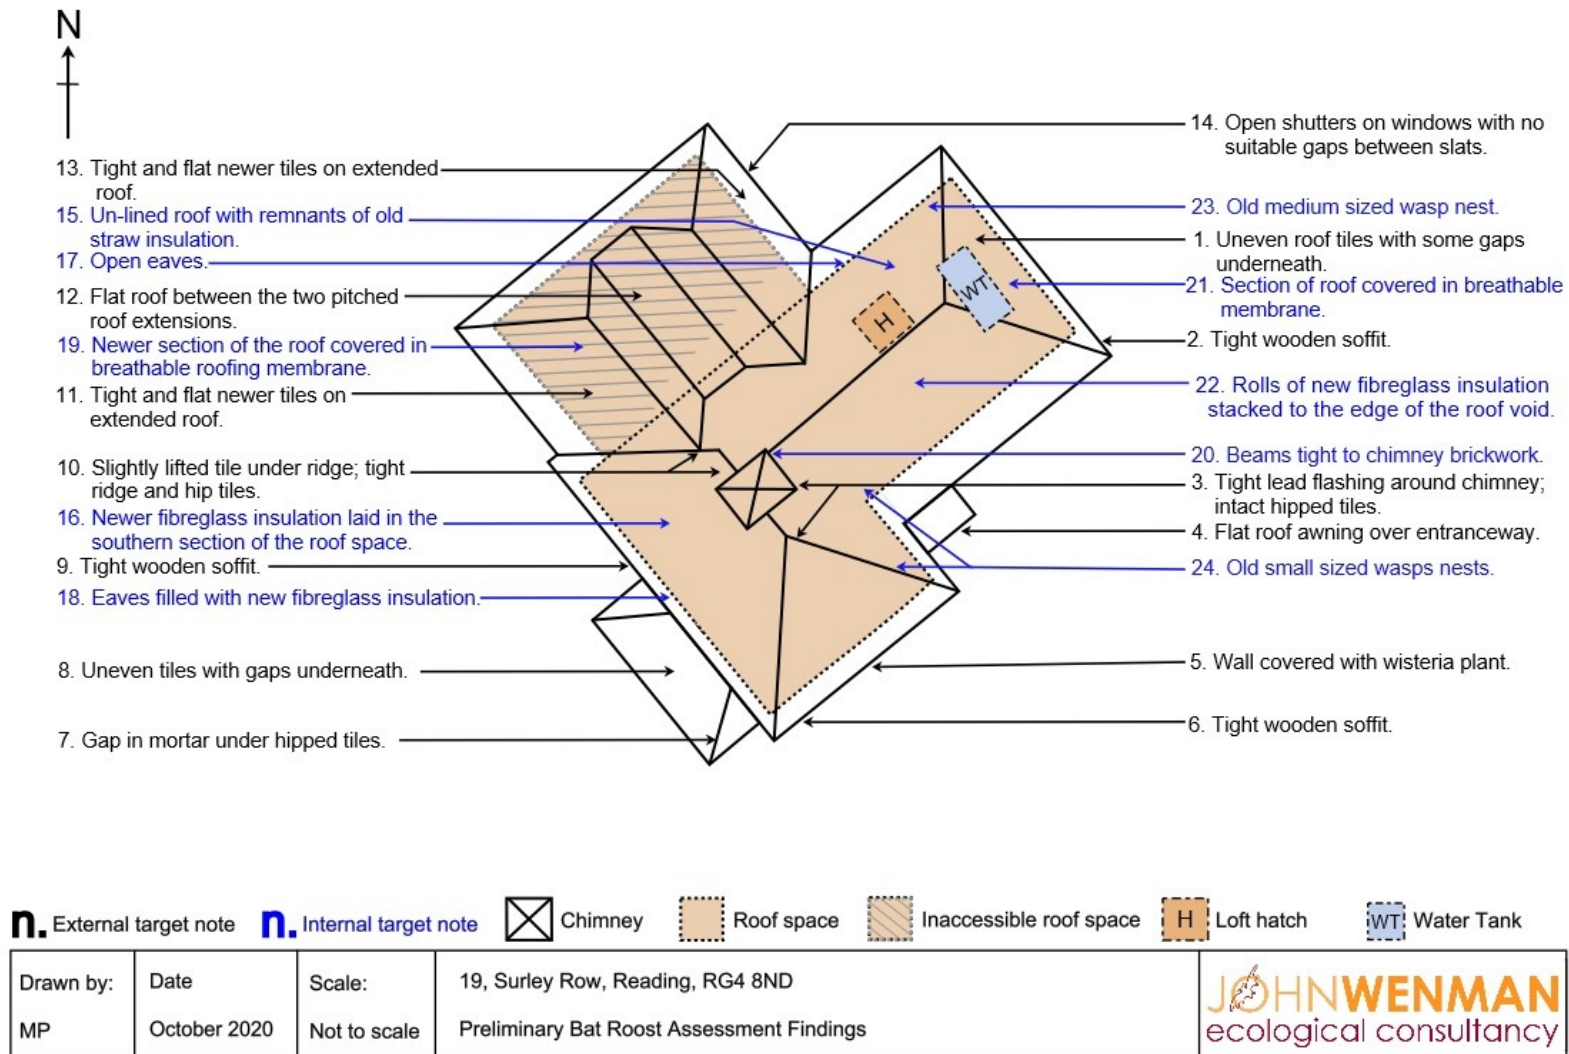
## APPENDIX 2 – PRELIMINARY BAT ROOST ASSESSMENT FINDINGS

- 4.1.1** There was no evidence of roosting bats (i.e. droppings or staining) found during the roost assessment. The house had some features suitable for allowing bats access, i.e. gaps under tiles and missing mortar under occasional hipped tiles of low bat roost potential. However, the gaps under the tiles were in the unlined section of the roof and therefore did not provide hidden crevices suitable for bats and there were not any bats or droppings visible within the roof void and as such it is considered unlikely that the house supports bats.
