**68 Shinfield Road  
Reading  
Berkshire  
RG2 7DA**

# **Preliminary Bat Roost Assessment**

**Ref: R2508/a**

**May 2020**

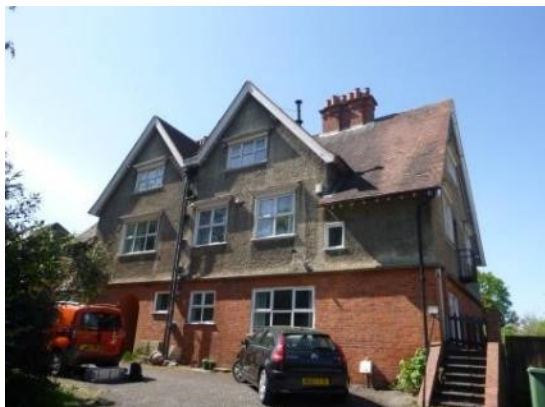
1. North-eastern elevation of the house.

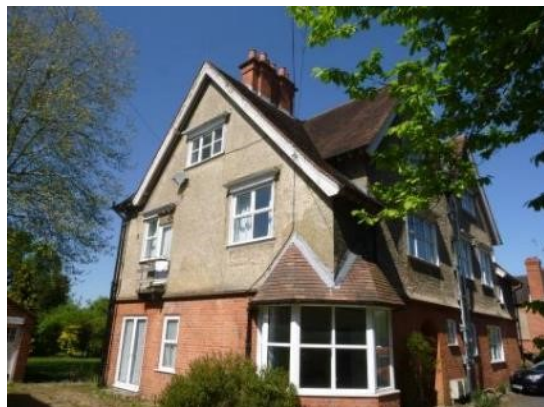
2. South-eastern elevation of the house.

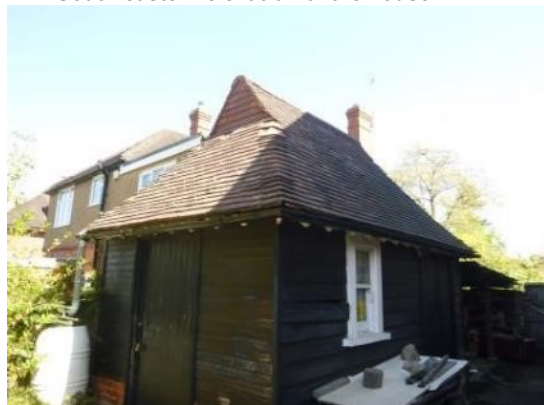
**3.4.1** The shed had a Dutch gabled roof with clay ridge, hip and roof tiles. The shed had close board and feather board timber clad walls, which are supported by a partially supported by a brick foundation (**Photograph 4**). The adjoining lean-to had a flat roof and walls. The roof had numerous missing, cracked or loose tiles, particularly along the hips and below an end ridge tile (**Photographs 51-53**). The ridge tiles were semi-circular and intact. The verges, fascias and soffits were in good order. The close boarded timbers were tightly fitting and therefore presented limited potential for bat access or roosting, however; gaps between the feather boarded timbers had opportunities for bat access and roosting. Additionally, a feather board by the window was loose (**Photograph 54**). No evidence of bat activity was found on the shed and lean-to.

4. South-western elevation of the shed.

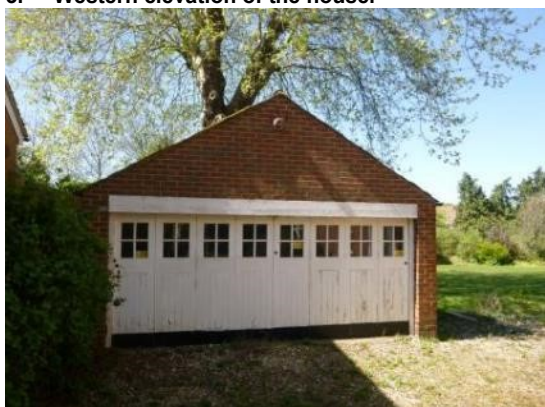
5. Eastern elevation of the garage.

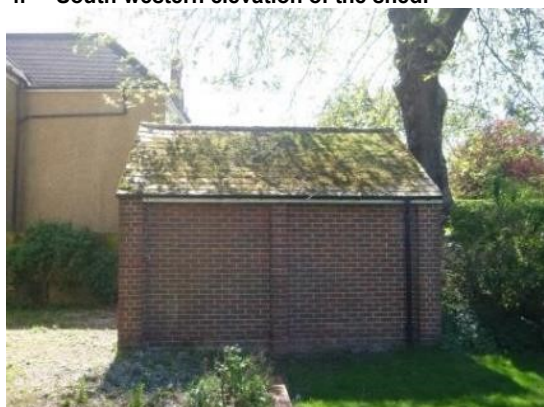
6. Northern elevation of the garage.

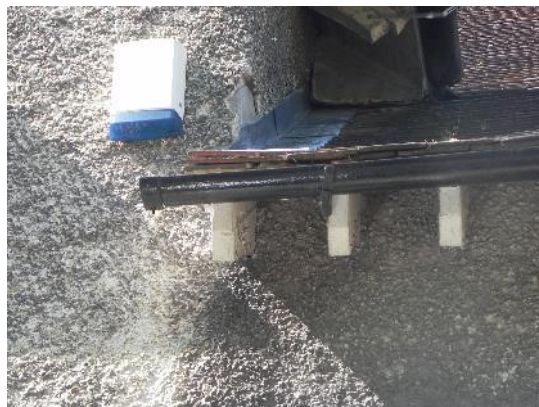
36. Gap between lifted gable soffit and tiles/ flashing (eastern elevation).

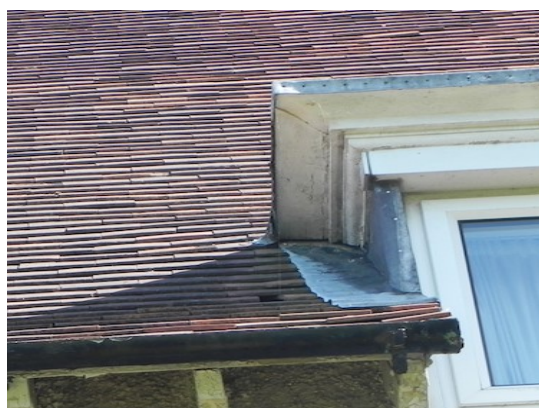
38. Felt starting to lift on dormer roof edges and soffit not flush with flashing.

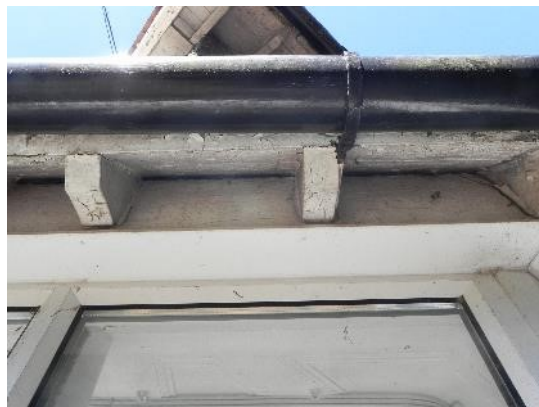
overlapped on the wall corner, providing access and roosting opportunities for crevice-dwelling bats (**Photograph 41**). The corner of the pebbledash wall directly above the area of central flashing was cracked, creating a small gap with potential for use by crevice-dwelling bats (**Photograph 42; Target note 11**). The eaves were in poor order overall, with heavy paint cracking narrow gaps between the soffits and the wall (**Photographs 43-45**).

44. Further gap between eaves and bay window.

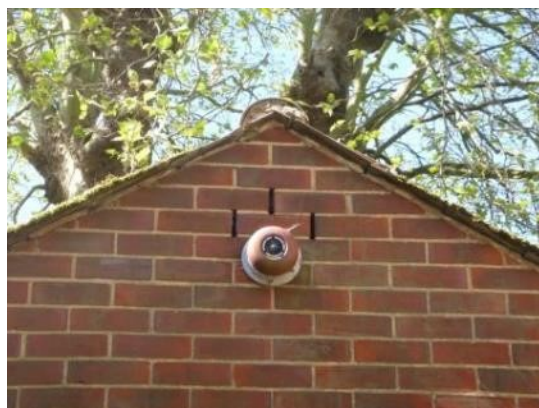
46. Weep holes between bricks in garage.

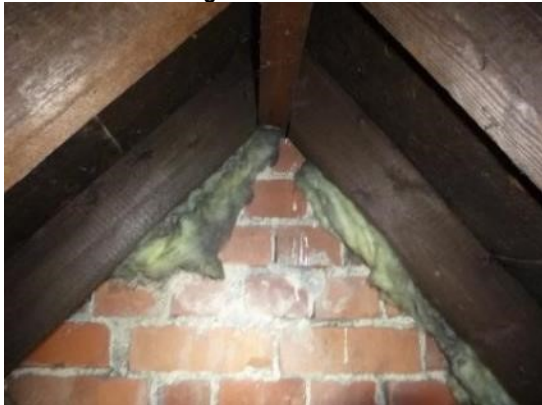
59. Gaps between bricks and timbers at all gables.

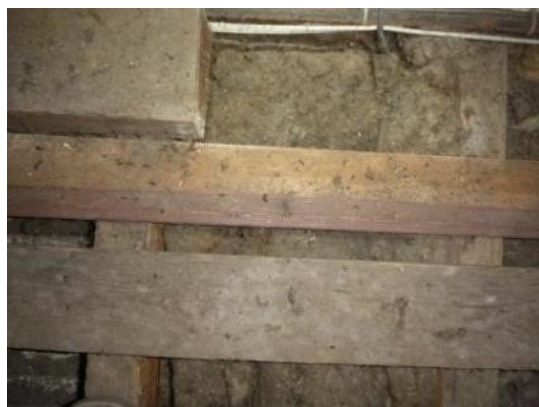
- 3.5.2** There were approximately 100 scattered medium bat droppings throughout the void, which were of a size and shape typical of long-eared bat species (*Plecotus* spp.). These droppings were found on fibreglass, floor boards and hanging from cobwebs on walls - four further medium-sized bat droppings were found toward the northern gable end: two on the loft hatch, one on the gable wall and one on floor boarding (**Photographs 62-68**). A concentration of 50-100 large bat droppings – of a size and shape most typical of serotine (*Eptesicus serotinus*) bats - were found on fibreglass at the south-eastern gable end (**Photograph 69**). No bats were visible in the void at the time of the survey.

**66. Further medium-sized bat droppings on floor of roof space.**

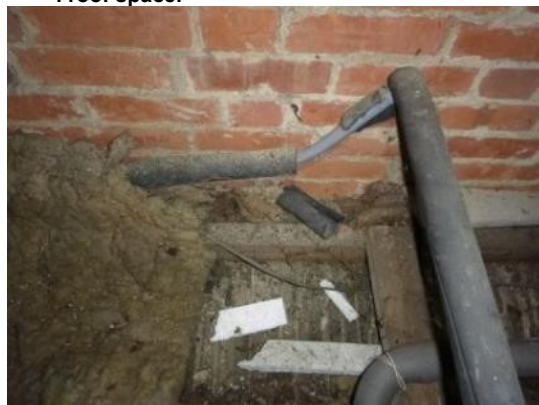
**68. Further medium-sized bat droppings hanging from wall of roof space.**
