# Preliminary Roost Assessment

## Greyfriars Church, Reading.

October 2017

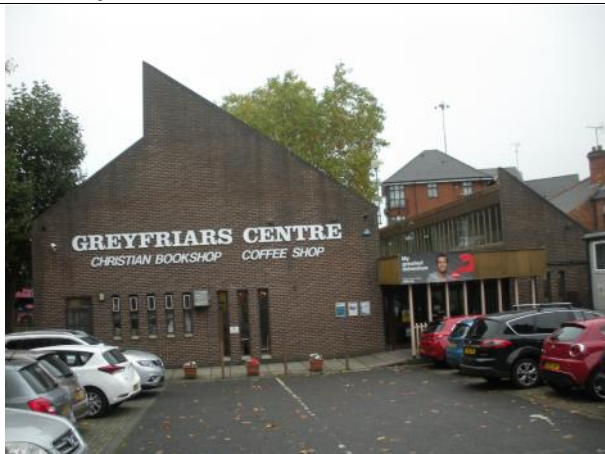
#### A – Greyfriars Centre

A modern brick-built structure constructed in the 1980s. Roof pitches are finished with closely interlocking concrete tiles.

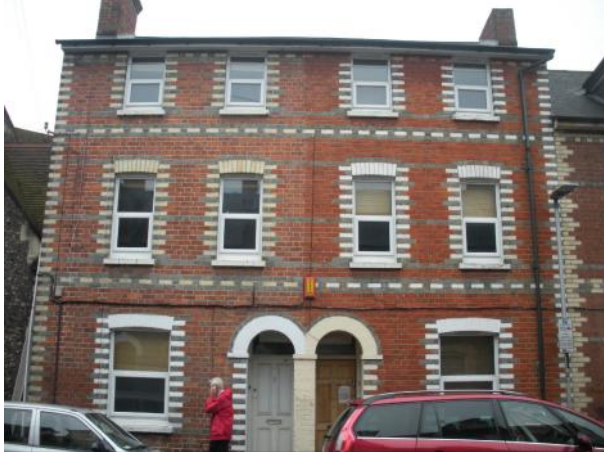
#### C – Sackville Street Properties

Former residential properties recently purchased by the church. The properties were used to provide single rooms for social housing and are interlinked internally. A single roof space sits above the properties. The roof is finished with slate and has been recently re-roofed.

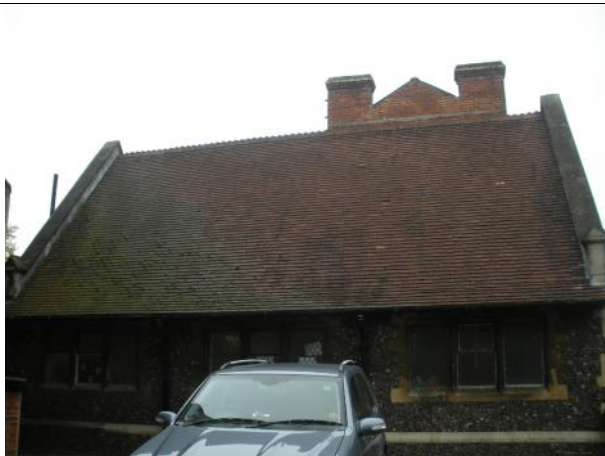
#### E – Memorial Hall

The Memorial Hall dates from the 1900s. The walls are inset with stone and the roof finished with clay tiles.

The proposals do not include works to Memorial Hall.
