**Pavilion at Mapledurham Playing Fields  
Upper Woodcote Road  
Caversham  
Reading  
Berkshire  
RG4 7LB**

## **Preliminary Bat Roost Assessment**

**Ref: R2416/a**

**November 2019**

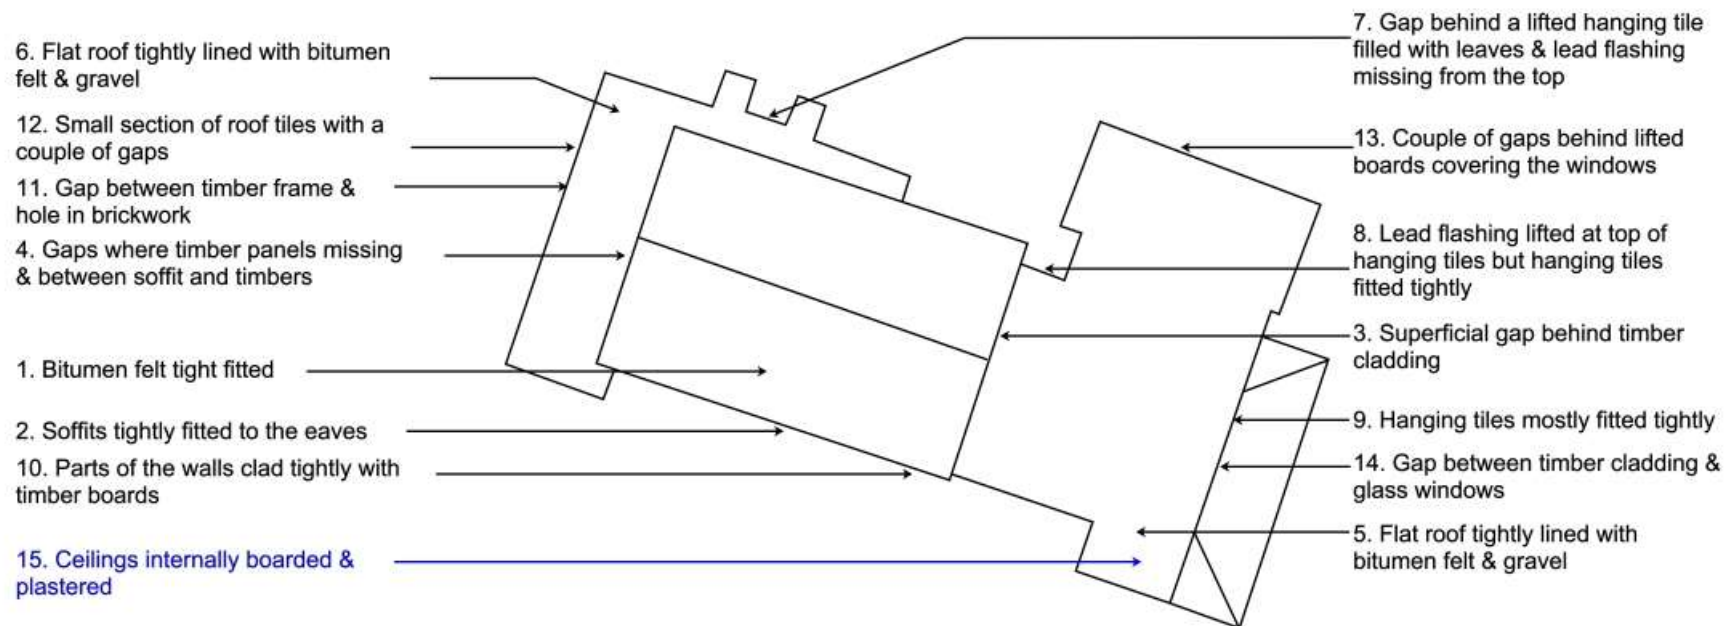
## APPENDIX 2 – PRELIMINARY BAT ROOST ASSESSMENT FINDINGS

| VP | Nov 2019 | Not to scale | Daylight Bat Survey Findings | |
