**Happy Drains Ltd**

Ref C0010505

Date 29<sup>th</sup> May 2019

**Project Description:** General CCTV

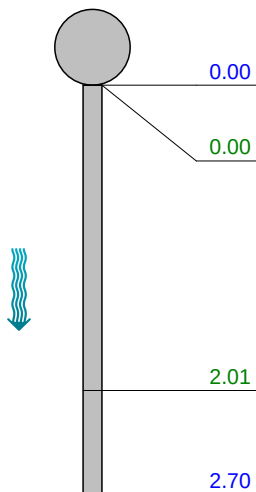
Depth: 0.40 m  
GREASETRAP

MH Start node type, manhole, reference number: GREASETRAP

WL Water level, 0 % of the vertical dimension
