## ARBORICULTURAL REPORT

Kendrick School  
41 London Road  
Reading  
Berkshire  
RG1 5BN

Sarah Duckworth  
DipArb(RFS), TechCert(ArborA), M. Arbor.A, BA (Hons)

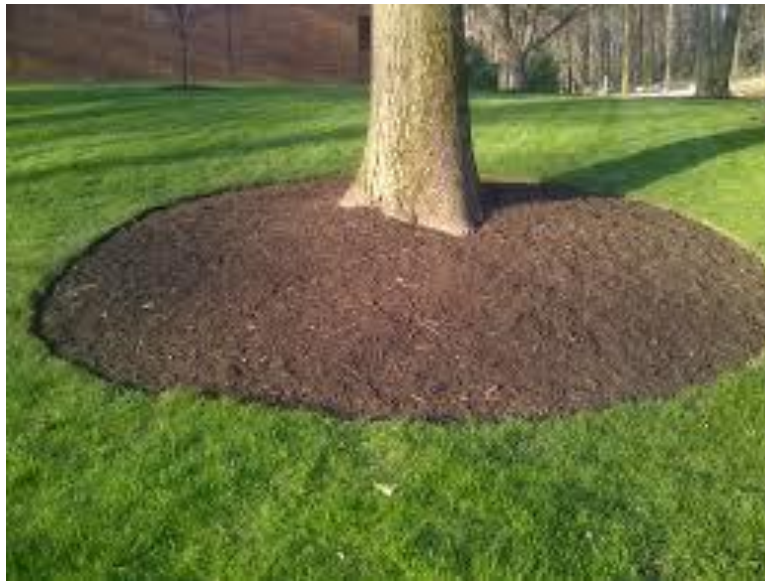
Fig.1 An example of appropriate turf clearance and mulching.

- Chemicals used on the lawn area around the trees such as 'lawn weed and feed' can be toxic to trees and should not be used under the canopy area of these trees.
- Turf can be removed around the base of the tree (as great a distance as can be provided). The ground in this area should be then decompacted with a garden fork or more specialist equipment such as the 'Terravent' ground decompactor or 'Airspade'.
- Slow release granular fertiliser should be added to the exposed soil or a well-rotted manure (or both) to improve the nutrient and organic matter content of the soil.
- The ground can then be covered with a bark mulch around 10cm deep – taking care not to allow the mulch or mature to build up around the root flare.
