**5 Woods Road  
Caversham  
Reading  
Berkshire  
RG4 6NA**

# **Preliminary Bat Roost Assessment**

**Ref: R2426/a**

**December 2019**

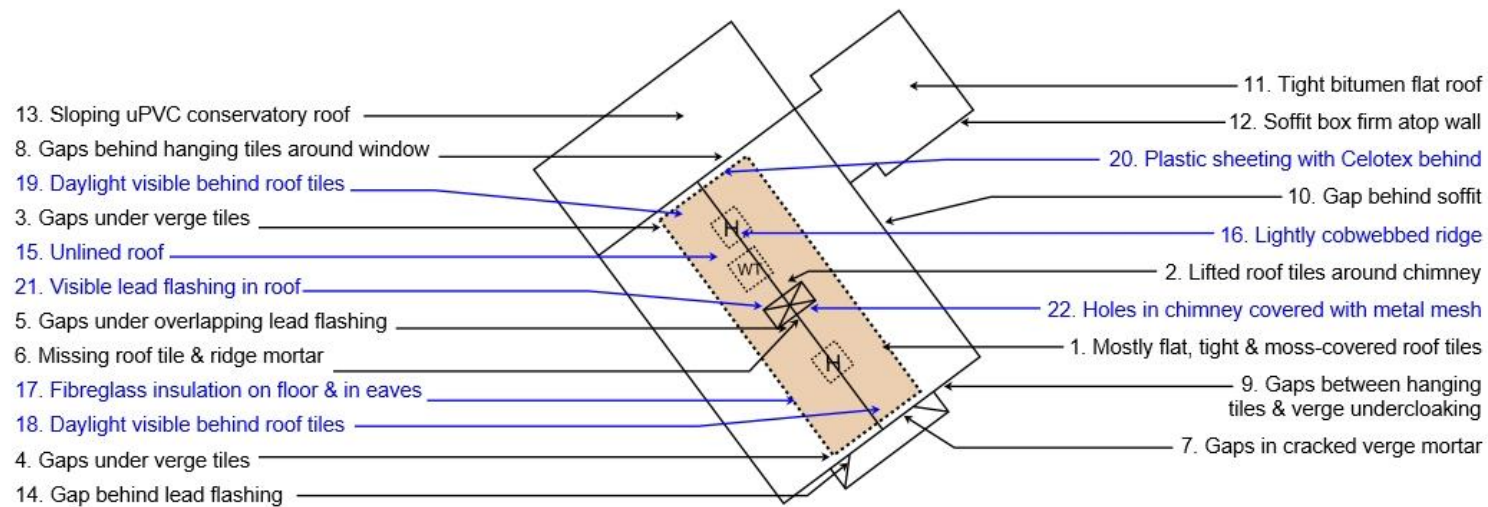
## APPENDIX 2 – PRELIMINARY BAT ROOST ASSESSMENT FINDINGS

**3.2.2** The roof tiles on the pitched roof were mostly flat, tight and covered in moss (**Photograph 3; Target note 1**). There were however, several gaps under lifted roof tiles around the chimney and under uneven verge tiles at the gable ends offering potential access and roosting opportunities for bats (**Photographs 4 & 5; Target notes 2, 3 & 4**). The chimney possessed suitable bat access points beneath overlapping sections of lead flashing, and where a roof tile and mortar were missing at the ridge (**Photographs 6 & 7; Target notes 5 & 6**). The verge mortar at the gable ends was reasonably intact (with one repointed section) except for a few gaps at the front gable end where the mortar had cracked (**Photograph 8; Target note 7**).

**4.1.1** No evidence of roosting bats was found during the roost assessment; however the property did possess a number of external features suitable for crevice-dwelling bat species. The features identified included: gaps under lifted roof tiles around the chimney; gaps under uneven verge tiles; gaps under overlapping sections of lead flashing around the chimney; a missing roof tile and ridge mortar next to the chimney; cracked verge mortar on the front gable end; gaps behind hanging tiles around the window on the rear gable end and gaps between hanging tiles and the verge undercloaking on the front gable end; a gap behind the timber soffit; and a gap behind lead flashing above the front porch. Therefore, despite a lack of bat roosting evidence (droppings etc.), the presence of bats utilising exterior features cannot be ruled out at this stage.
