## The Waterhouse Building: Repairs and Maintenance Works to Chimneys, Roofs &amp; Rainwater Goods

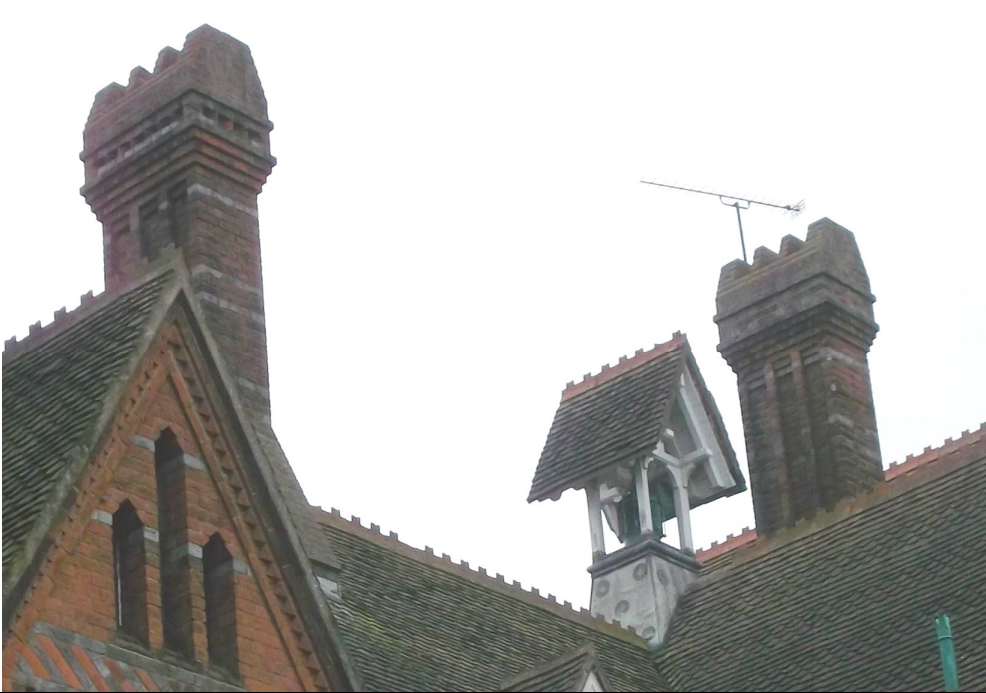
| | <p>6) West Wing, Front Elevation.</p> <p>Rectangular chimney stacks</p> |

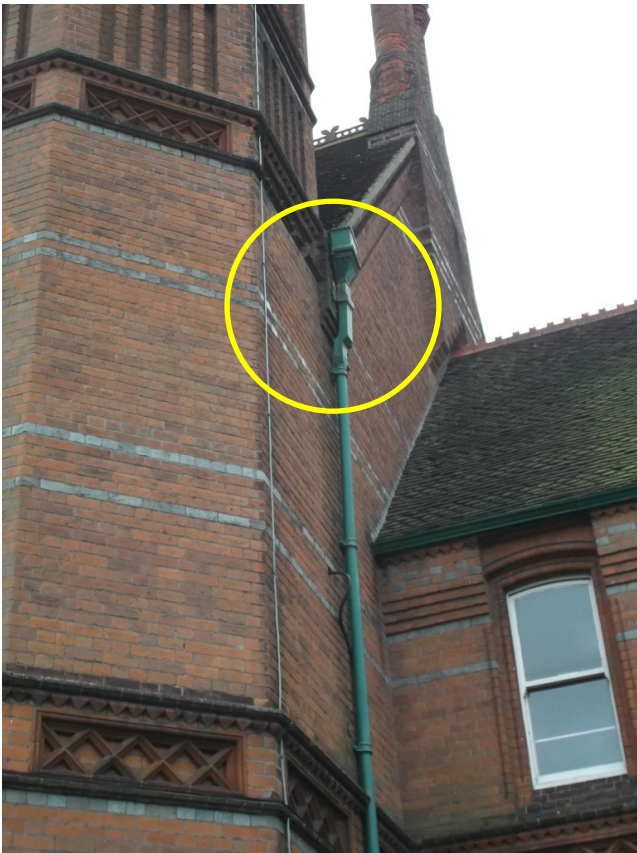
| <p>21) West-facing Elevation of Central Main Building.</p> | <p>22) West-facing Elevation of Central Main Building.</p> <p>Note gap between hopper and brickwork, plus missing fixing to bracket immediately below rectangular section of downpipe.</p> |
