| Document Title: | Arboricultural Method Statement |
| Project Title | Proposed Development - Colliers Way, Tilehurst |

| Document Title: | Arboricultural Implications Assessment - initial tree survey |

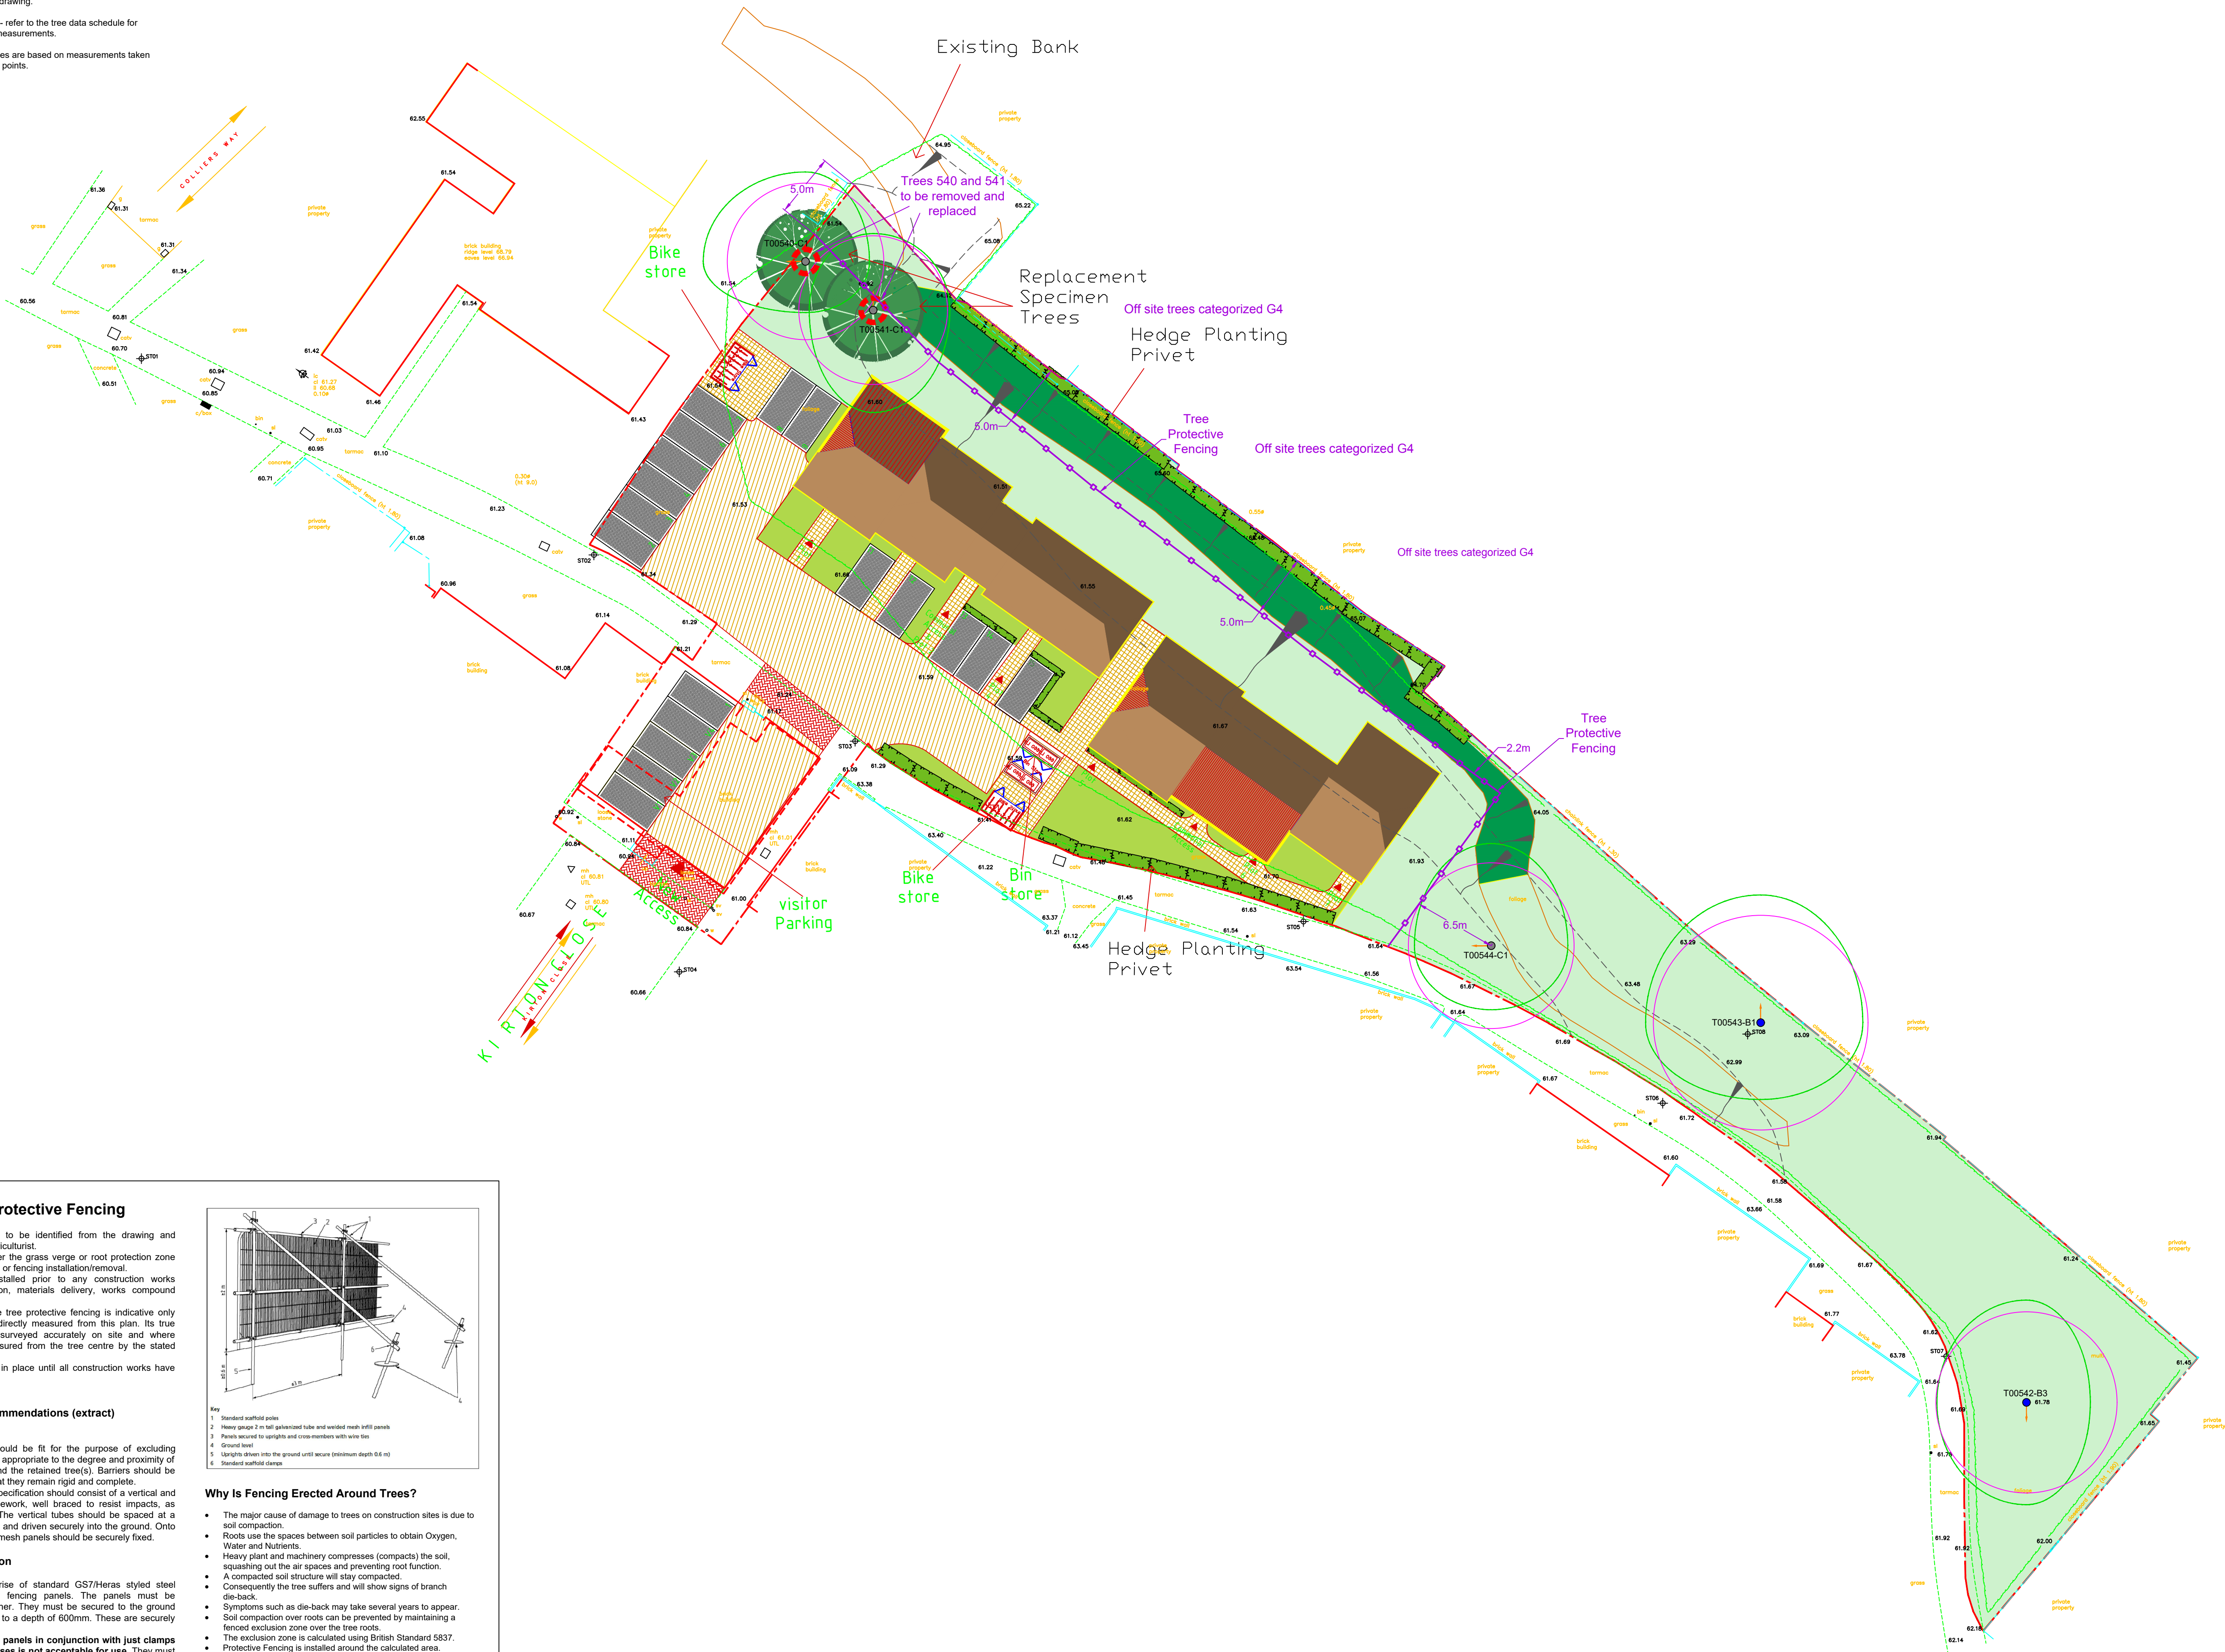
## Tree Protection Plan

Plan showing existing site, proposed development, protective fencing and trees for removal.

- Trees for removal to be identified from the drawing and marked by an arboriculturist.
- No vehicles to enter the grass verge or root protection zone during tree removal or fencing installation/removal.
- Fencing to be installed prior to any construction works (including demolition, materials delivery, works compound installation).
- The location of the tree protective fencing is indicative only and must not be directly measured from this plan. Its true location must be surveyed accurately on site and where applicable be measured from the tree centre by the stated dimension value.
- Fencing to remain in place until all construction works have ceased.

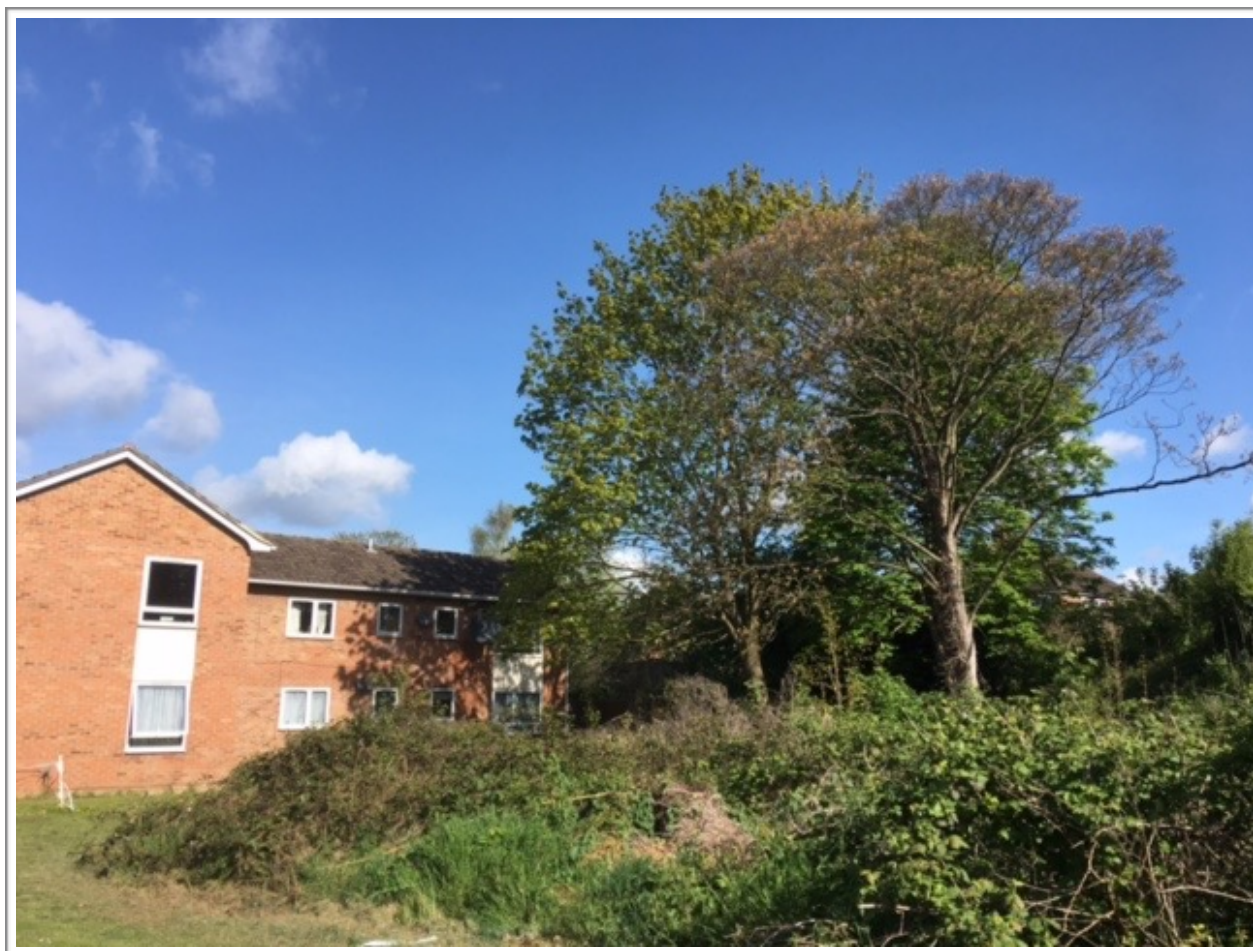
- 4.4.1 Full details of the tree population can be found in the AIA but is summarised below.
- 4.4.2 T1 and T2 are located toward the northern extent of the site close to the built footprint. T1 is a mature Norway Maple with a crown spread of some 14m. The tree is in an overall fair condition but has been downgraded due to the thin asymmetric crown and lack of overall vitality.

- 4.4.3 T2 is a mature sycamore in poor condition. It is located near to the built footprint but further south than T1. The tree has very low vitality and a stag headed crown. We suspect there maybe a fungal pathogen present. The tree has a limited useful life expectancy and has been downgraded accordingly.

**Photographic Plate showing 'Thorpe House' and trees T1 and T2**

6.1.1 In undertaking the development as indicated on the proposed plans a number no trees require direct removal however two should be removed due to their condition.

Of these removal both are category C1 having been downgraded due to their condition and limited useful life expectancy.

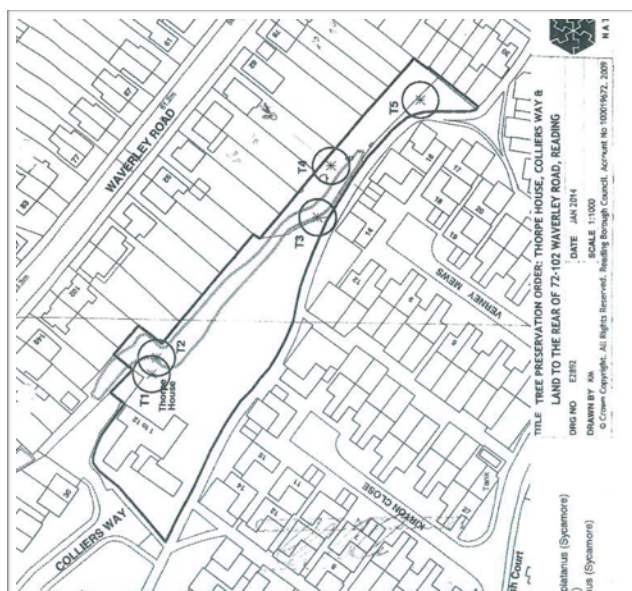
Figure 1.

- 1.5 The site was assessed and data was collected on five individual trees protected by a preservation order as highlighted on the PDF extract below. (Figure 1)
