**37 Coley Avenue  
Reading  
Berkshire  
RG1 6LL**

## **Daylight Bat Survey**

**Ref: R1864/b**

**April 2018**

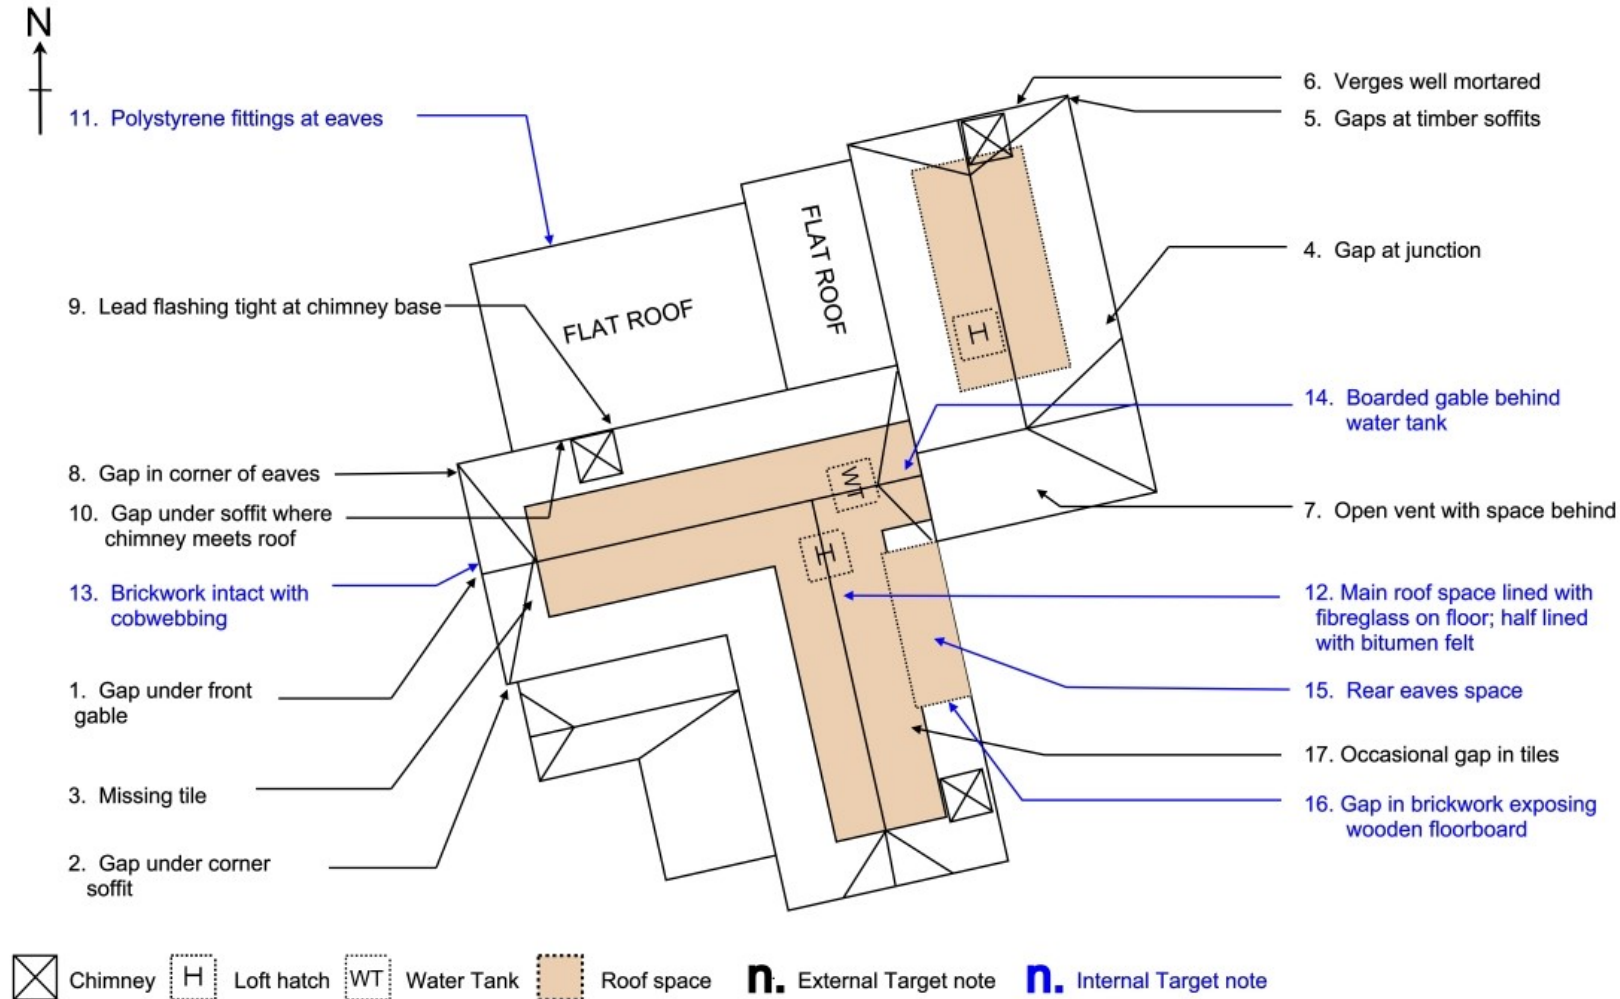
## APPENDIX 2 – DAYLIGHT BAT SURVEY

- 3.2.2** The flat clay tiles covering the roof were uneven in several places, with tiles missing occasionally. The gaps were more prevalent at the rear (**Target note 15**) than at the front, offering potential roosting opportunities for bats although no evidence of use was seen at the time of the survey. A missing tile was present at the top of the west facing gable on the south-facing side (**Photograph 5; Target Note 3**). At the rear of the building, occasional gaps beneath the roof tiles were visible (**Photograph 6**). A tile was lifted at the gable junction at the single storey pitched roofed section (**Photograph 7; Target Note 4**).

- 3.3.5** No bats or evidence of bats was visible within the roof spaces of the house during the survey. Mouse droppings were found at the northern end of the converted loft space in the rear extension.

- 4.1.1** There was no evidence of the roof spaces of the house being used by roosting bats and it is unlikely therefore that the property supports species that primarily occupy roof voids such as long-eared bats (*Plecotus* sp.). The house had several features however that could potentially be used by crevice-roosting species such as the pipistrelles (*Pipistrellus* spp.) and small *Myotis* spp. Such features noted included: gaps beneath raised and misplaced tiles; gaps behind soffits at the front gable; a missing tile on the front gable; a gap behind the soffit at the side (northern) chimney; an open vent on the rear extension; and a lifted tile at the junction of the rear extension.

- 4.3.2** Replacement roosting opportunities should be provided so that they are available to bats in the short-term i.e. prior to and during the work by erecting woodcrete bat boxes suitable for the species present on nearby mature trees or buildings before the work starts.

- 4.3.4** If roosts are to be lost, the newly extended property could incorporate replacement roosting opportunities. For example, bat access tiles that provide access for bats beneath tiles in new sections of roof. Alternatively purpose built bat roosting boxes could be installed such as Schwegler 1FR bat tubes or Habibat 001 boxes within the walls of the extended house. **N.B. if bats are allowed access to the space between tiles and lining, breathable roofing membranes, which are harmful to bats must not be used; bitumen and hessian (Type 1F) felt or timber sarking should be used instead.**
