## Arboricultural Post Completion Report

Geoffrey Field Infant School  
Exbourne Road  
Reading  
RG2 8RH

Reading Borough Council  
Level 11  
Civic Centre  
Castle Street  
Reading RG1 7AE

Survey Date: 30<sup>th</sup> January 2018  
Report Date: 13<sup>th</sup> February 2018  
Project no: 564

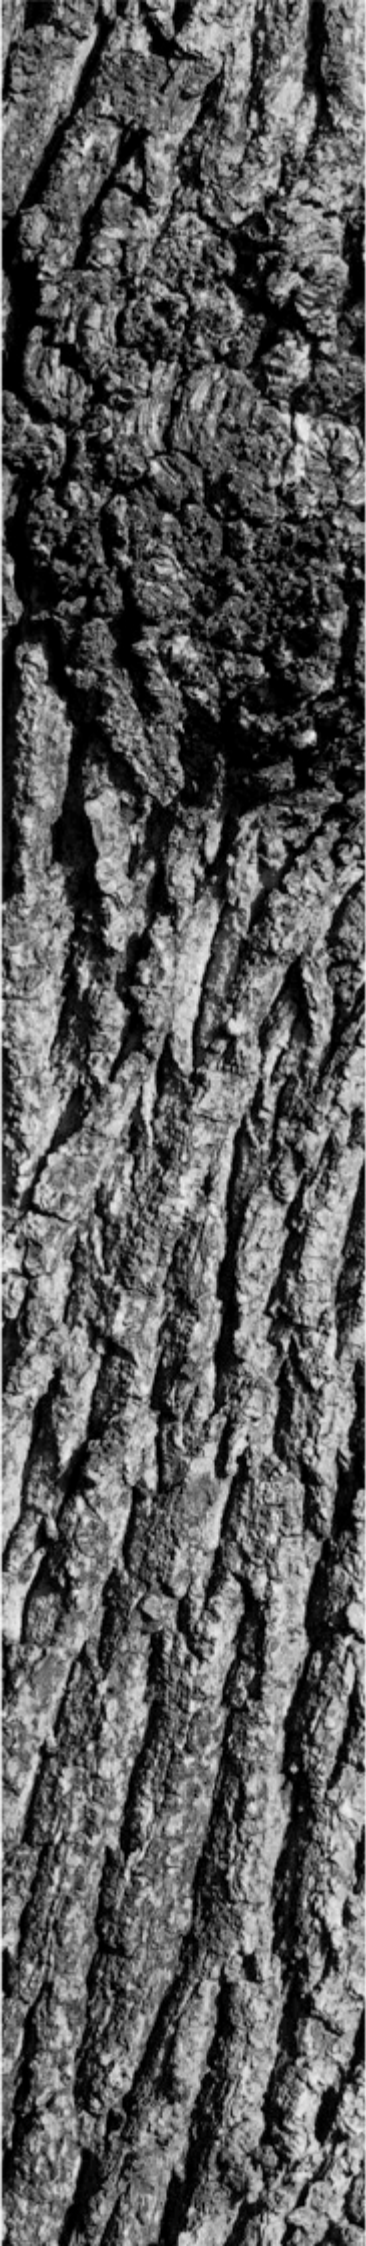
Basal stems of two newly planted cherry trees (*Prunus avium Plena*). Both have significant wounds and may require replacement.

- 4.1 It is recommended that the two damaged cherry trees in the northeast corner of the site are re-inspected within 18 months to ascertain whether the basal stem wounds are occluding, or whether heartwood decay is developing. If the trees are found to be of poor vitality, or if there are other signs that decay is progressing, then the trees must be replaced in accordance with Condition 20 of the approved planning permission.
- 4.2 Trees must be maintained in accordance with the approved maintenance plan. It is of particular importance that the trees ties and spacers are adjusted as necessary to allow for growth, in order to prevent stem damage, until such time as the trees are established and the ties can be removed.
