## DETERIORATED SOFFIT TO THE ENTRANCE PORTICO OF THE ROYAL BERKSHIRE HOSPITAL NORTH BLOCK

### HERITAGE STATEMENT / DESIGN & ACCESS STATEMENT

June 2017

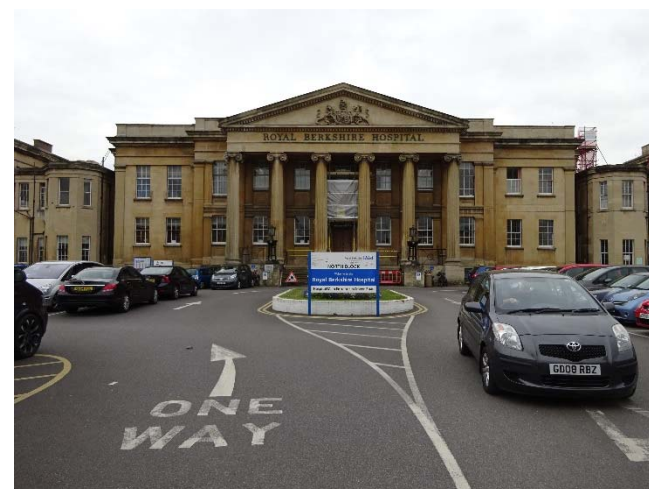
Figure 6: Front Elevation

The central Ionic portico to the north elevation is constructed of Bath Stone ashlar blocks with the roof of that part of the structure supported by 6 pedimented columns.

The soffit to the portico comprises what is understood to be original lime plasterwork on a substrate of wooden laths. The roof covering is understood to be of natural slate, which appears to have been overlaid with a layer of bitumen asphalt sheet.

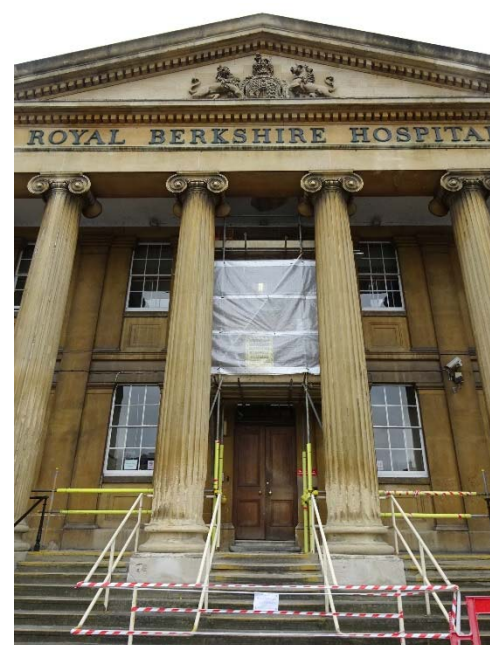
Figure 7: Front Elevation

The site access will not be altered in any way. Temporary access may be necessary due to safe working platform, as figure 7.
