| Project Title: | St John's Lodge, Reading |
| Subject: | Structural Survey Report |

## STRUCTURAL SURVEY REPORT FOR ST. JOHN'S LODGE, READING.

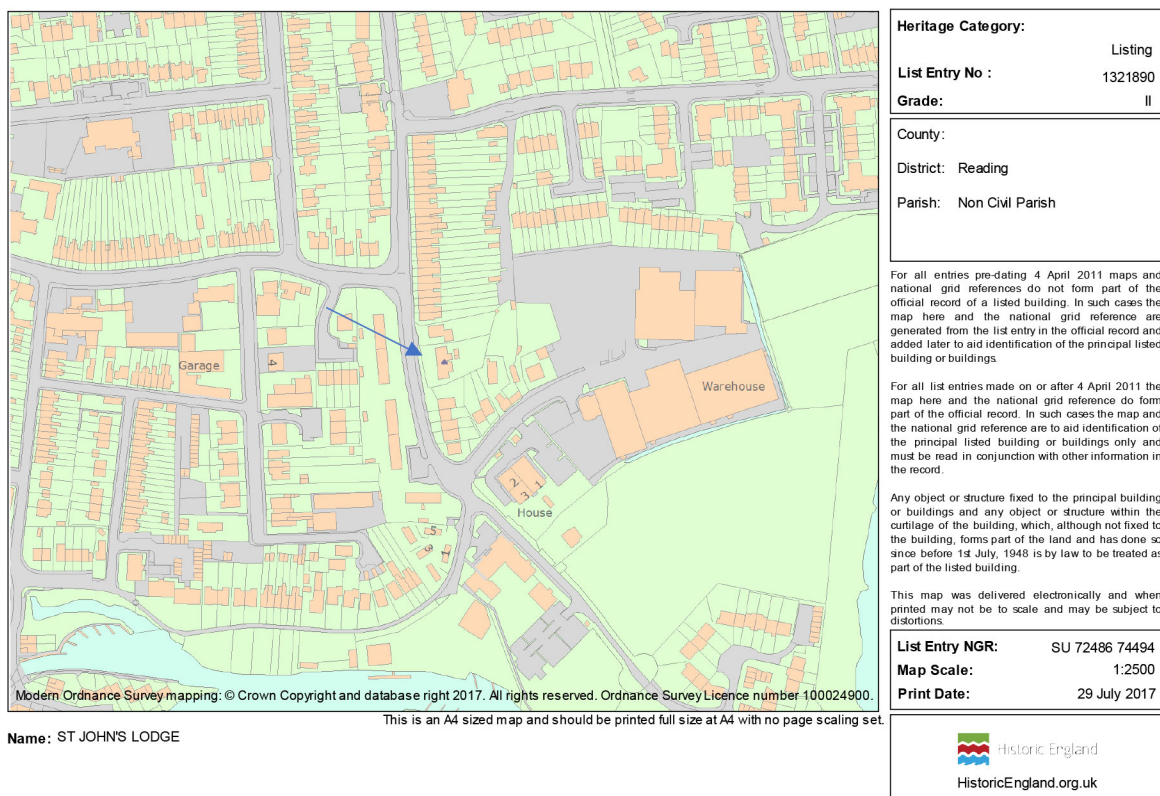
St. Johns Lodge is listed under the Planning ( Listed Buildings and Conservation Areas) Act 1990 as amended for reasons of architectural or historic interest. It was first entered into the register of listed buildings on the 22<sup>nd</sup> of July 1976. The property had two extensions. The original building is believed to have been built in the 17<sup>th</sup> century, while the extensions were built on the 18<sup>th</sup> and 19<sup>th</sup> century. The original building is of stone and timber construction with tiled roofing, while the extensions were made of other masonry materials. The deflected gable wall adopted a timber box frame with brick infill.

During the ocular inspection, it has been observed that the rear portion of the property adopts a box type timber frame system, which is the norms in the 17<sup>th</sup> century. In between the box frame are brick infills. At the time of the visit, the brick infills appear to be bulging and much of the timber frame is decayed.

At present, the physical state of some of the timber members are now decayed. Further, the bond between the brickwork has deteriorated. Since the brick infills sit on the decayed timber members, portions of the brick infill are no longer sufficiently supported. The combined effect of the decayed timber and the poor bonding between the bricks resulted in a fault which is evidenced by the bulging of the brick infill.

The wall in question is structurally unstable. It is not safe to use the area of the property until remedial measures are made. The structural stability of the structure discussed above is primarily dependent on the timber members. Therefore, the decayed timber members must be addressed, while remedial measures must be taken to prevent further movement of the brick infills.

Primarily, temporary support must be provided to prevent the walls to move further out. A scaffolding system designed to support the wall may be a good option, as it may also be used to carryout repair works. Also, it is recommended to remove all vibration causing equipment in the area, such as the washing machine. The said area must not be used for storage or habitation until it is repaired.

The heavily rotten timber members can be repaired by way of carving out the decayed part and reinserting green timber to match the existing. However, suitable bonding agents such as injected epoxy resin must be employed. The bulging brick infills maybe repaired by providing permanent lateral support system, such as those provided by Newman Building Solutions, Helifix or other similar anchorage systems. To address the bond between the brick infills, the soft part between the bricks must be removed and replaced by a suitable material, normally a bonding grout. All bonding agents have different curing periods, and must therefore be taken into account when deciding whether the structure is already stable.
