# Bat Activity Survey

**94 Oak Tree Road**

16-002-IBA

June 2016

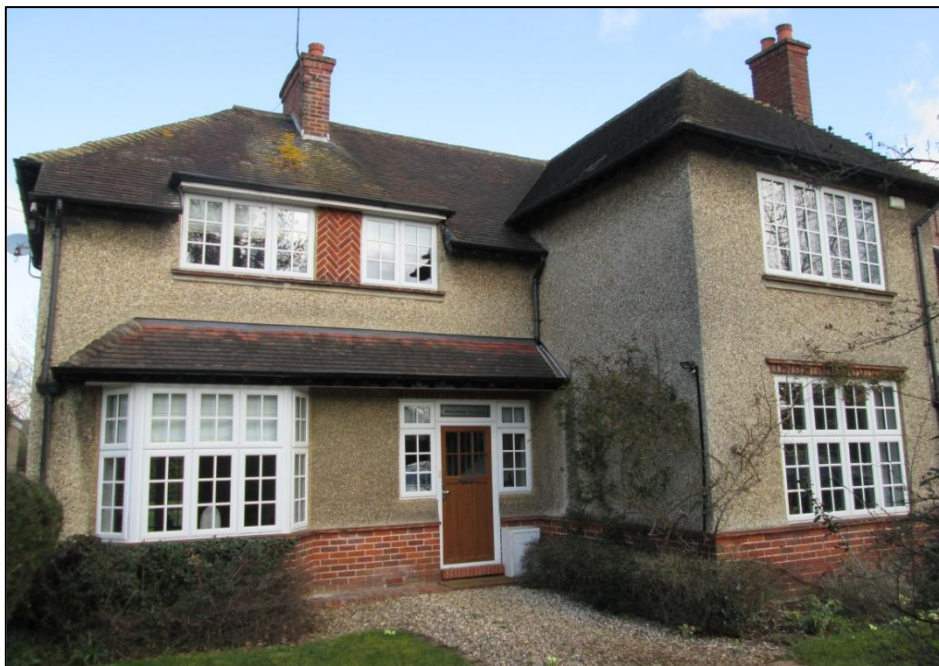
**Figure 2 – Southern (front) elevation of 94 Oak Tree Road**

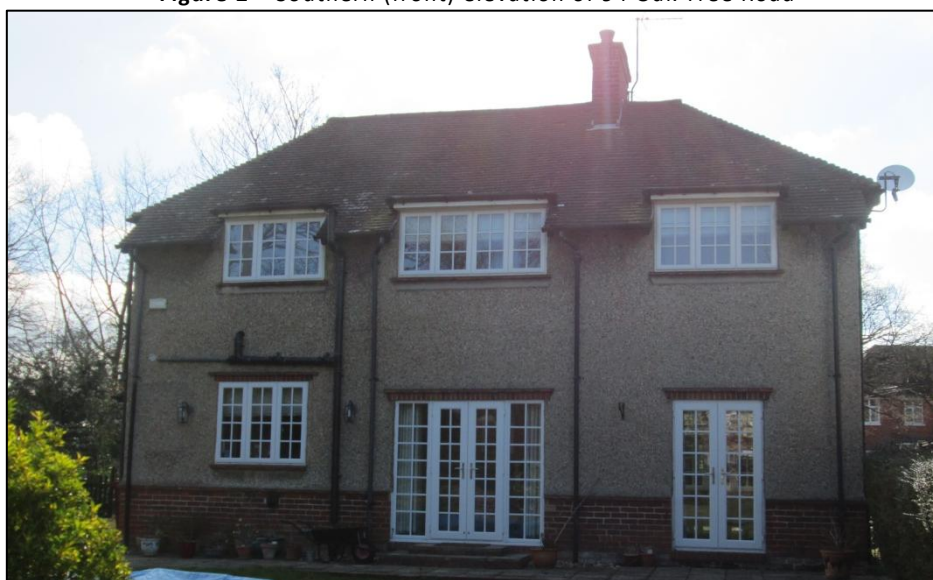
**Figure 3 – Northern (rear) elevation of 94 Oak Tree Road**

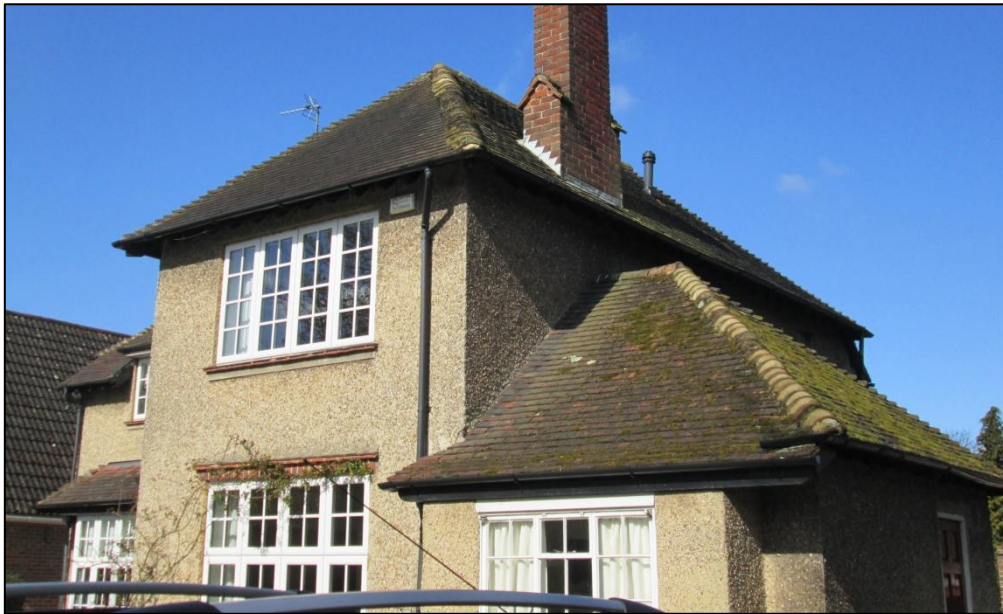
**Figure 4** – North-eastern (side) elevation, showing single storey extension

In addition to the main roof void in the property, there was an additional void above the single storey extension to the side of the property (Figure 4). There was no access to this void and as a result an internal survey could not be conducted.

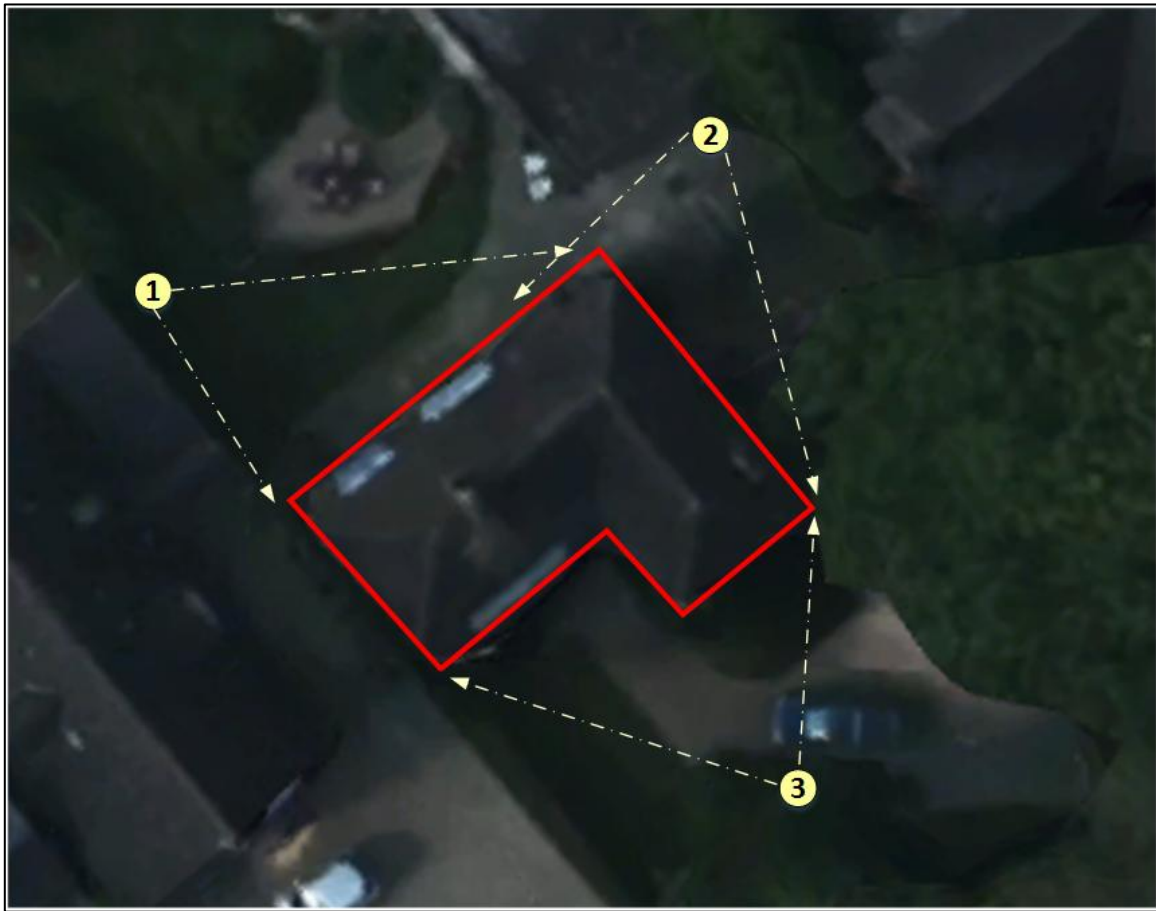
The emergence surveys were carried out on the main house only as the garage was not deemed suitable to support roosting bats. Three surveyors were used for all three surveys, the positions of which are indicated in Figure 13.

Figure 13 – Surveyor locations during the three evening emergence surveys a 94 Oak Tree Road

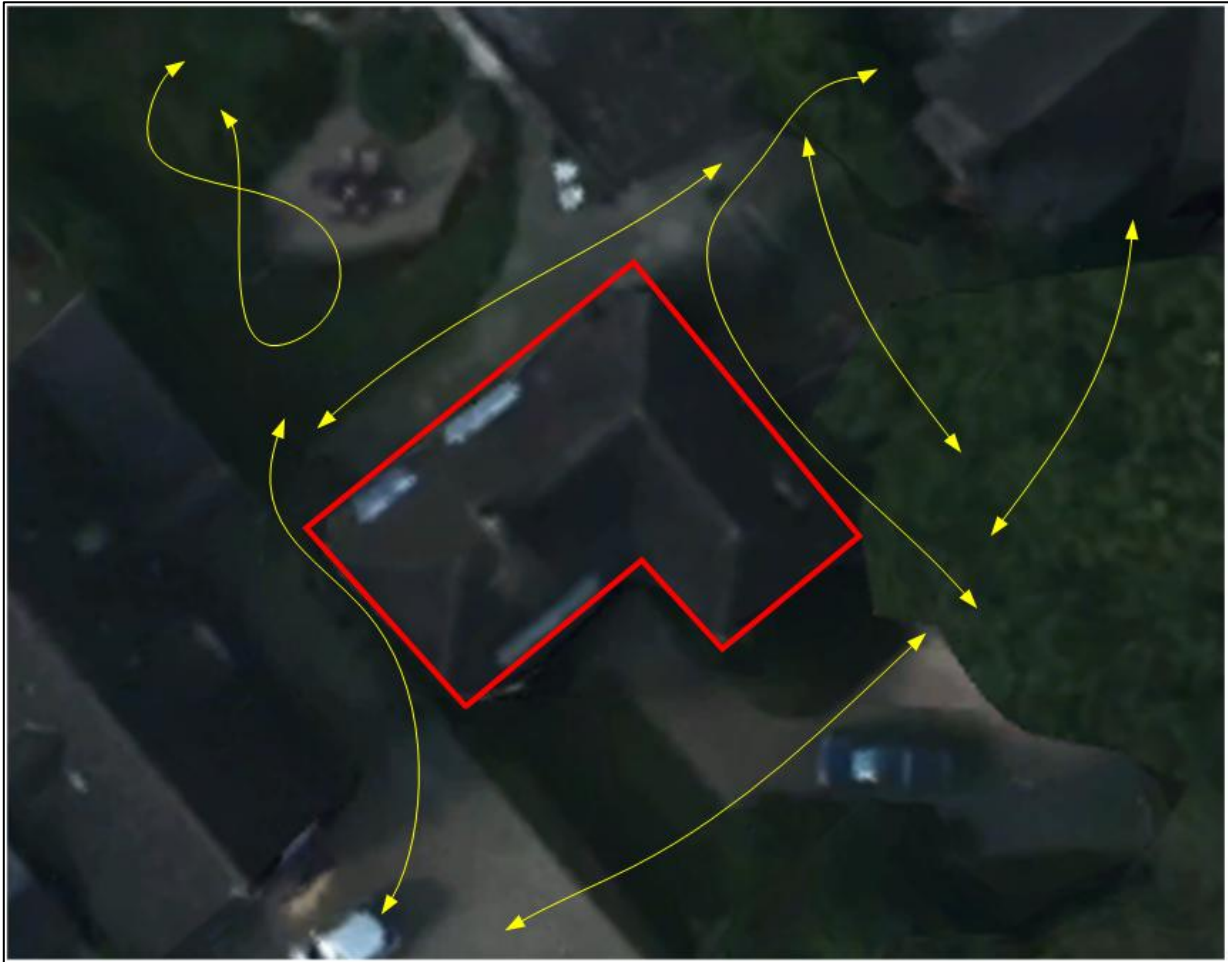
During the three emergence surveys conducted on the 16<sup>th</sup> May, 6<sup>th</sup> June and 17<sup>th</sup> June 2016, no bats were seen emerging from or entering the property at 94 Oak Tree Road. There was a moderate level of bat activity, primarily foraging in the rear garden and flying around the buildings. Over the three surveys at least four species (*Pipistrellus pipistrellus*, *Pipistrellus pygmaeus*, *Auritus plectous* and *Nyctalus noctula*) were recorded flying or foraging in the gardens surrounding 94 Oak Tree Road.

Several bats were observed emerging from the neighbouring property (No. 113 Oak Tree Road) on all three surveys. The full results of the three emergence surveys are detailed in Table 1 and Figure 14.

Figure 14 – Main flight paths used by bats observed during the three evening emergence surveys at 94 Oak Tree Road
