Name: OSBERT HOUSE

List entry Number: 1113556

### **Timber Fillet & Resin Repairs at Osbert House (Balcony)**

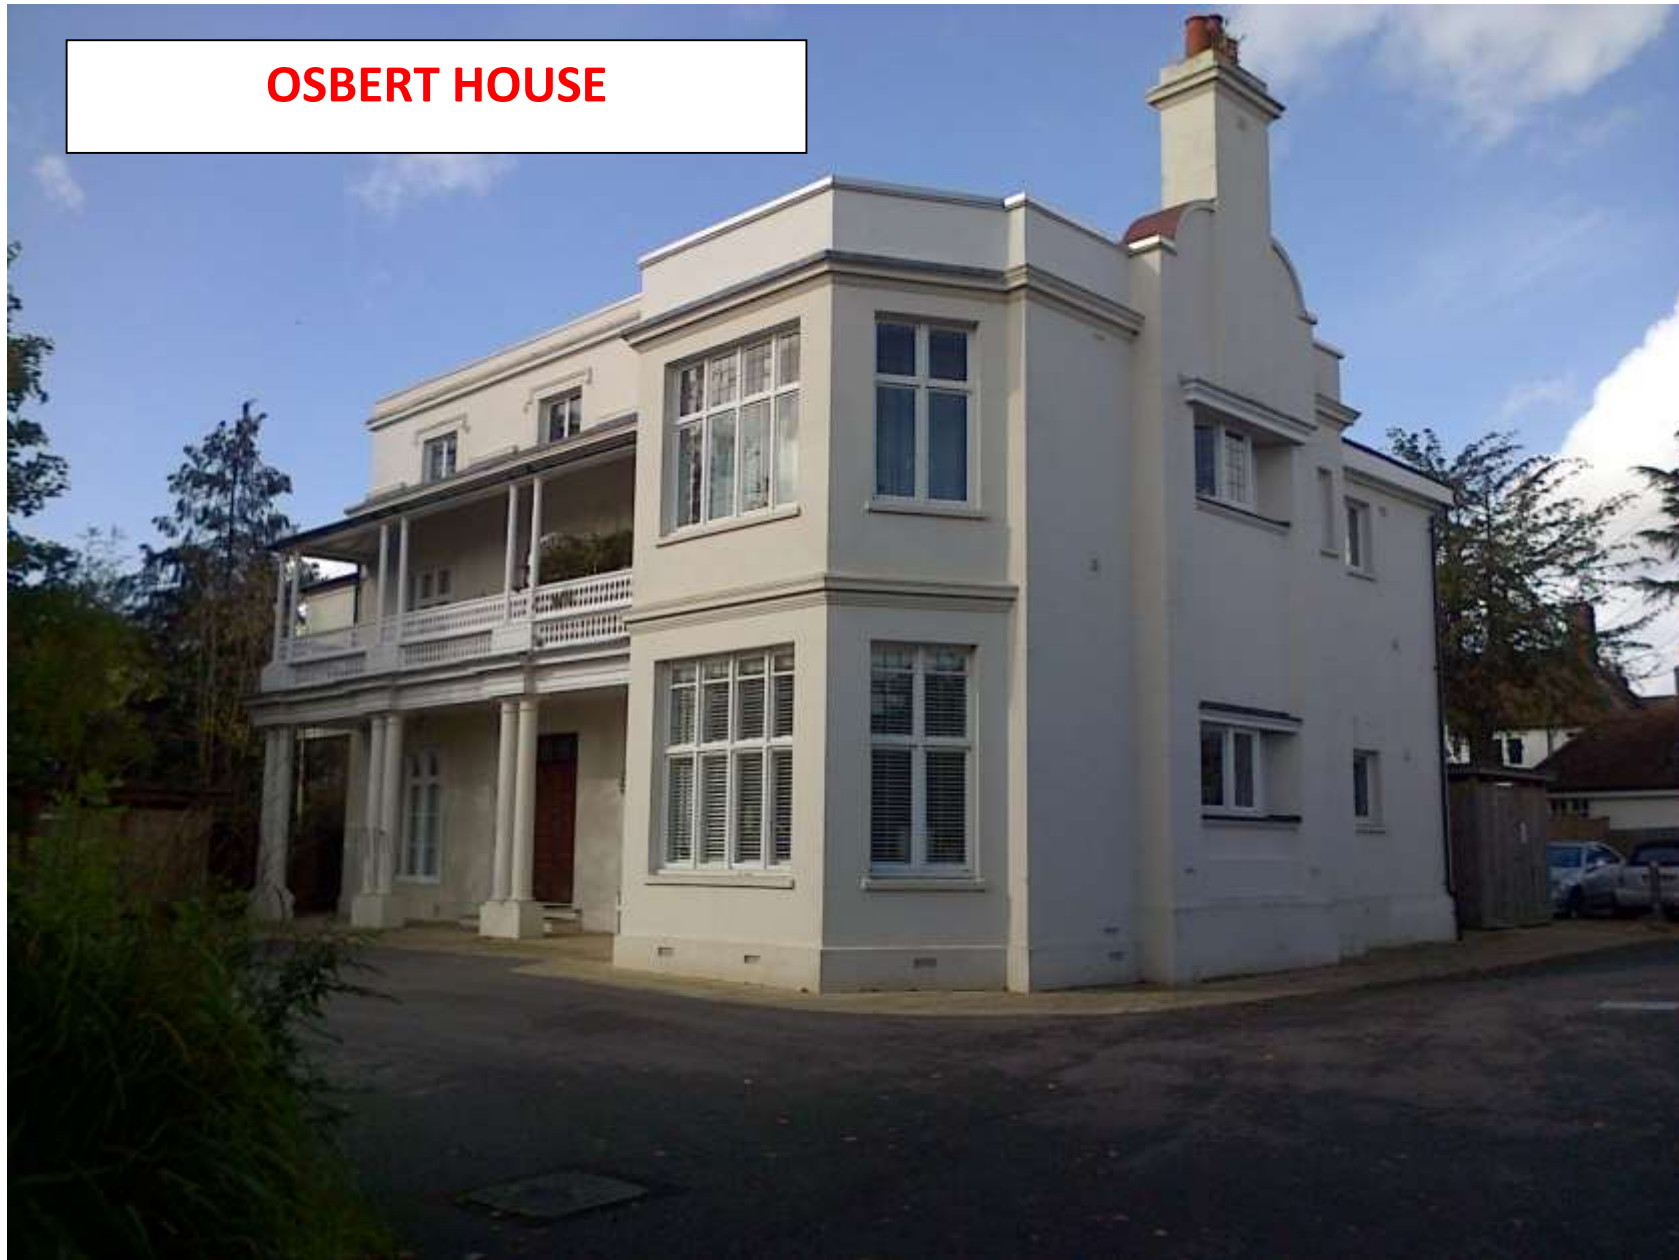
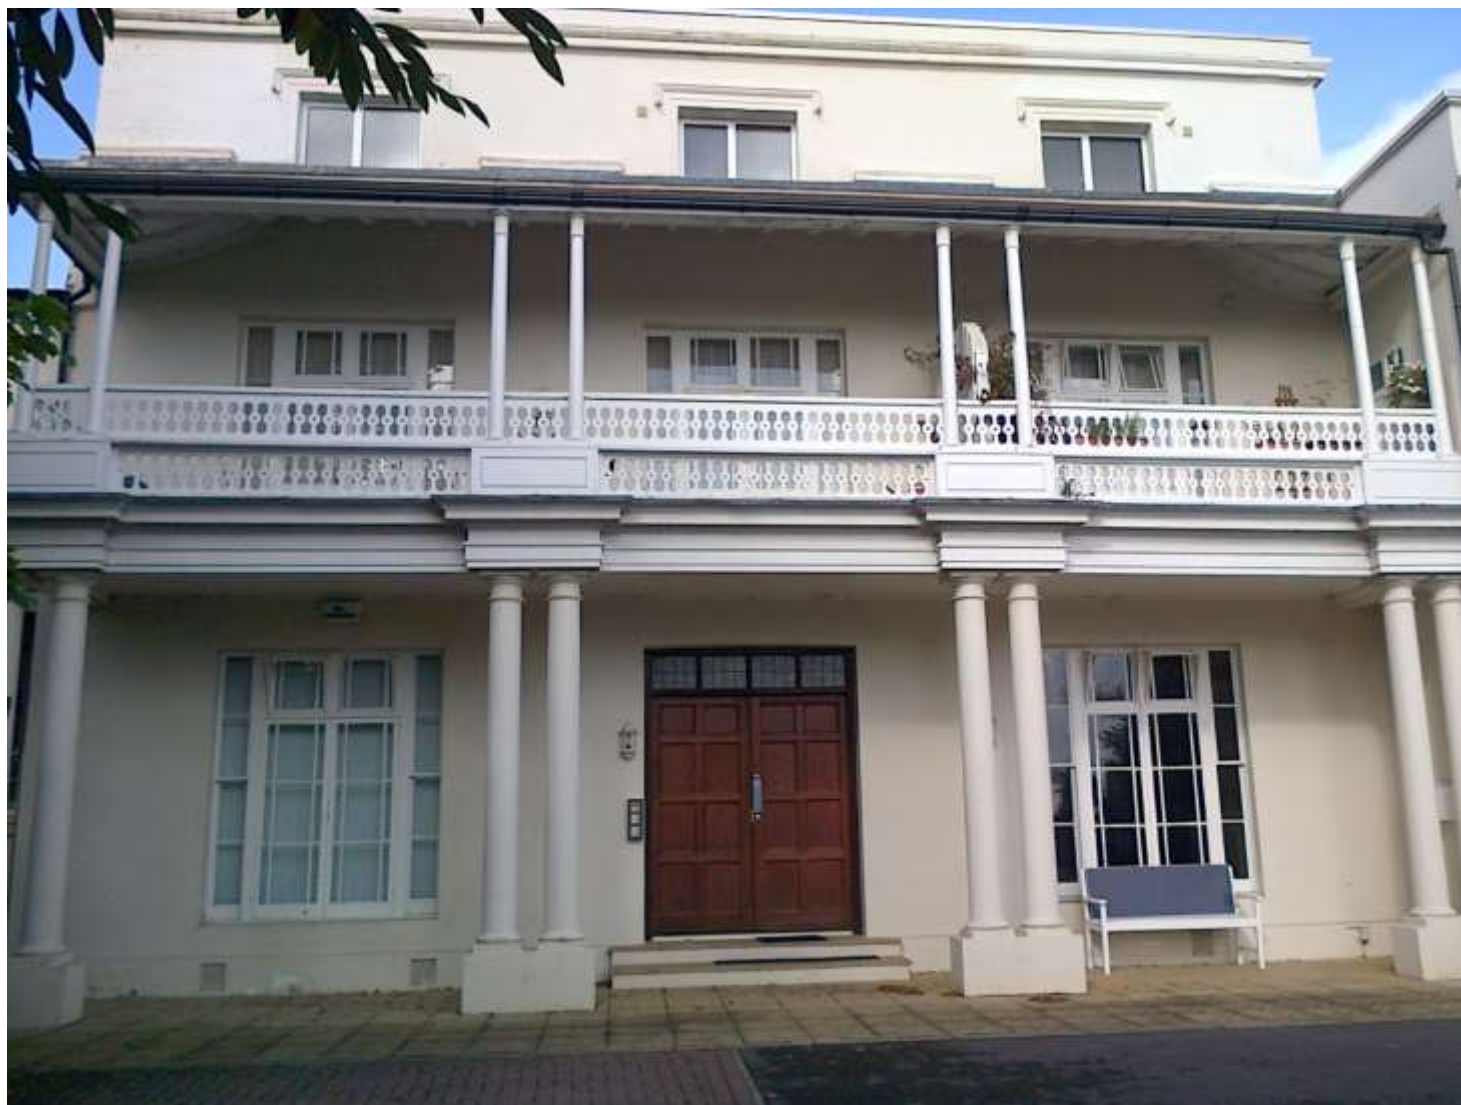
There are various areas of the timber framing, pillars and detailing which have splitting and wet rot. This will continue to travel further into the framework, which, if not dealt with in the near future, could eventually result in replacing the whole structure. It is proposed to cut out the areas of rot, treat them with a preserver solution and repair via 2pack resin wood filler. There are some fillets which are detailed and will require a carpenter to make and shape them to match the existing detailing. Once these maintenance repairs are completed, the whole of the timber balcony will be redecorated using ICI Dulux Weathershield Wood Primer, 1 coat of Weathershield Undercoat & Gloss.
