# FLOOD RISK ASSESSMENT

Caversham Park, Peppard Road, Caversham, Reading, RG4 8TZ

Prepared for: Beechcroft Developments Ltd  
Ref: 013\_ 8210940\_AP\_Flood\_Risk\_Assessment

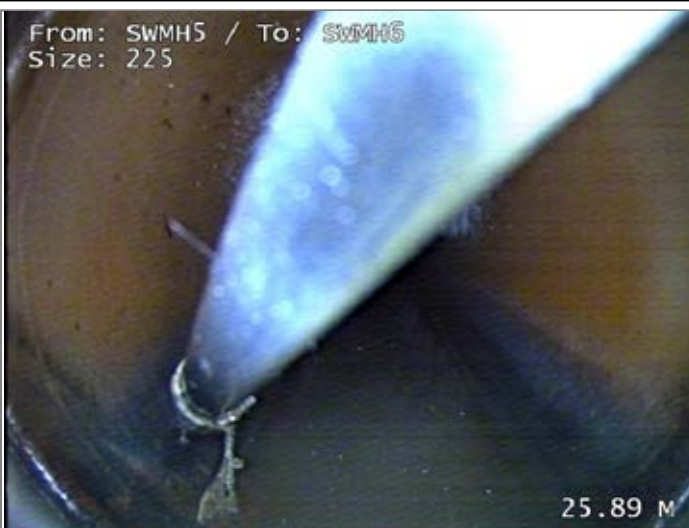
Other obstacles through connection/junction at 1 o'clock 50% cross-sectional area loss

Survey abandoned - Remark: ABANDONED SURVEY DUE TO ROD PROTRUDING THROUGH JUNCTION UNABLE TO GET CAMERA PAST ROD.

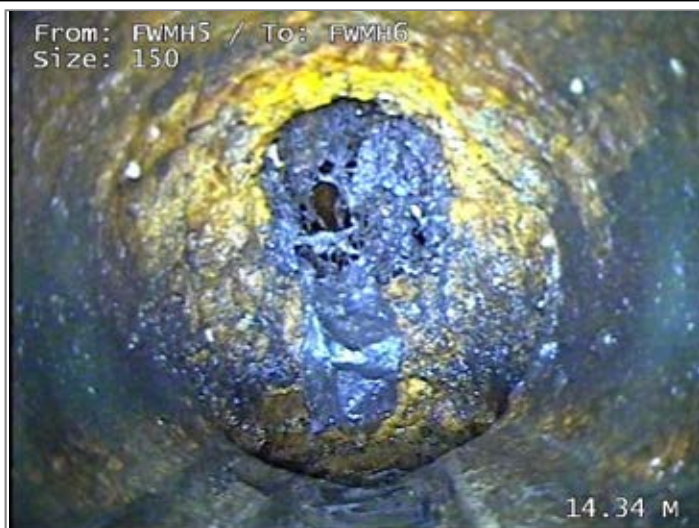
NOW AT RUNNING TRAP AT FWMH6

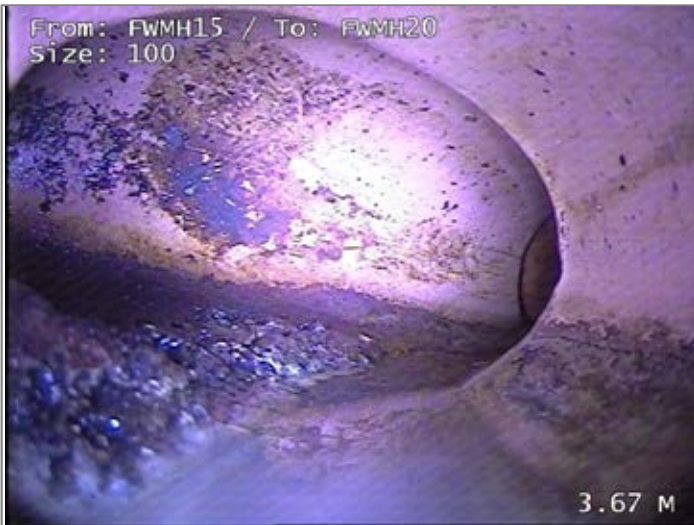
JOINING ANOTHER PIPE

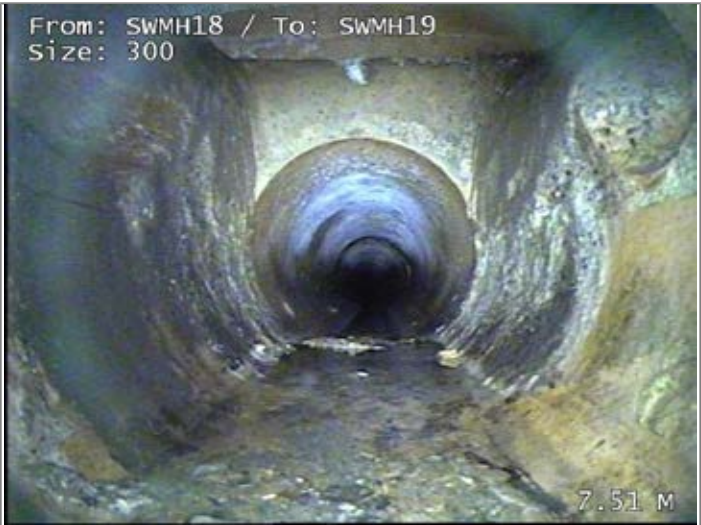
| Job Number<br><b>780878</b> | Surveyed by (Operator)<br><b>PAUL BAYNHAM</b> | Base Unit<br><b>DDFRT6A12S</b> | Date<br><b>18/06/2019</b> |
|---|---|---|---|
| <p>From: SWMH18 / To: SWMH19<br/>Size: 300</p> <p>7.51 M</p> <p>HIDDEN MANHOLE UNDER GRAVEL ACCESS ROAD</p> | | <p>From: SWMH18 / To: SWMH19<br/>Size: 300</p> <p>28.02 M</p> <p>NOW AT BACK DROP INTO SWMH19</p> | |

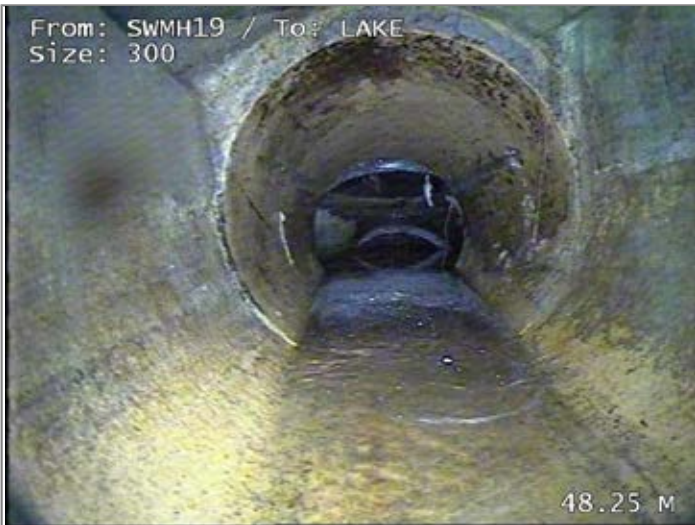
| Job Number<br><b>780878</b> | Surveyed by (Operator)<br><b>PAUL BAYNHAM</b> | Base Unit<br><b>DDFRT6A12S</b> | Date<br><b>18/06/2019</b> |
|---|---|---|---|
| <p>From: SWMH19 / To: LAKE<br/>Size: 300</p> <p>48.25 M</p> <p>HIDDEN MANHOLE</p> | | <p>From: SWMH19 / To: LAKE<br/>Size: 300</p> <p>49.10 M</p> <p>HIGH WATER LEVELS DUE TO LAKE LEVELS UNABLE TO SURVEY FURTHER</p> | |
