Entrances Lodges at Reading Old Cemetery  
Cemetery Junction  
Reading

Structural Inspection

Clave Hudson Associates  
Consulting Structural & Civil Engineers

Nov 2023  
Project Ref: 236607

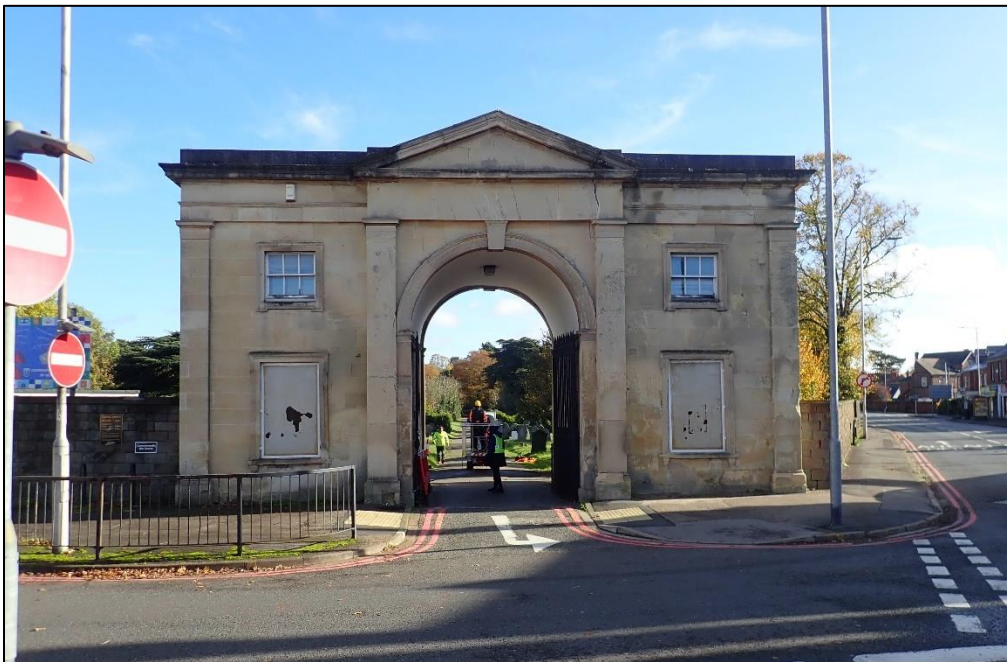
Figure 1. Principal (west) elevation of the Entrances Lodges at Reading Old Cemetery.

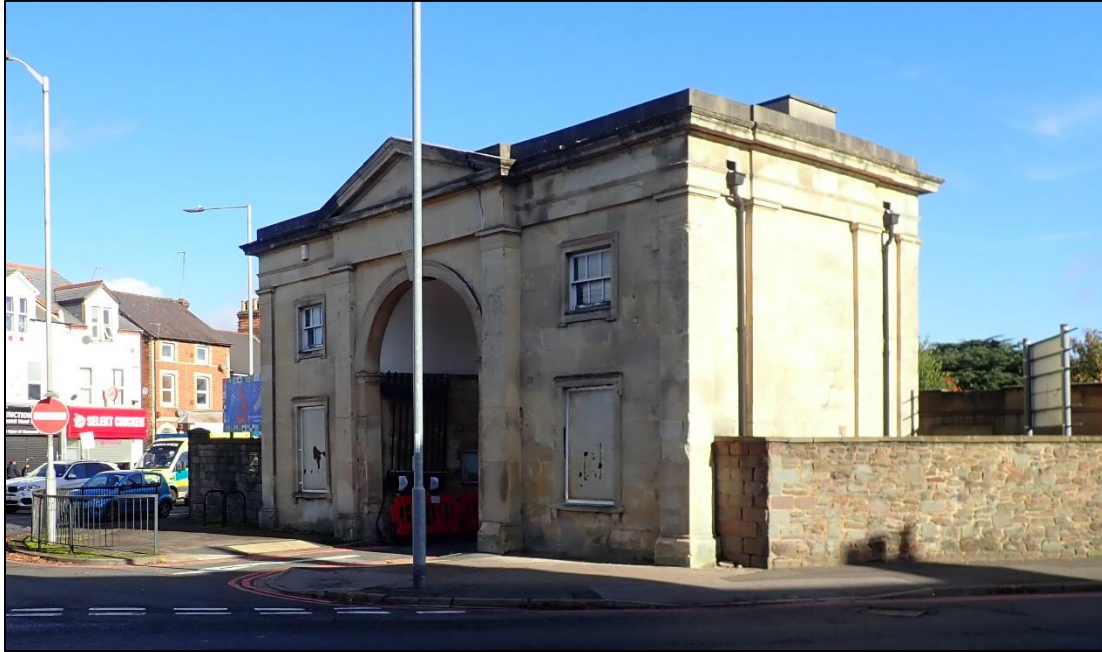
Figure 4. General view from the south-west.

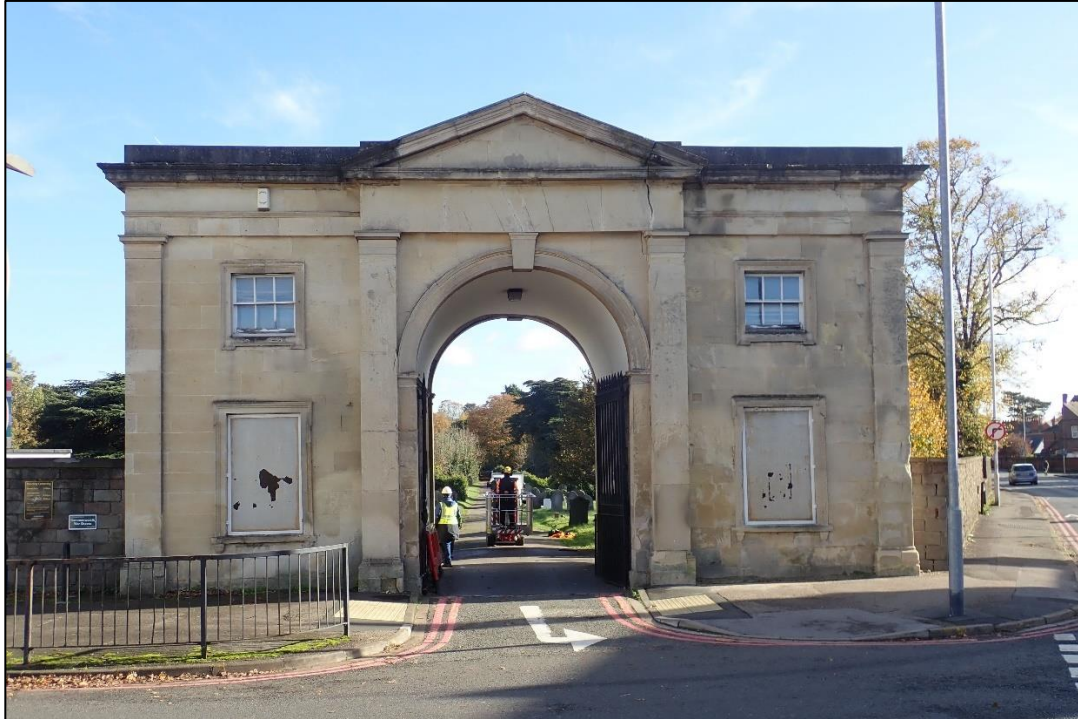
Figure 5. General view of the west elevation.

- i. The west elevation is faced in ashlar (Bath Stone) and comprises the pedimented arched opening with the two lodges on each side of the arch.

The Bath Stone on all the elevations is in varying states of repair and reflects the building's age, environment, and past interventions.

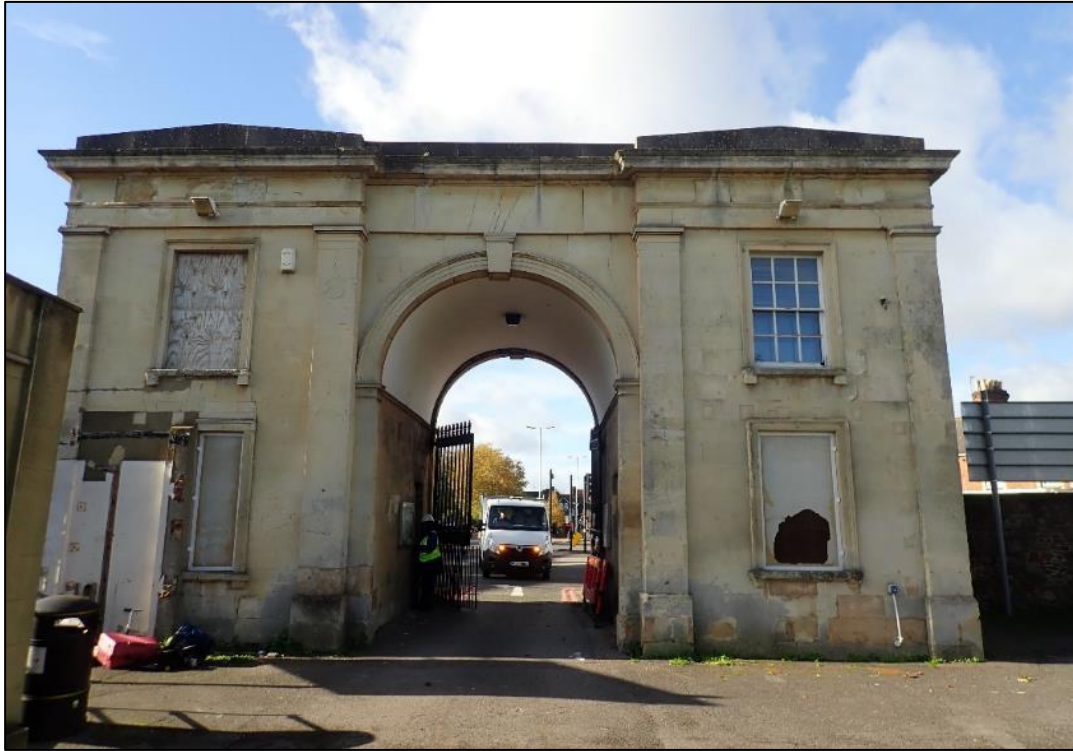
Figure 20. General view of the east elevation.

- i. The east elevation is faced in ashlar (Bath Stone) and comprises the arched opening and the two lodges.
- ii. Similar to the front elevation, the pilasters on each side of the archway are not plumb but lean outwards at a high level. While it was not observed/accessed during the inspection, images from KRP's 2020 report (dating to 2016) indicate there is a discontinuity/gap in the brickwork behind the pilaster to the south of the arch and that the pilaster may not be tied to the brickwork. As part of the next phase, we would recommend investigations are undertaken to confirm how the ashlar is tied back to the brickwork in this location, and whether the discontinuity in the brickwork still exists.

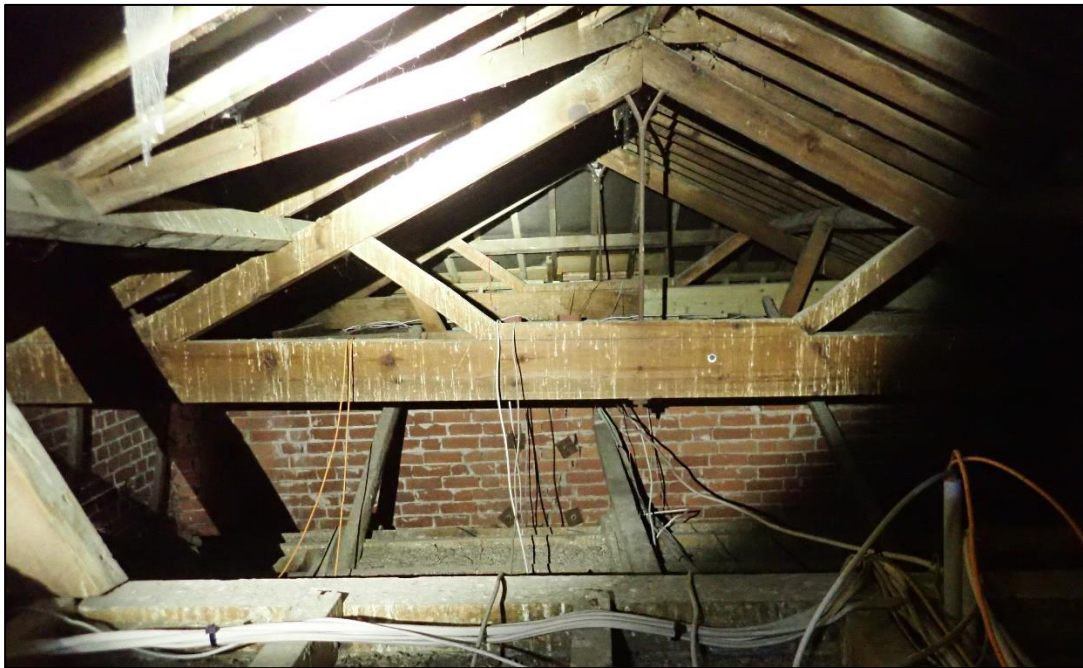
- i. As previously documented, the inspection of the roof space was limited to what could be seen from the two loft hatches under torchlight.
- ii. The roof structure comprises cut rafters, purlins and 3No trusses, with the purlins also propped off the brick walls on either side of the archway. The roof structure has been subject to extensive remedial works relatively recently with repairs to the tie-beams, rafter feet and

the valley gutter timber work observed. While there were no signs of significant structural distress to the roof structure, we would question how the timber beam/plate that supports the west end of the central truss is supported; i.e., is it supported off a brick ledge or partially embedded within the brickwork or propped off the arch? We would recommend this is investigated as part of the next phase of investigations, and an allowance is made to tie the brickwork to the ends of the central truss (Fig. 42).

Figure 40. General view of the roof structure (Looking south from the northern access hatch).
