Airsafe Surveys Ltd

## Demolition / Refurbishment Asbestos Survey Report

Phase 2  
Thurso Close  
Reading  
RG30 4YG

22<sup>nd</sup> & 23<sup>rd</sup> November 2023

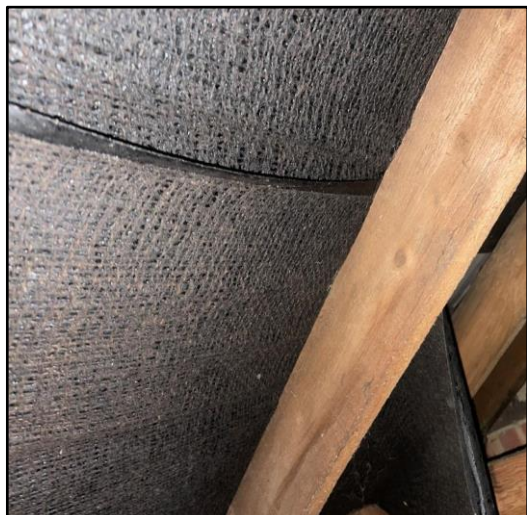
| Sample Ref: | B01 | Location: | 27 & 29 Devron Close & Blocks 2 & 4 Thurso Close |

Material Sampled: Bitumen Roof Lining

Analysis Result: **No Asbestos Detected**  
 Approximate Quantity:  
 Product Type:  
 Condition:  
 Surface Treatment:

Remarks / Recommendations: N/A

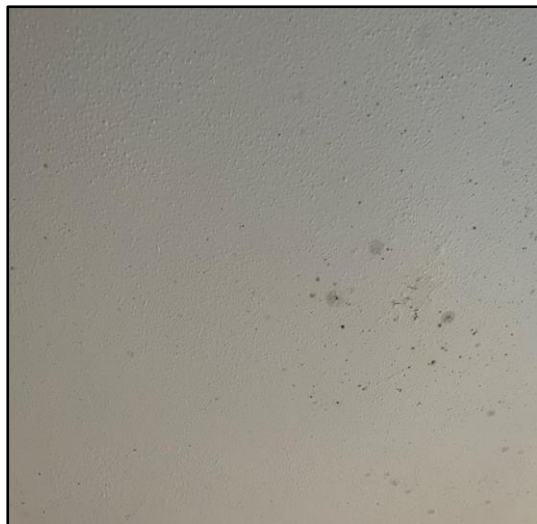
| Sample Ref: | B10 | Location: | 29 Devron Close Flat 1 Kitchen |

Material Sampled: Texture Coating

Analysis Result: **No Asbestos Detected**

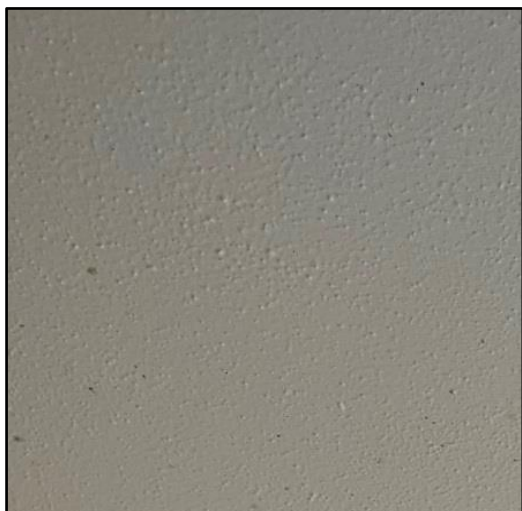
| Sample Ref: | B19 | Location: | 27 Devron Close Flat 2 Kitchen Ceiling |

Material Sampled: Texture Coating

Analysis Result: **No Asbestos Detected**

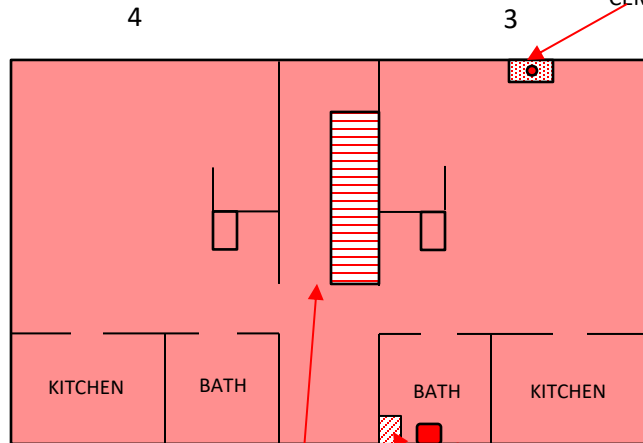
### 1<sup>ST</sup> FLOOR

**B13** – LANDING  
FLOOR TILES +  
BITUMEN  
ADHESIVE

**B16** – PRE-FORMED  
CEMENT FLUE PIPE  
IN RISER

**B20** – THROUGHOUT GROUND  
FLOOR BITUMEN ADHESIVE

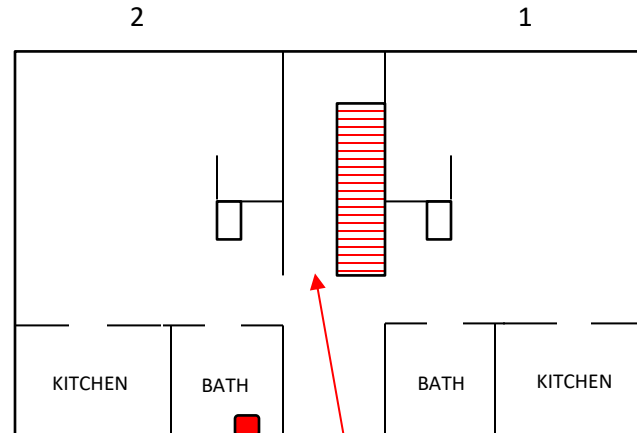
### GROUND FLOOR

**B21** – LOBBY  
FLOOR TILES +  
BITUMEN  
ADHESIVE

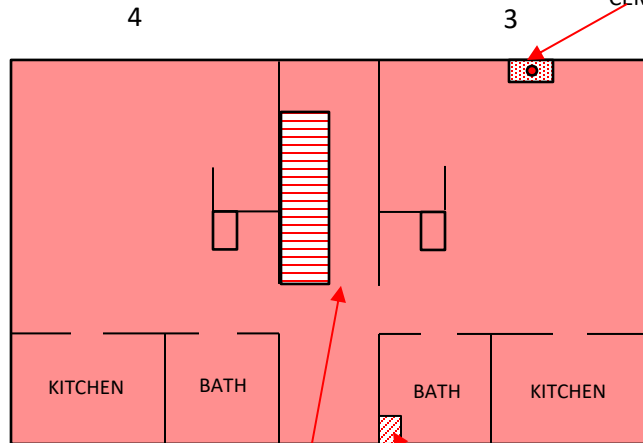
### 1<sup>ST</sup> FLOOR

B25 & V40 – INSULATION  
BOARD BOXING AND  
CEMENT FLUE PIPE

B26 – LANDING  
FLOOR TILES +  
BITUMEN  
ADHESIVE

B29 – THROUGHOUT GROUND  
FLOOR BITUMEN ADHESIVE

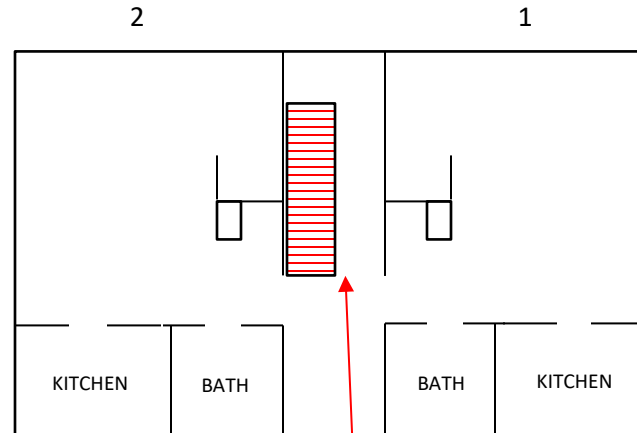
### GROUND FLOOR

B28 – LOBBY  
FLOOR TILES +  
BITUMEN  
ADHESIVE

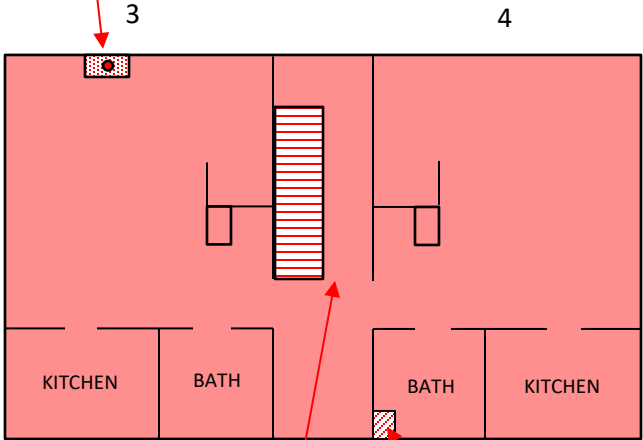
**1<sup>ST</sup> FLOOR**

B30 & V41 – INSULATION  
BOARD BOXING AND  
CEMENT FLUE PIPE

B34 – LANDING  
FLOOR TILES +  
BITUMEN  
ADHESIVE

B33 – PRE-FORMED  
CEMENT FLUE PIPE  
IN RISER

B37 – THROUGHOUT GROUND  
FLOOR BITUMEN ADHESIVE

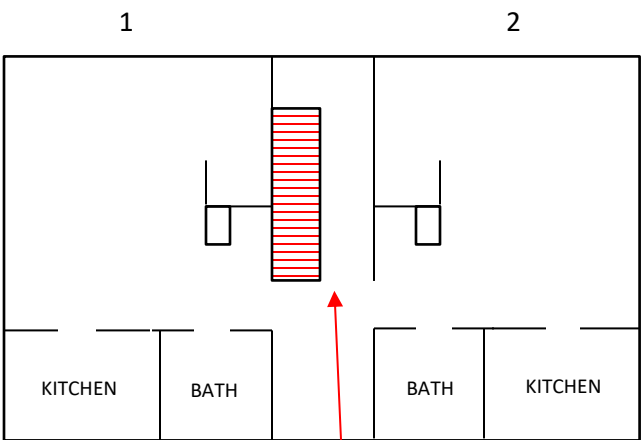
**GROUND FLOOR**

B36 – LOBBY  
FLOOR TILES +  
BITUMEN  
ADHESIVE
