# Health & Safety Duty of Care Report©

Site: Haywood Court, St Bartholomew's Road, Reading, RG1 3QF

Client: Alba Management Date: 16/04/2024 Surveyor: Danny Konstantinidis.

## HERITAGE TREE SERVICES ARBORICULTURAL HEALTH & SAFETY SURVEY

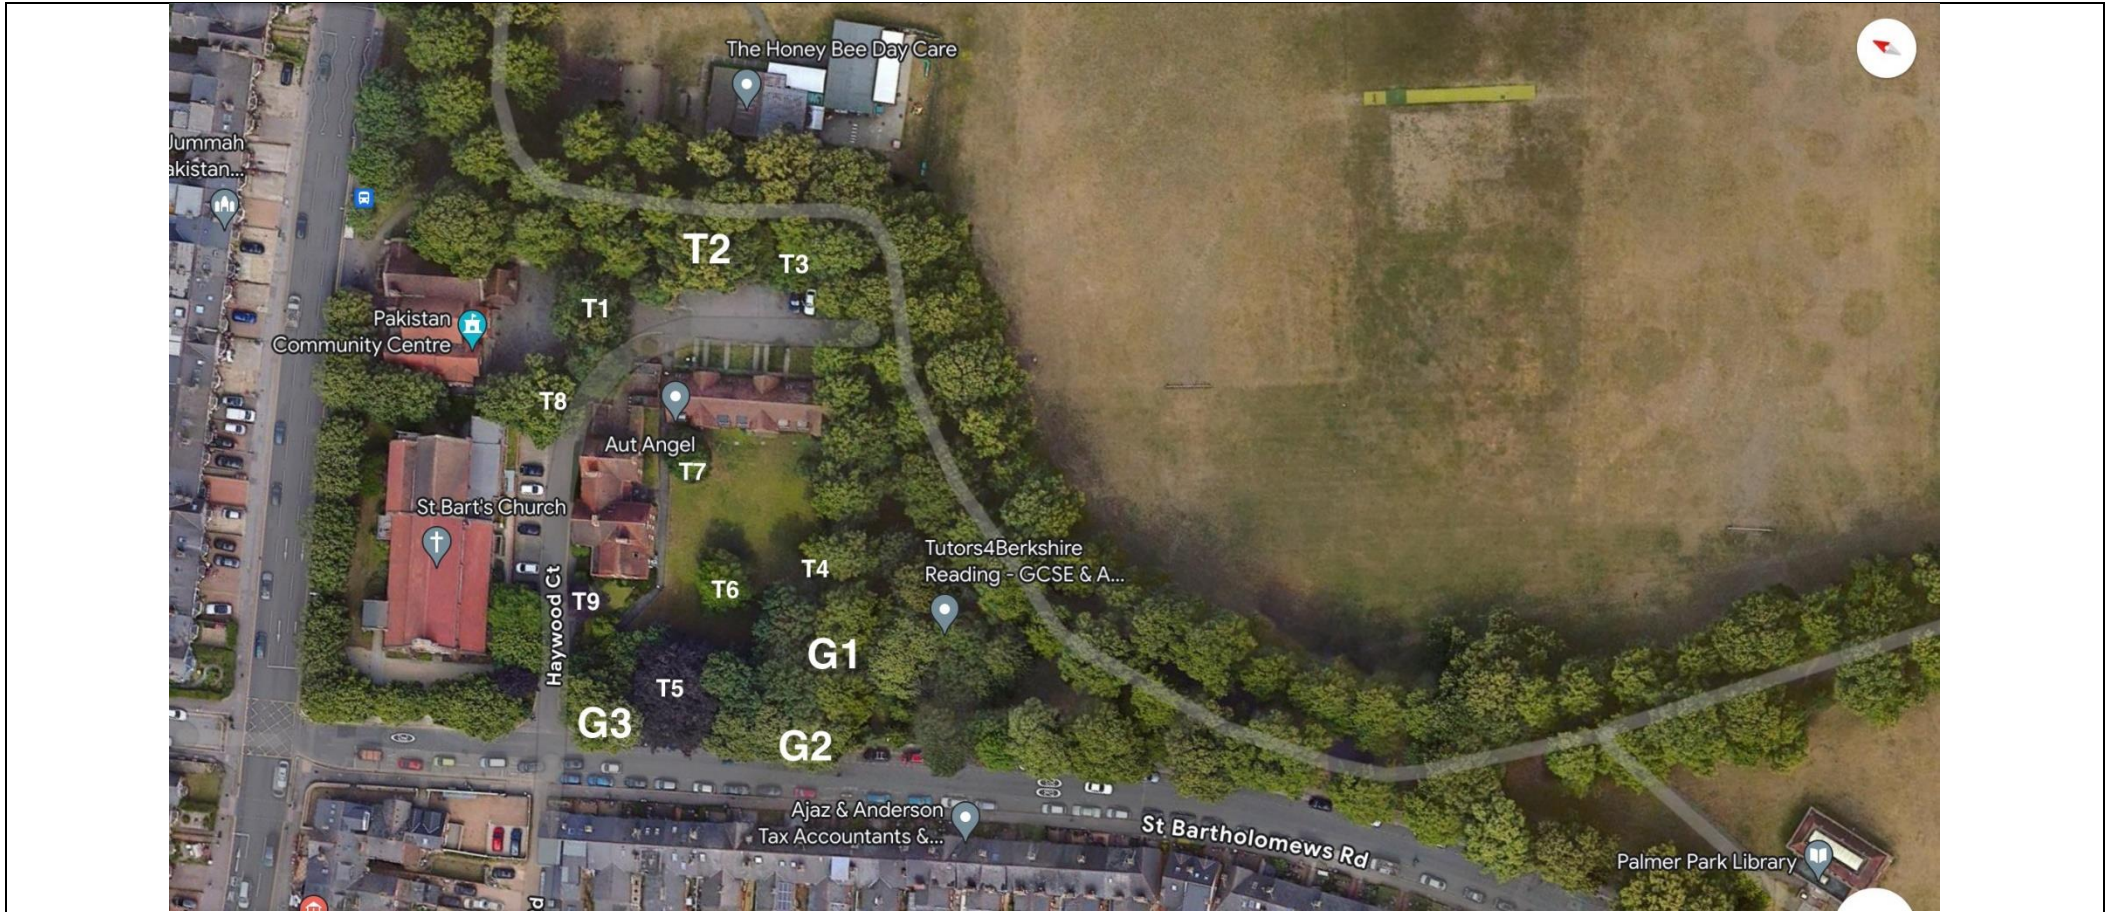
| <b>T9</b> | Plum | EM | M | G | F | Dead stem over relatively low occupancy grassed area. | Remove dead stem to source | 2<br>2<br>2 | 6 | 5 |
