# Heritage, Design and Access Statement

BrewDog, 11 Castle Street, Reading

Project: 2404-02

External Repairs, 11 Castle Street, Reading

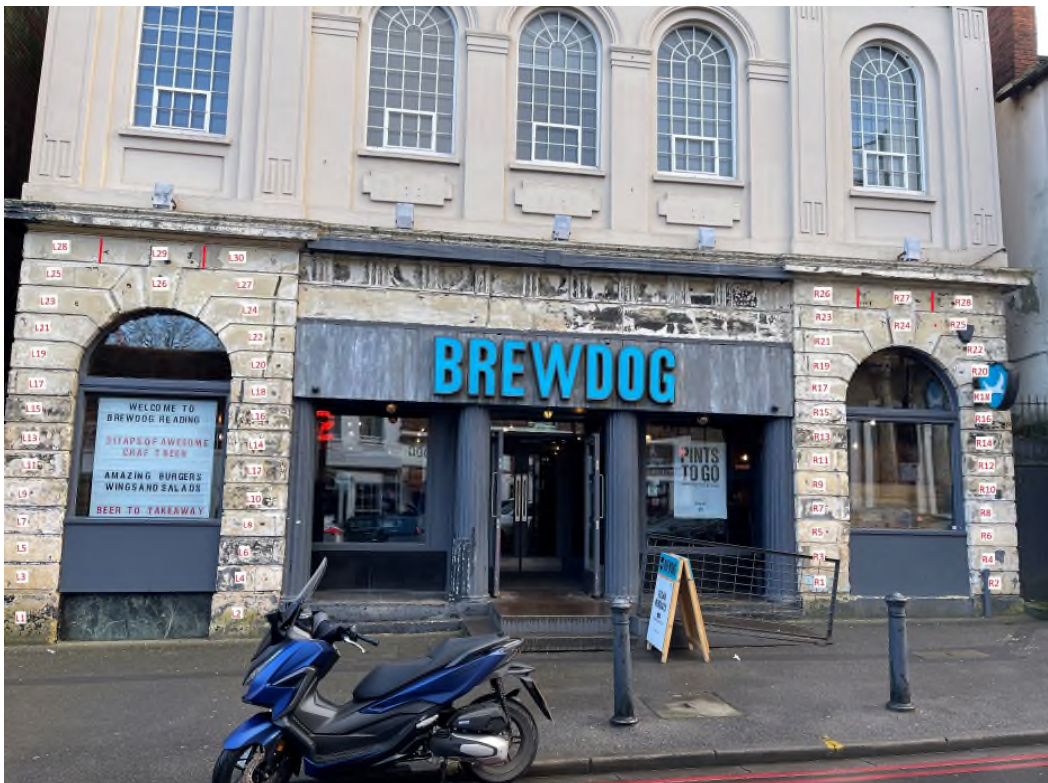
Right Bay Survey

| Item | Description |
|---|---|
| R1 | crack repair, plastic repair |
| R3 | plastic repair |
| R5 | crack repair, plastic repair |
| | The plinth will require plastic repairs along the top and face filling |

| Item | Description |
|---|---|
| R2 | plastic repair |
| R4 | plastic repair |

| Item | Description |
|---|---|
| R7 | plastic repair to right, face fill rest |

| Item | Description |
|---|---|
| R13 | crack repair |
| R15 | crack repair, plastic repair |
| R17 | crack repair, large hole to repair |

| Item | Description |
|---|---|
| | All stones require edges repairing |
| | The cornice looks in poor condition and unstable in some areas, this will require closer inspection when we have access |
