## Phase 3 Geo-Environmental Investigation

Nos. 389-389A Gosbrook Road & Nos. 2-4 Send Road,  
Caversham  
Reading  
Berkshire  
RG4 8EH

Project Reference J163A

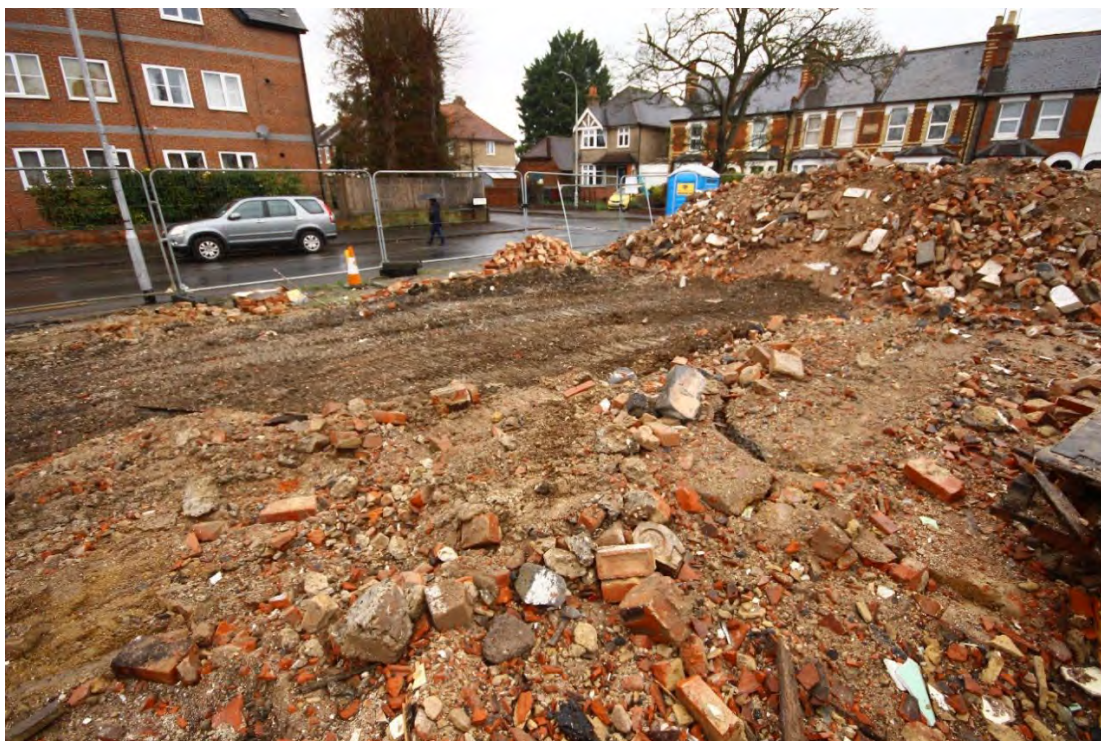
#### 3.1 No. 389 Gosbrook Road Workshop & 389A Gosbrook Road Bungalow (Paint Shop)

The breaking up and removal of the hardstanding from below these buildings revealed differing areas of concrete slabs, varying in thickness and apparent age. The foundations of the buildings were very shallow and the floor slabs appeared to have been poured directly onto the dark grey brown ashy topsoil layer. Below the ashy topsoil was the paler coloured made ground comprising largely Langley Silt with intermixed possibly trafficked brick fragments.

A patch of blackened soil was noted below the footprint of the old stable block (see pic page 11). There was no notable smell of solvents or fuel however, a sample of this material referenced Paint Shop 2 was recovered and scheduled for additional detailed semi volatiles (SVOC) analysis. Some further excavation showed this was not a plume of contamination it was just a smear of blackened clay.

The remnant foundations of the building were shallow as discussed and included what appeared to be an old drain chamber. This chamber was found to be filled with fragments of asbestos cement roof board (see pic page 11). This was cleared by the demolition contractor by hand and bagged to go into a dedicated asbestos skip. Once the remaining rubble had been removed, a final inspection of the exposed ground was carried out and two samples were recovered.
