# GEOSHIELD Verification Report

PROJECT REFERENCE:

GEO103260

Riverside Academy

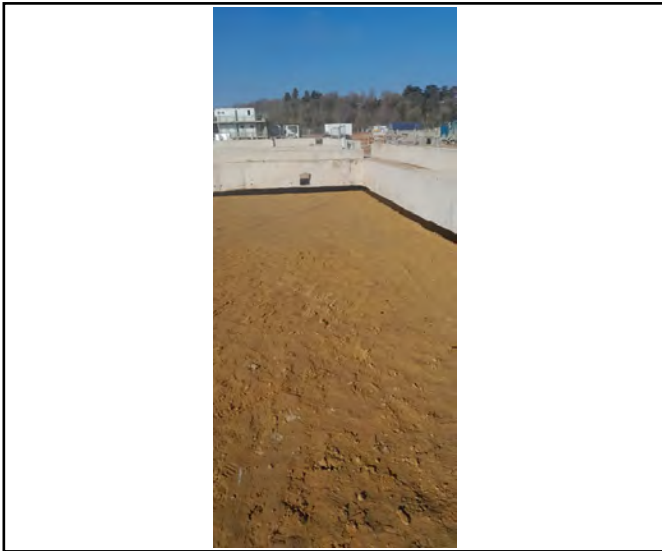
Photograph of the sand blinded  
floor ready for the membrane.

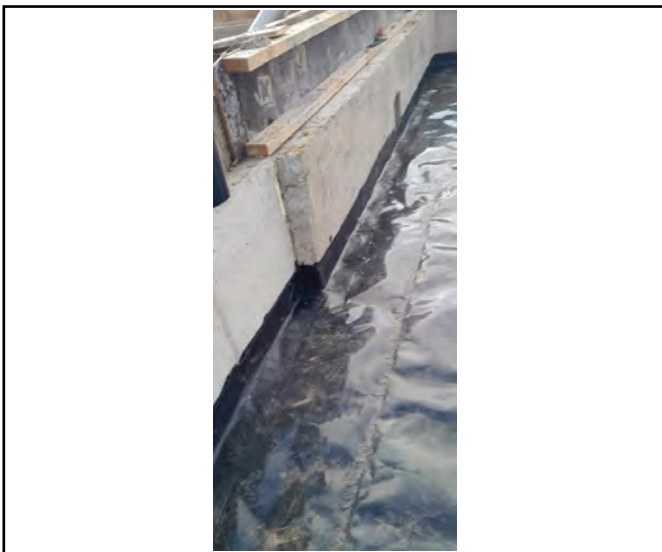
Installation of the retrofit  
dealing required onsite.

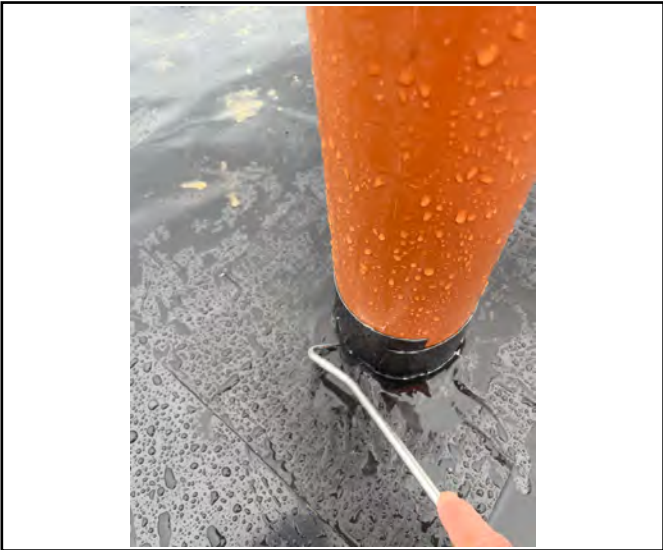
Pick and probe test carried out  
on a pipe penetration.

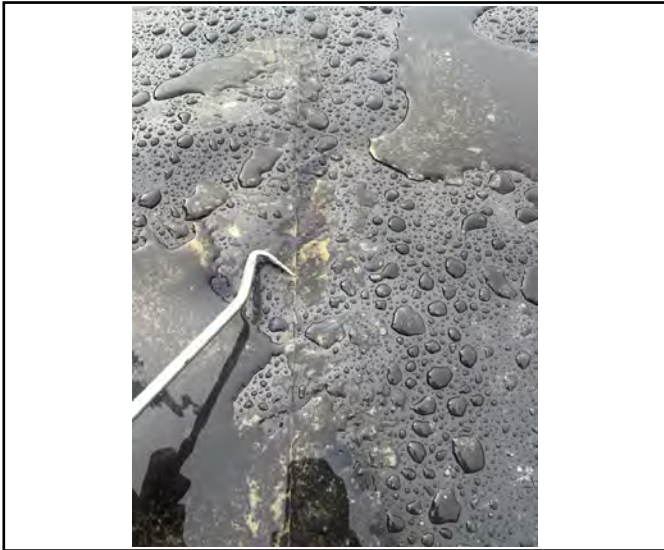
Pick and probe test conducted  
upon a sealed lap joint.

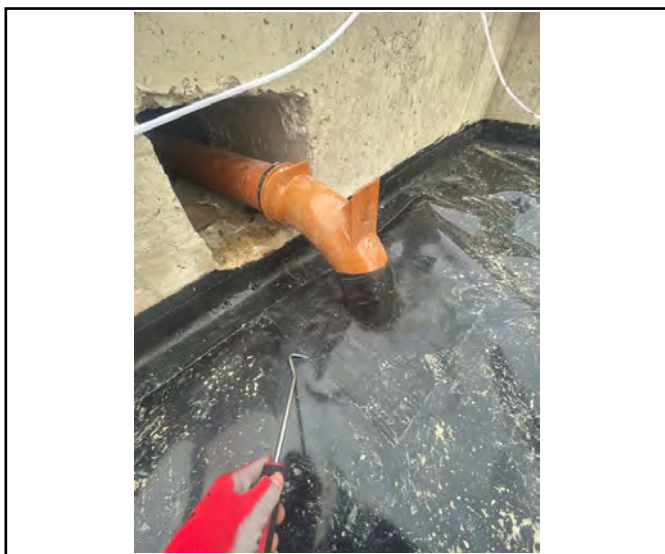
Pick&probe testing to pipe penetration.

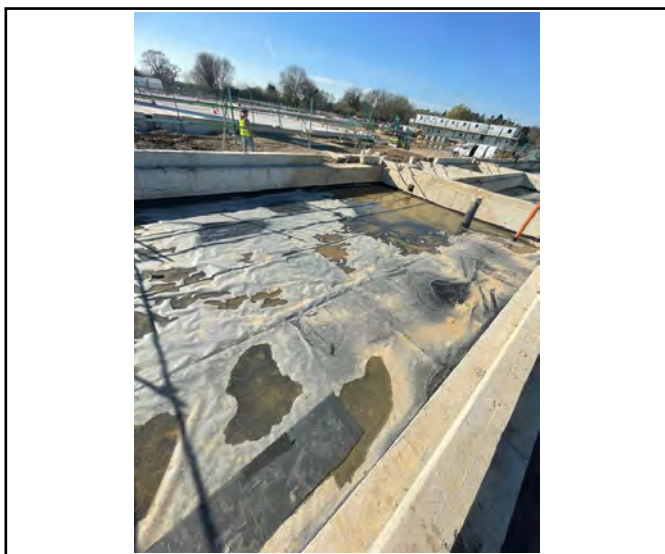
Outstanding remediations, remediated

on previously verified areas.

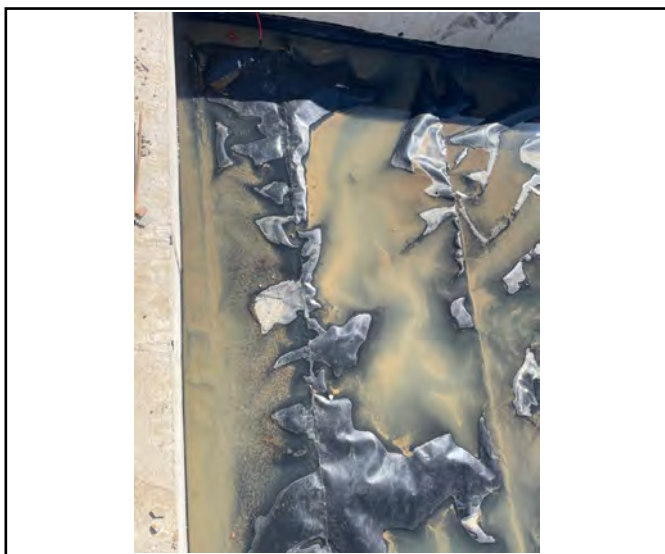
Cut membrane remediated from  
previous visit.

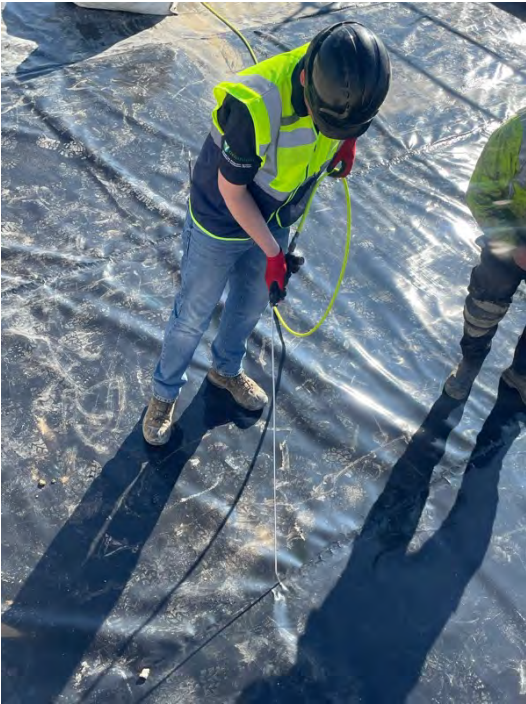
Airlance integrity testing to welded lap joint.

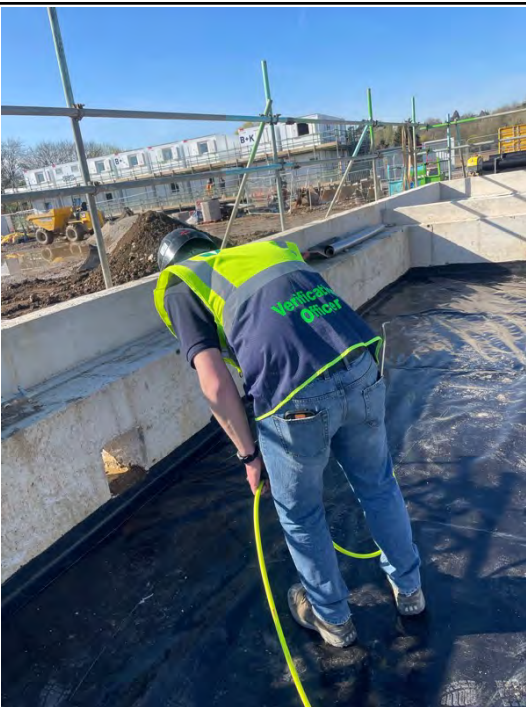
Airlance integrity testing to welded lap joint.

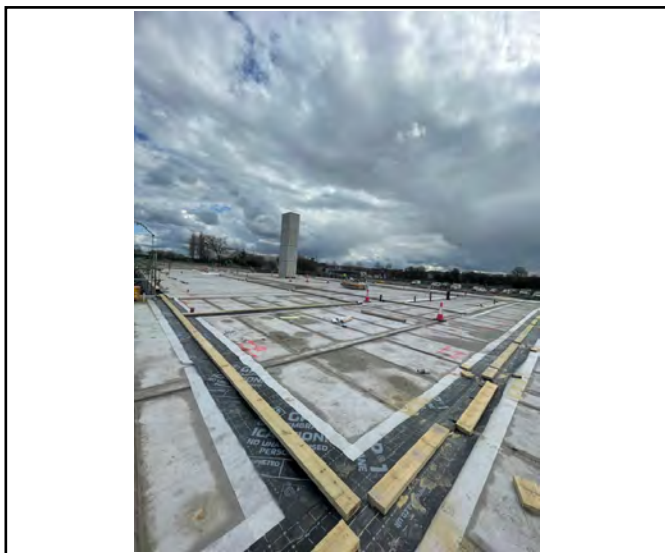
Juta GP1 perimeter and internal wall

installation in progress.

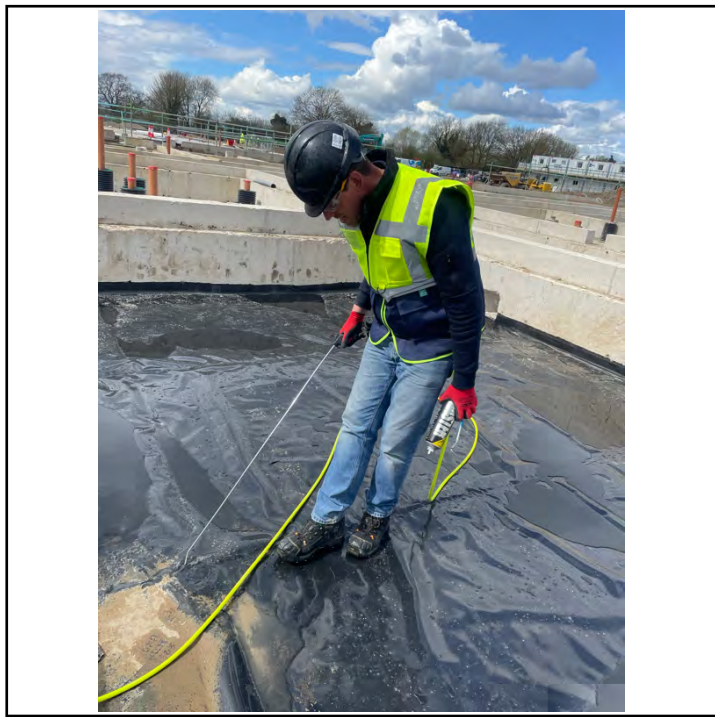
Airlance integrity testing to welded lap joint.

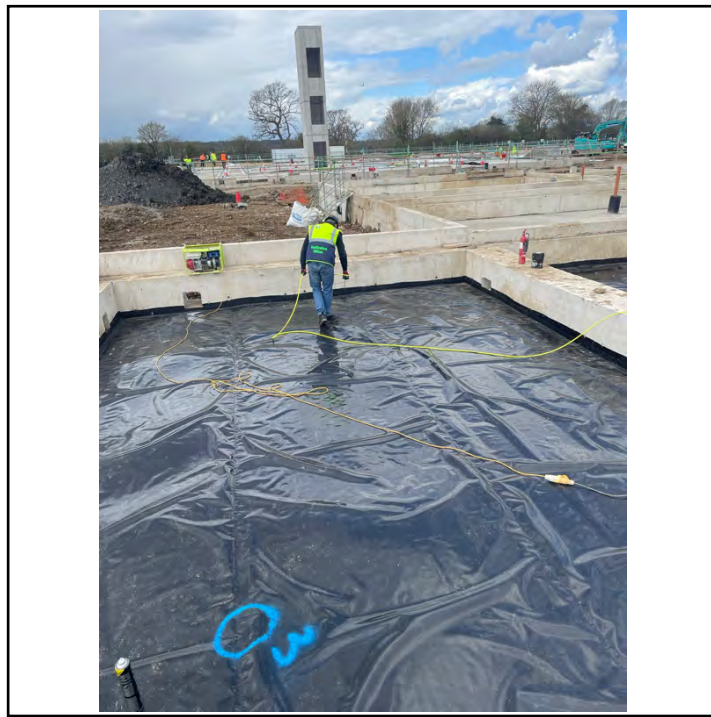
Airlance integrity testing to welded lap joint.

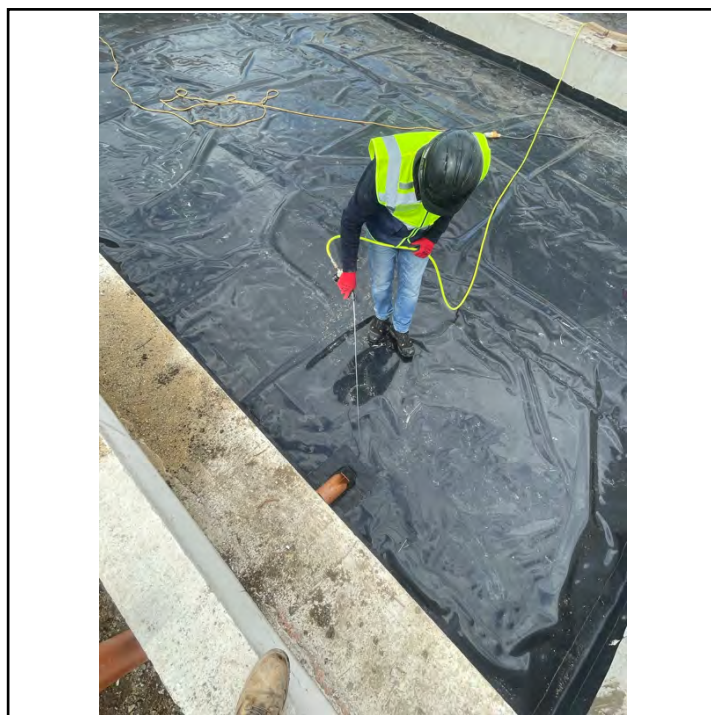
Airlance integrity testing to sealed pipe.

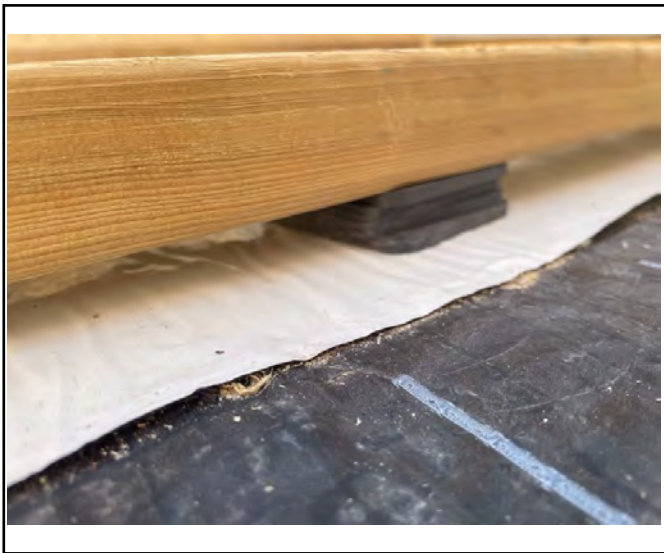
Evidence of GPSAM beneath

soleplate.

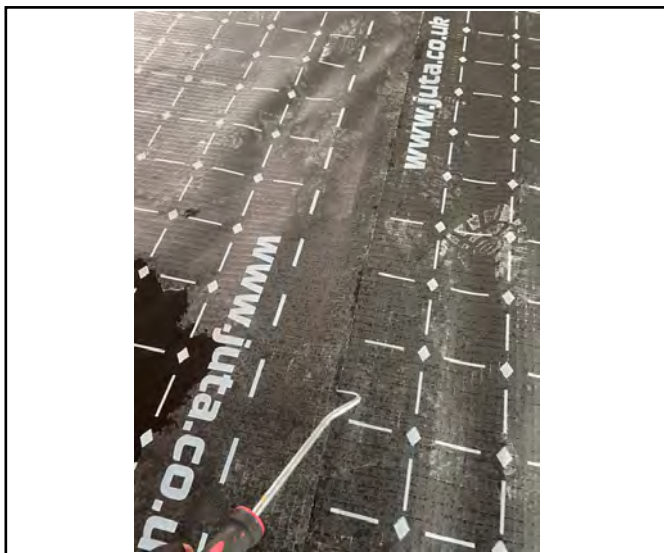
Pick&probe testing to welded lap joint.

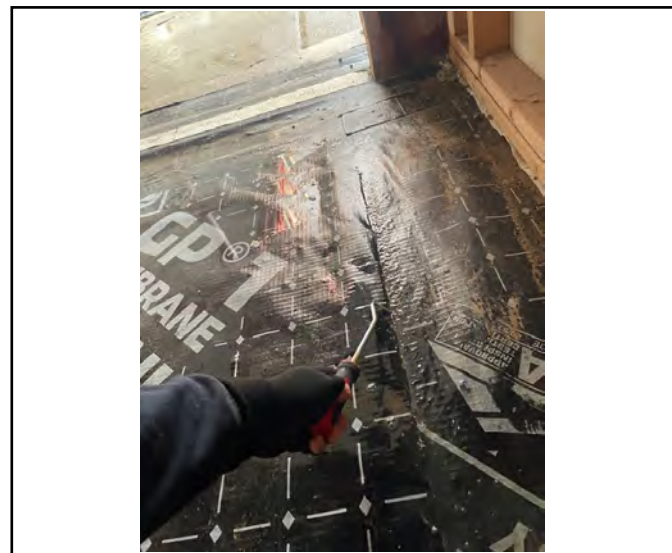
Pick&probe testing to welded lap joint.
