# GeoShield Verification Report 31

PROJECT REFERENCE: GEO103260 R31

PROJECT: Riverside Academy

West Block Perimeter Skirt - Gridlines: 1/A-D, 10/M-N & E/10  
East Block Perimeter Skirt - Gridlines: T/1-8 & 1/S-T

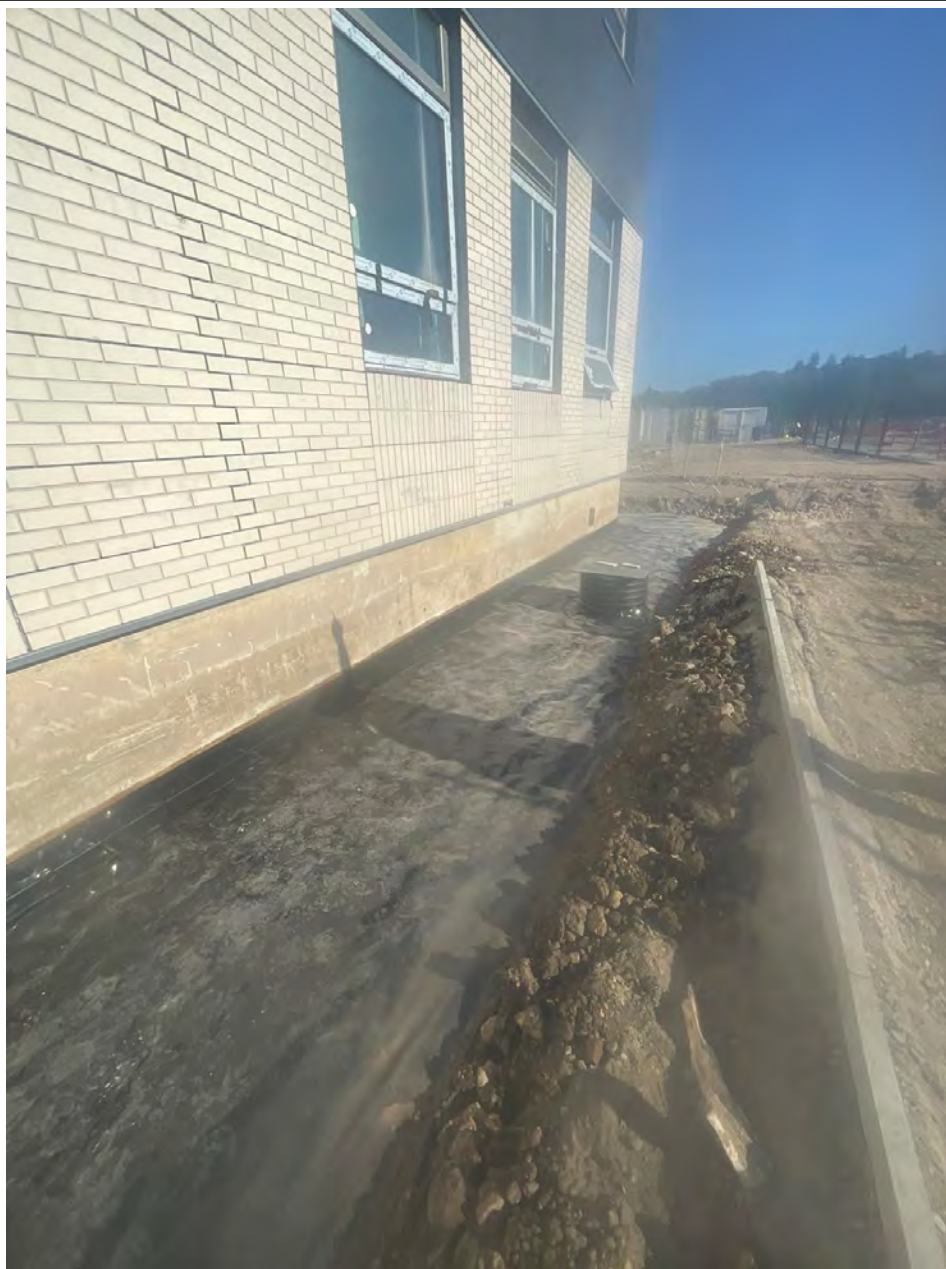
## OVERVIEW

The photograph above displays an overview of the area where today's verification inspection took place on site.

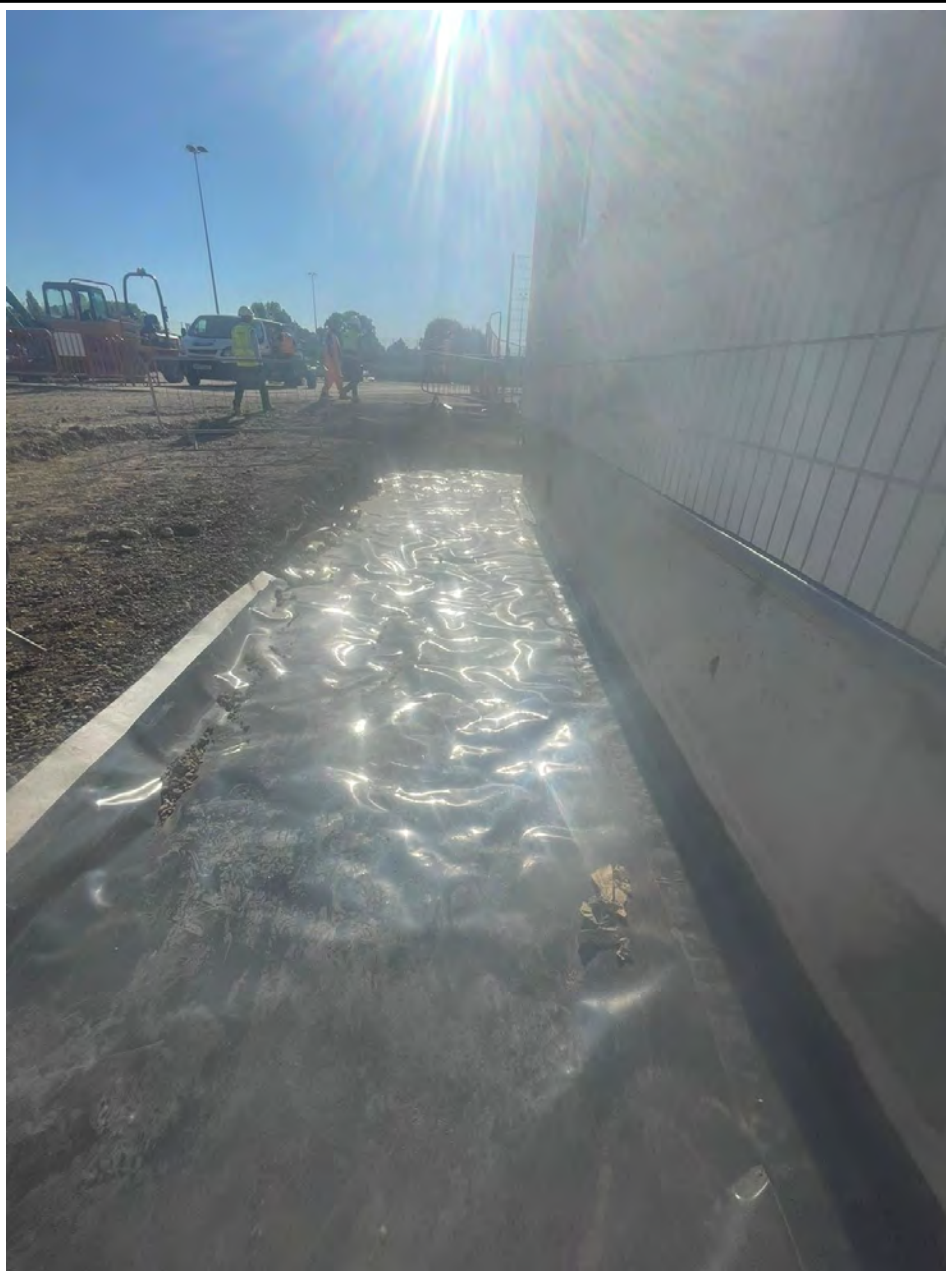
## OVERVIEW

The photograph above displays an overview of the area where today's verification inspection took place on site.

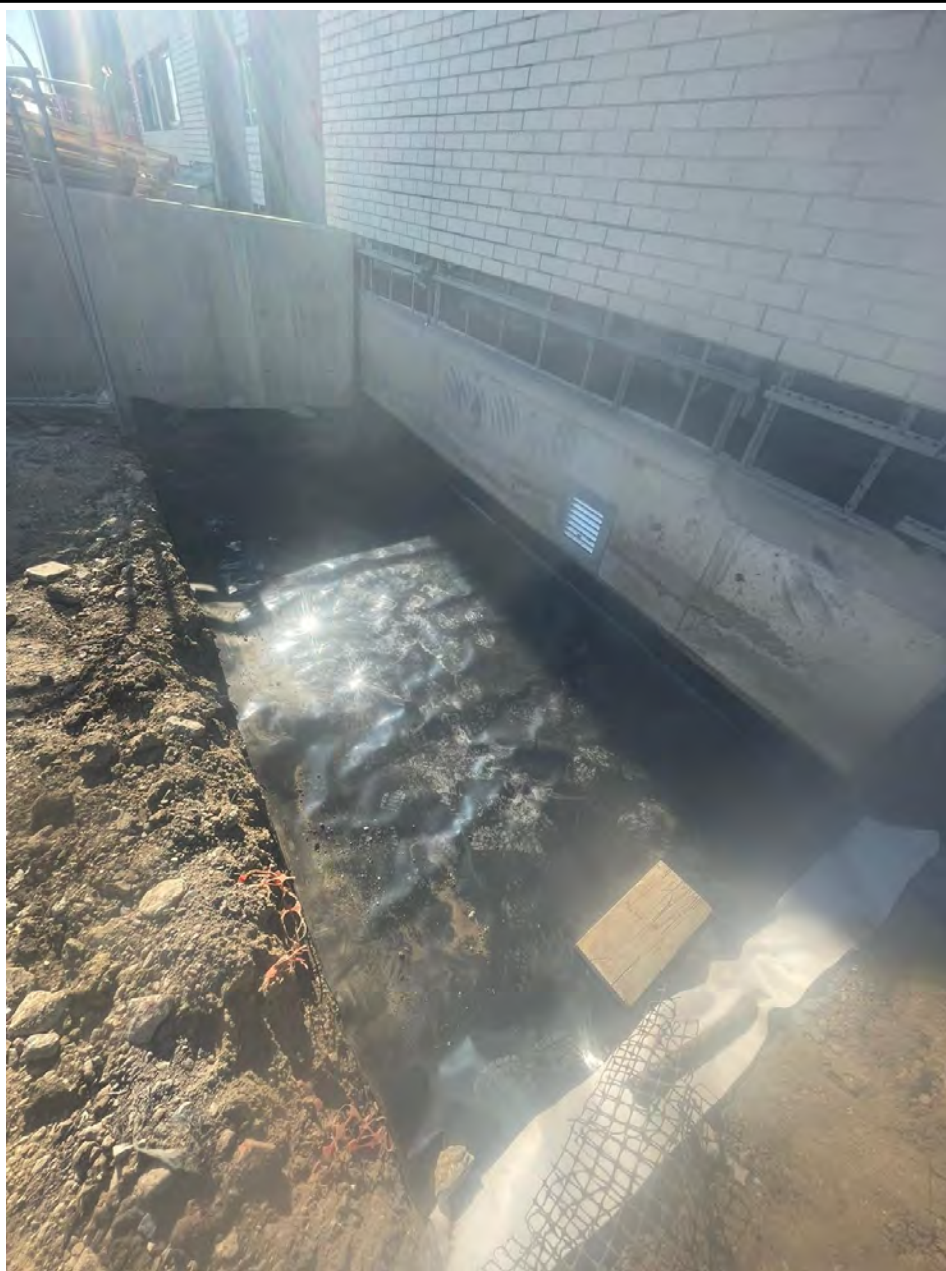
## OVERVIEW

The photograph above displays an overview of the area where today's verification inspection took place on site.
