**ASBESTOS REFURBISHMENT SURVEY REPORT**

**EMERALD HOUSE (BLOCK 2), NAPIER COURT, NAPIER ROAD, READING, RG1 8BW**

**PROJECT NO: PMRS3252A**

**SURVEY DATE: 21 AUG 2024**

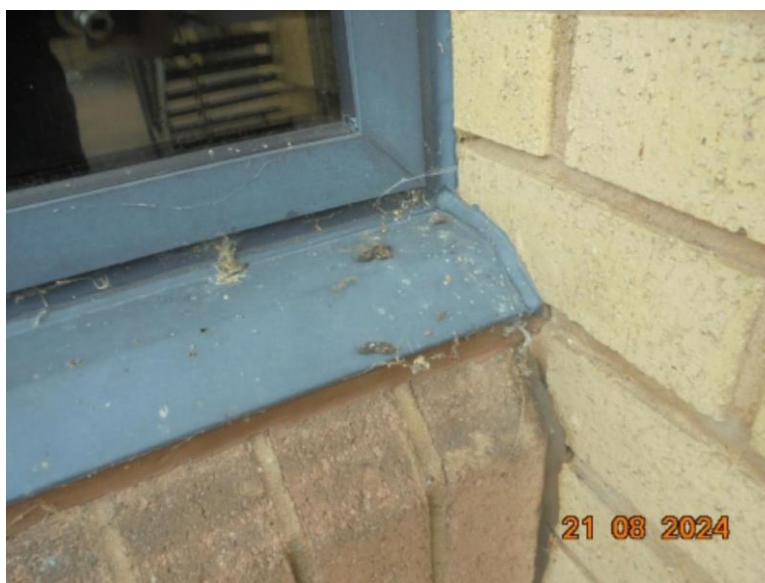
| <b>Location No</b> | PMRS3252A-Loc60701 | <b>Position Description</b> | Window frame sealant |

| <b>Room Number</b> | External | <b>Asbestos Suspected</b> | No |

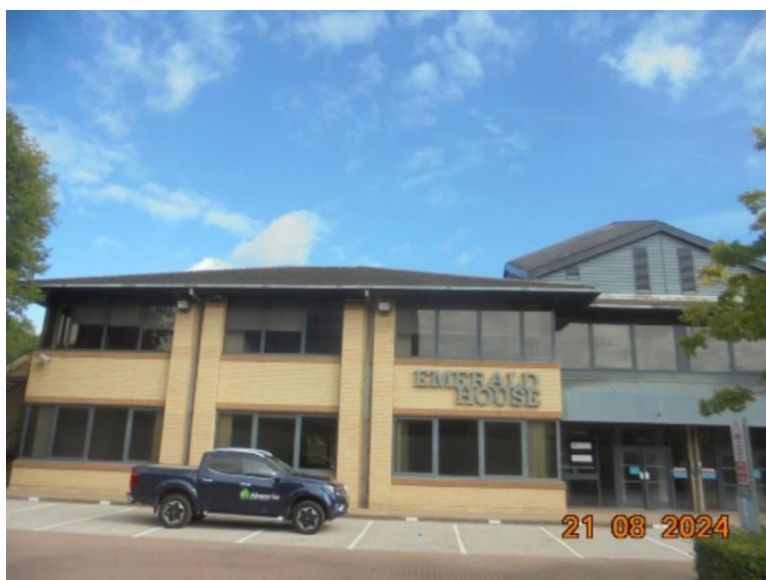
| <b>Location No</b> | PMRS3252A-Loc60704 | <b>Position Description</b> | Cement slate roof tiles to plant areas |

| <b>Room Number</b> | External | <b>Asbestos Suspected</b> | <b>No</b> |

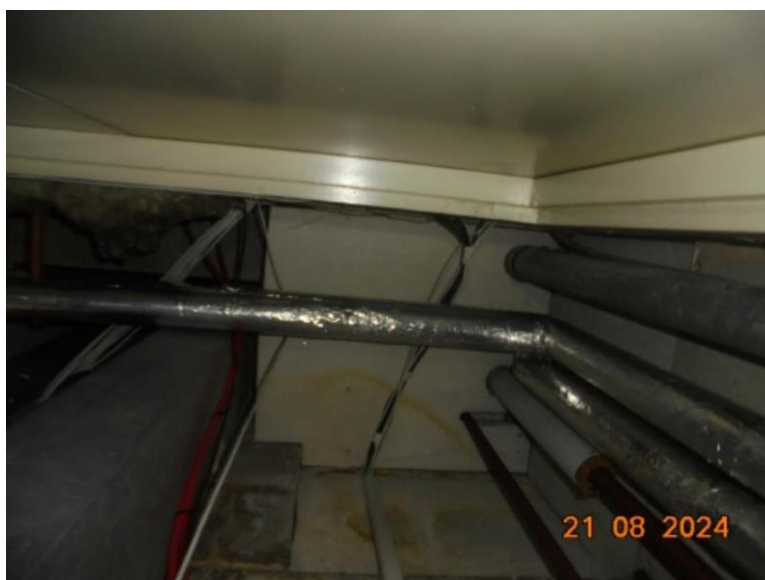
| <b>Location No</b> | PMRS3252A-Loc60725 | <b>Position Description</b> | Supalux boxing |

| <b>Room Number</b> | Building 1 Rear Service Riser | <b>Asbestos Suspected</b> | <b>No</b> |

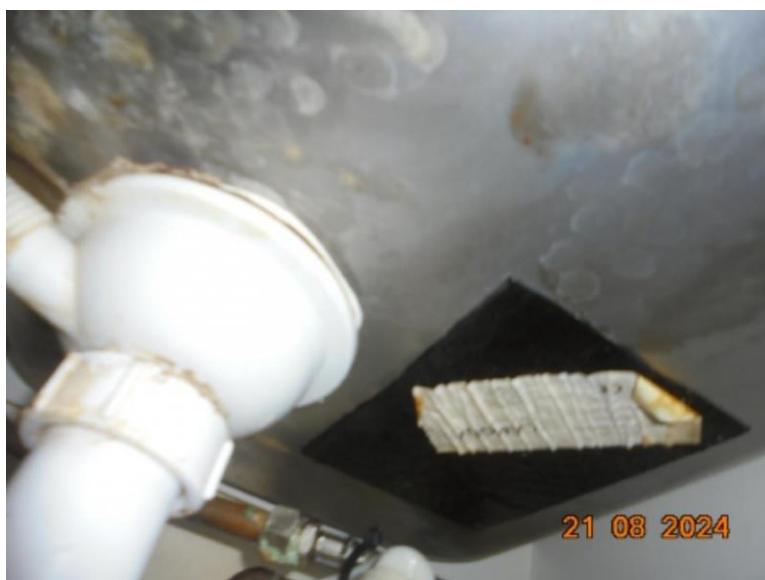
| <b>Location No</b> | PMRS3252A-Loc60730 | <b>Position Description</b> | Bitumen sink pad |

| <b>Room Number</b> | Building 2 canteen | <b>Asbestos Suspected</b> | <b>No</b> |

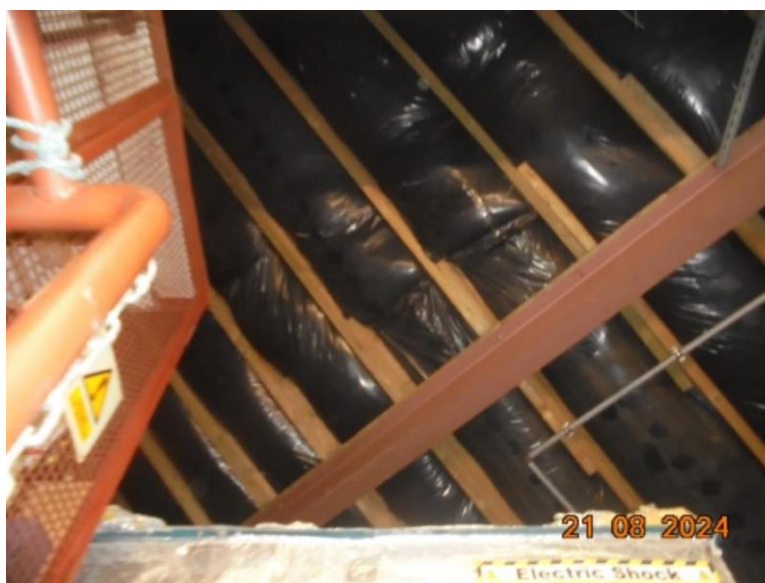
| <b>Location No</b> | PMRS3252A-Loc60737 | <b>Position Description</b> | Bitumen sarking felt to roof |

| <b>Room Number</b> | Building 1 Plant Room | <b>Asbestos Suspected</b> | No |

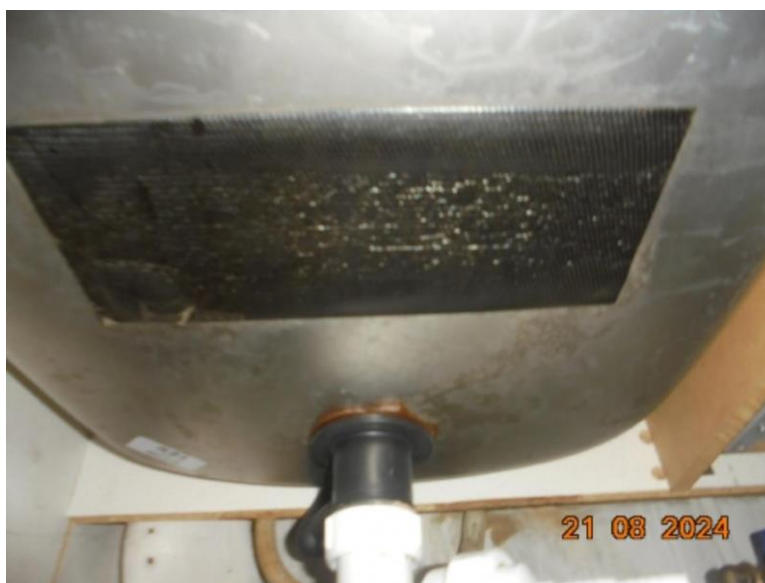
| <b>Location No</b> | PMRS3252A-Loc60750 | <b>Position Description</b> | Bitumne sink pad |

| <b>Room Number</b> | Female WC | <b>Asbestos Suspected</b> | <b>No</b> |
