## ARBORICULTURAL REPORT

28 Northcourt Avenue  
Reading  
Berkshire  
RG2 7HA

August 2024

Ref: 24107

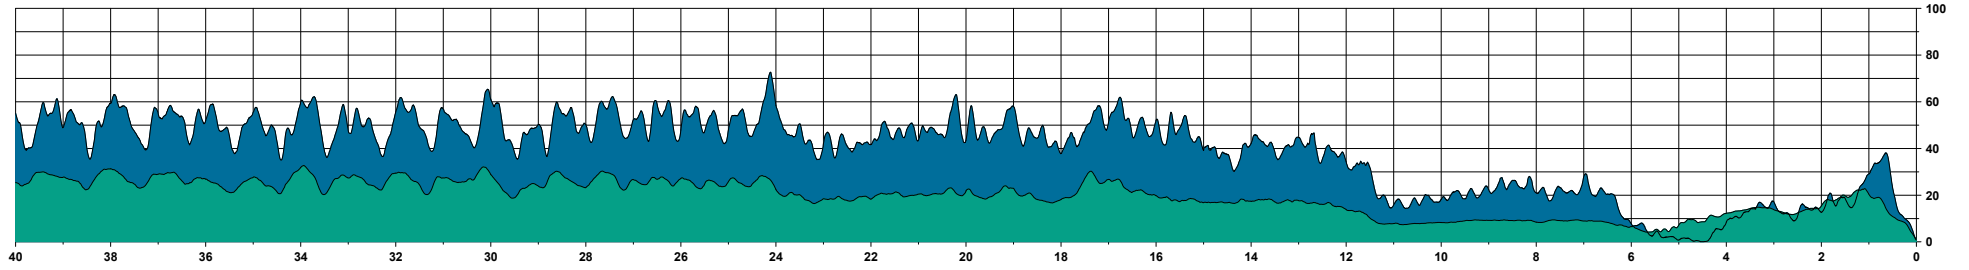
Measurement028.rgp

45 degrees - west side of tree  
0-2cms sap wood. Good Resistance along the remainder of the trace.

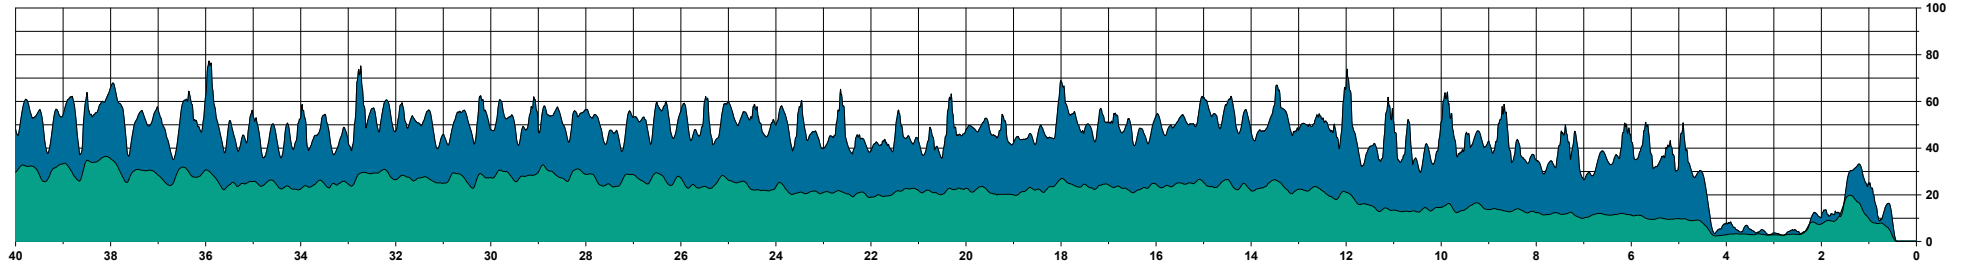
Measurement029.rgp

- 5.3 Due to the cavities and areas of soften wood observed during the May site visit five Resistograph traces were carried out.
- 5.4 Four traces were conducted at the north, east, south and west axis around the lower stem of the tree. Trace 5 was conducted at a 45° angle. (Appendix 3 Resistograph Traces). All five traces illustrate that resistance to the drill is consistent with the density of wood associated with oak trees. No decay has been recorded within the locations of the traces.
