**Inspection photos**Place:  
**Reading**Road:  
**2 Norman Place**Date:  
**06/09/2023**section number:  
**29**PLR:  
**? X**

## Inspection report

## **Appendix E – Thames Water Sewer Records and PPSE Response**

**Site: 2 Norman Place, Reading RG1 8DA**

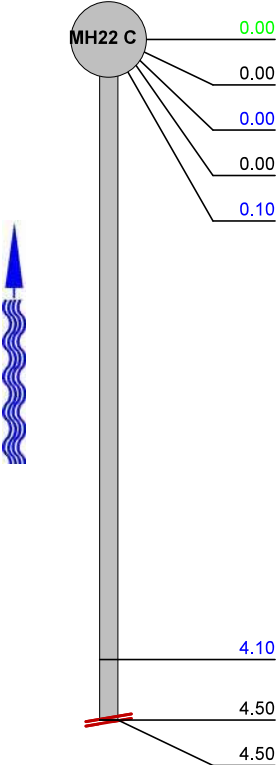
| 1:50 | position | code | observation | counter | photo | grade |
|---|---|---|---|---|---|---|
| | <u>0.00</u> | WL | Water level, 40 % height/diameter | 00:00:00 | | (Serv) 0 |
| | <u>0.00</u> S1 | CU | Camera Underwater, Start | 00:00:00 | | (Misc) 0 |
| | <u>0.10</u> | DES | Debris silt, 10 % cross-sectional area loss | 00:00:00 | | (Serv) 1 |
| | <u>4.10</u> | WL | Water level, 0 % height/diameter | 00:00:00 | | (Serv) 0 |
| | <u>4.50</u> F1 | CU | Camera Underwater, Finish | 00:00:00 | | (Misc) 0 |
| | <u>4.50</u> | SA | Survey abandoned, Remark: Restricted Leverage | 00:00:00 | | (Misc) 0 |

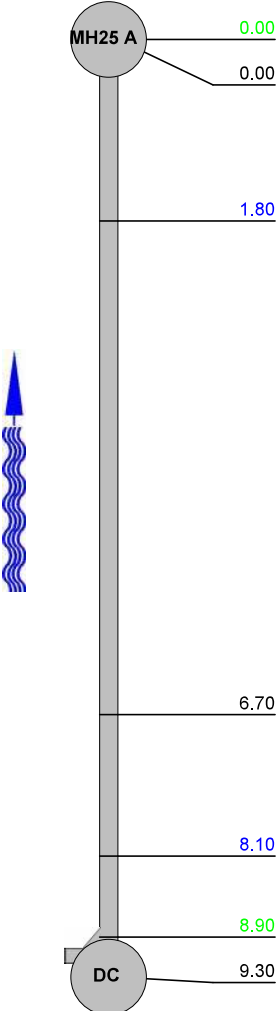
| 1:75 | position | code | observation | counter | photo | grade |
|---|---|---|---|---|---|---|
| | 0.00 | MH | Manhole Remark: MH25 A | 00:00:00 | | (Constr) 0 |
| | 0.00 | ST | Start of Survey | 00:00:00 | | (Misc) 0 |
| | 6.70 | GP | General Condition photograph | 00:00:00 | 41_4a | (Misc) 0 |

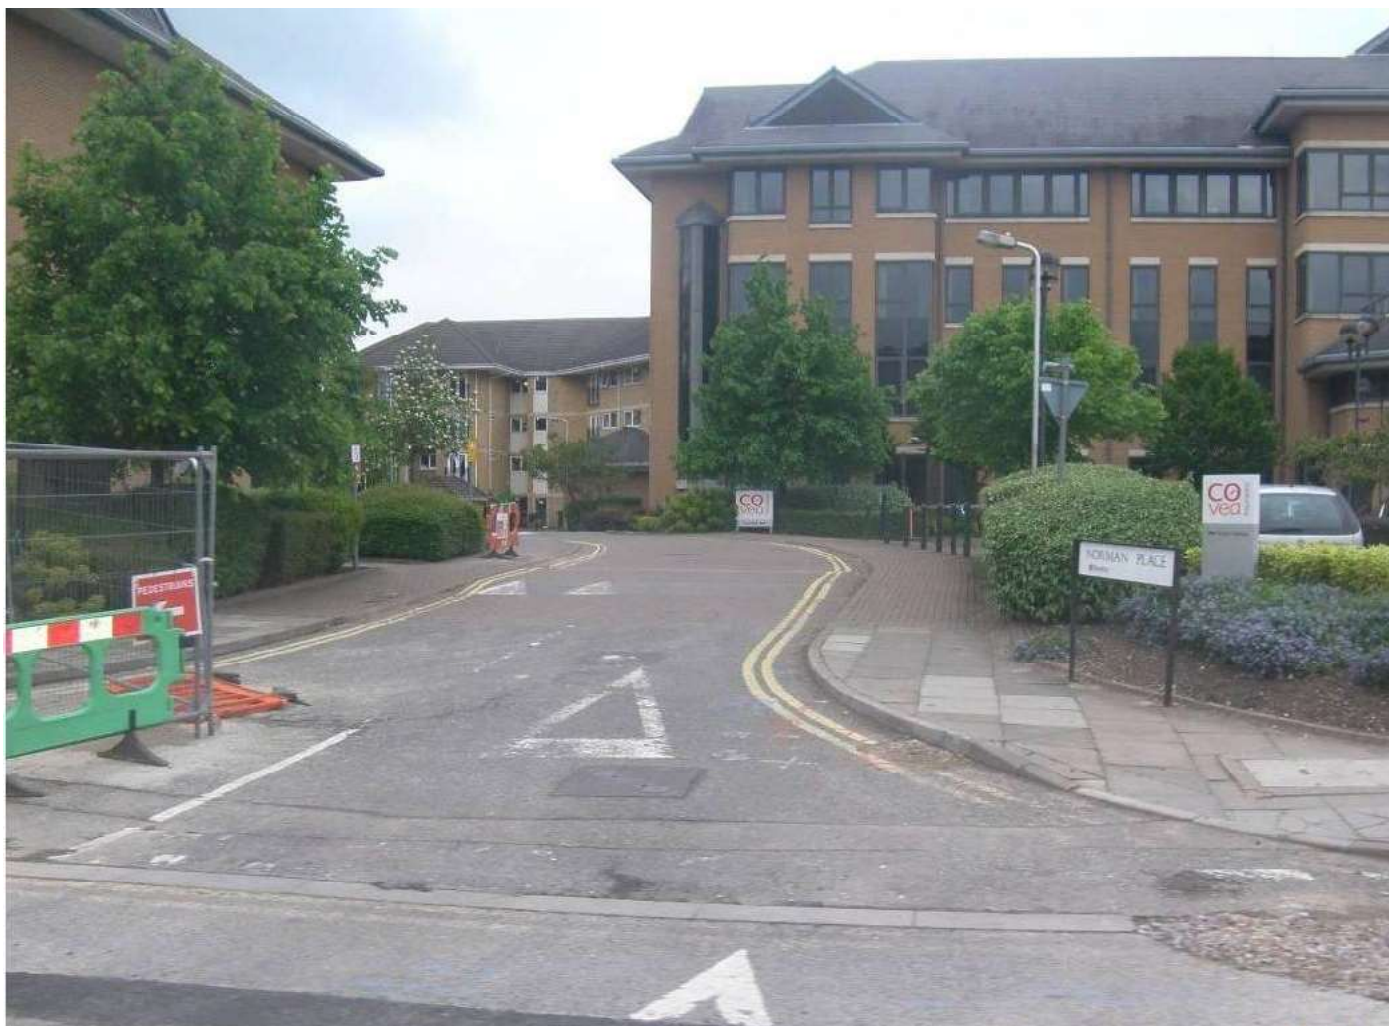
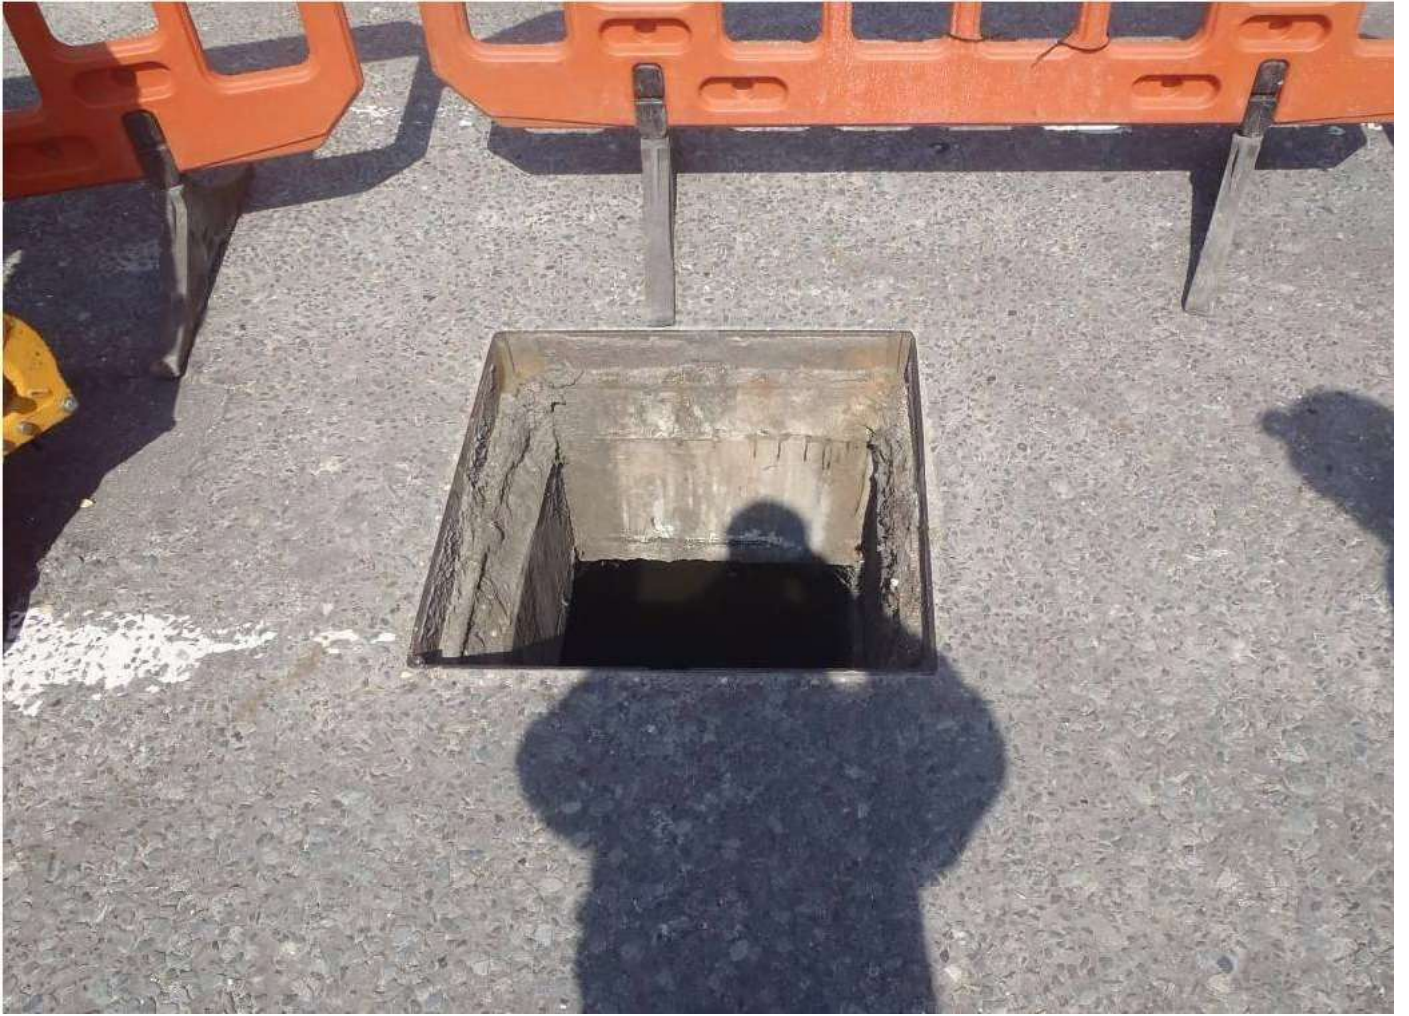
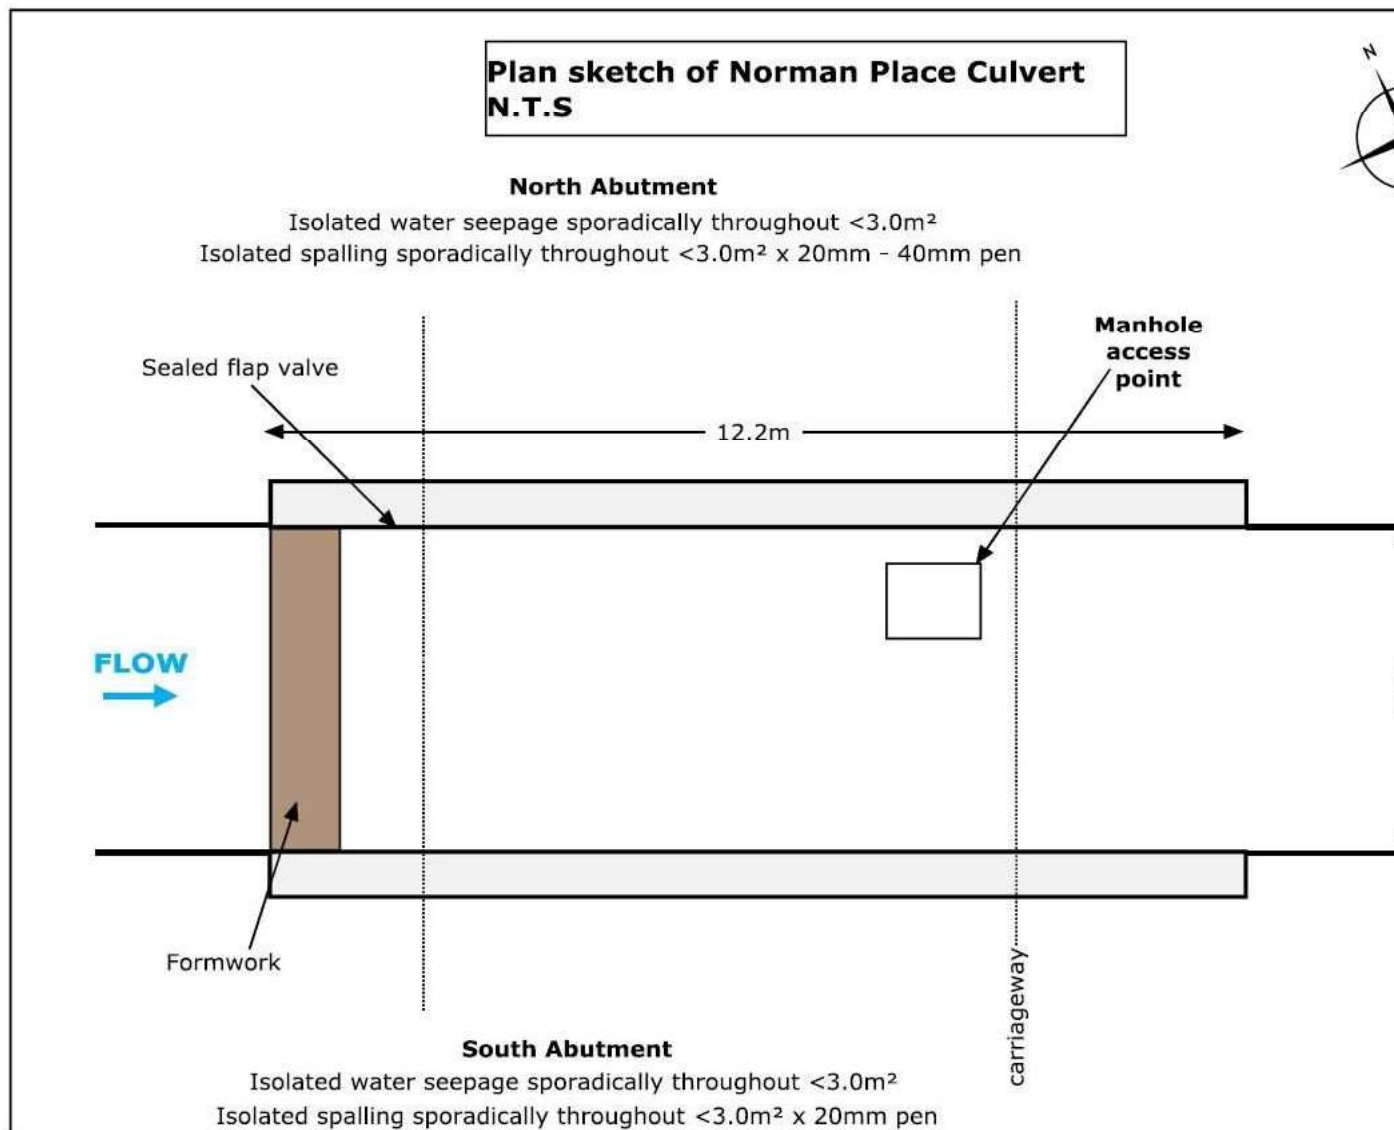
There are no as-built drawings of the culvert under Norman Place but the below images may be useful to you. The structure under Norman Place is a concrete box culvert. The section of culvert outside the highway boundary is not maintained by Reading Borough Council so we don't have any information on it. However, I know the culvert continues almost parallel to Vastern Road and passes under George Street where it is a brick arch. I'd advise you to undertake independent investigations to confirm the line of the culvert and its make-up.

Note that if you're planning to undertake any works near the section of culvert within highway boundary, aspects of your design may be subject to technical approval.
