## **No. 10 GUN STREET, READING RG1 2JR**

### **A Conservation Plan for Historic Fabric**

**Project No: RHC 2024-55**

**Date: 21/10/2024**

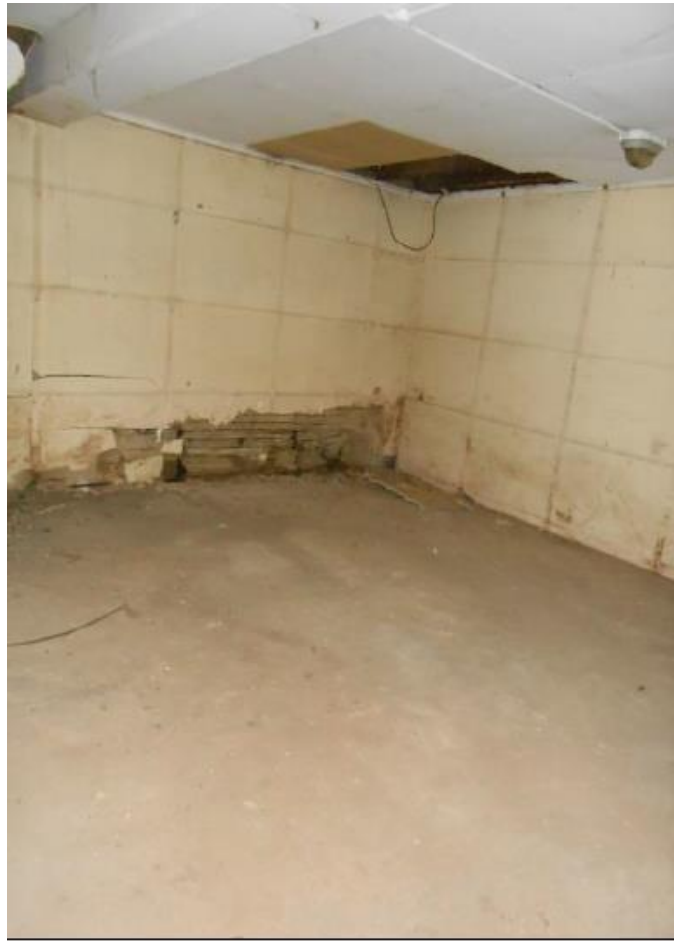
**Fig. 6:** View, looking north-east within the basement, with modern floor and surfaces.

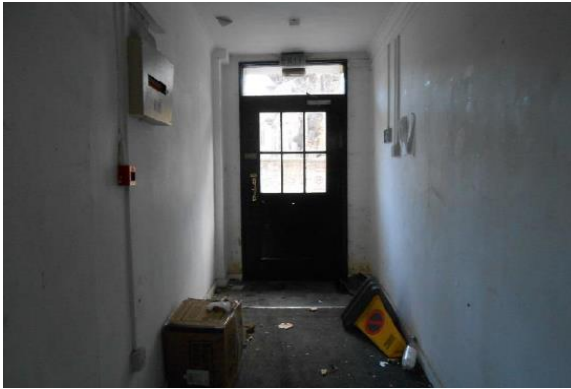
and may be a later nineteenth-century replacement. The original glazing design of the rectangular fan-light has been lost, and replaced with plain glass of modern date (Figs. 3 and 8).

**Fig. 8:** View, looking north along the ground-floor central passageway, with the front door.

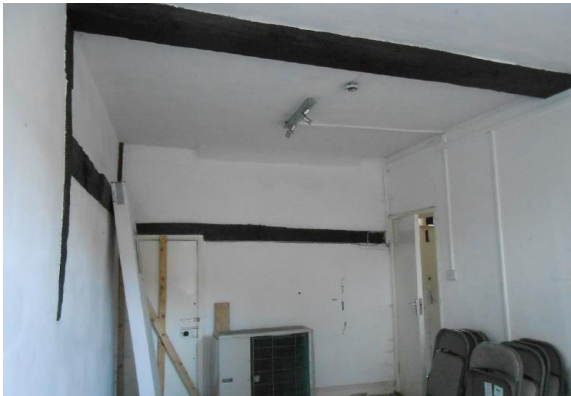
**Fig. 9:** View, looking south within the eastern ground-floor room, with exposed timber framing.

- The cleaning, refurbishment and repainting of the interiors of both shopfront windows;
- The removal of modern partitions within the western room, to enable direct access to the central passageway and stairs;
- The removal of the inauthentic black paint finish on the exposed timber beams;
- The consolidation and repainting of any deteriorated plastered and painted surfaces, including parts of the ceiling in the western room; and
- Replacement of the modern double doors at the southern end of the central passageway.

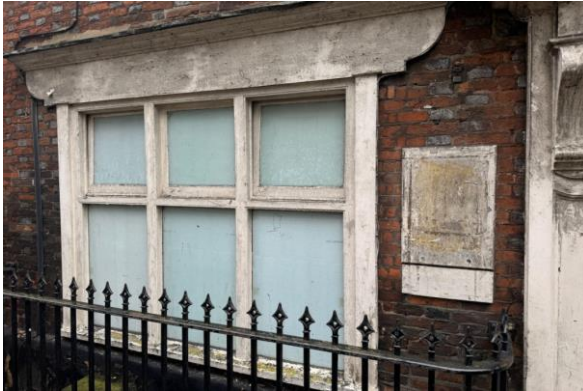
**Fig. 12: Detail of the left-hand, timber-mullioned shopfront window.**

- Removal of old cabling and fixtures from brickwork;
- Cleaning and repainting of doorcase with paint of approved type and tone;
- Cleaning and repainting of timber elements of the two shopfront windows, with local repair of any defective elements according to specification;

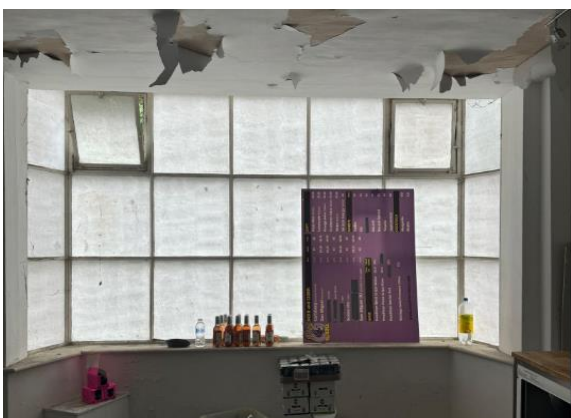
- 4.2 Within the left-hand ground-floor room, the wall on the right-hand (ie. the dividing wall of the adjacent passageway on this side) may be a modern insertion. The back wall of this room is likely to have accommodated a fireplace, which has since been removed. The right-hand shop premises retain no visible surviving features, except for the bow-fronted window, and an exposed axial ceiling beam (Figs. 7 and 15). The date of the skirtings is unclear, although these are likely to be modern.

**Fig. 15: View, looking north, of the interior of the bow-fronted shopfront window.**

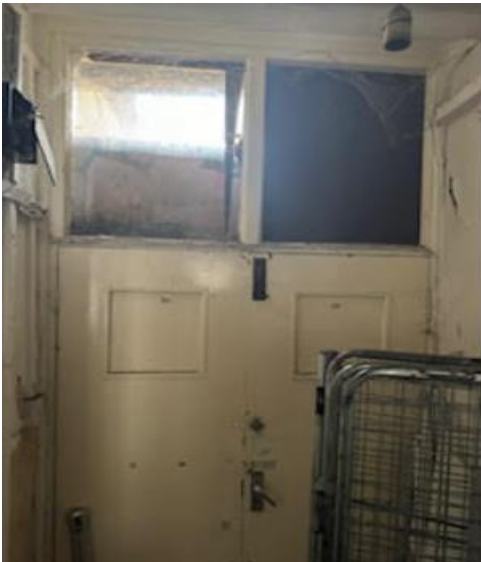
**Fig. 17:** View, looking south within the ground-floor passageway, of the rear double doors and top-light.

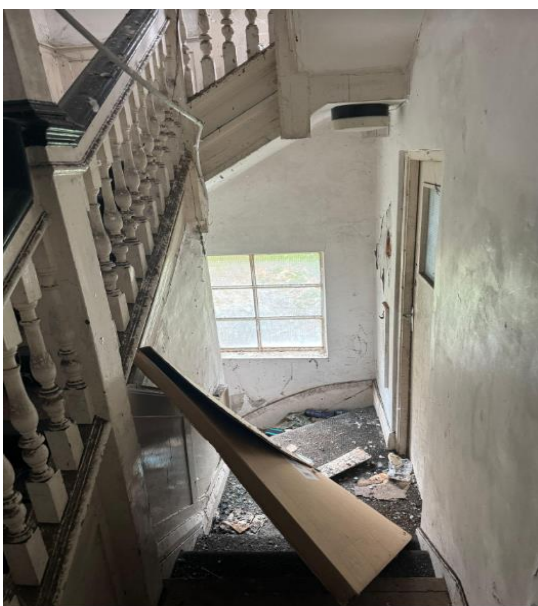
- 5.4 The stairs are lit by a succession of window openings in the rear and side walls of the stair tower, all of which appears to be inserted items of different dates. There is a modern, steel-framed Crittall-style window at the split landing below the first floor (Fig. 22), and a nineteenth-century, six-over-six sash window at the split landing below the second floor (Figs. 25 and 27). A distinctive round-headed window opening, with timber glazing bars, is positioned below the attic landing (Fig. 30), with a simple six-pane casement below the first-floor landing (Figs. 28 and 29). With the exception of the round-headed window, the existing fenestration of the staircase appears to be in relatively good condition, and contributes to the historic character of this feature.

**Fig. 22: Looking down to first-floor landing, with modern inserted door and window.**

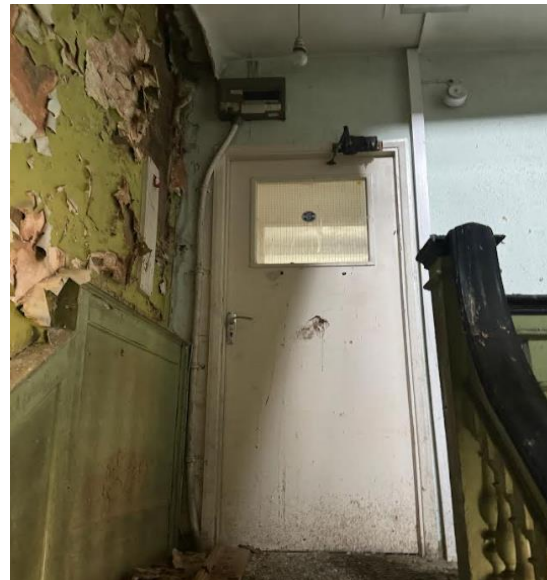
**Fig. 34: Dado panels and modern cabling and trunking at second-floor landing.**

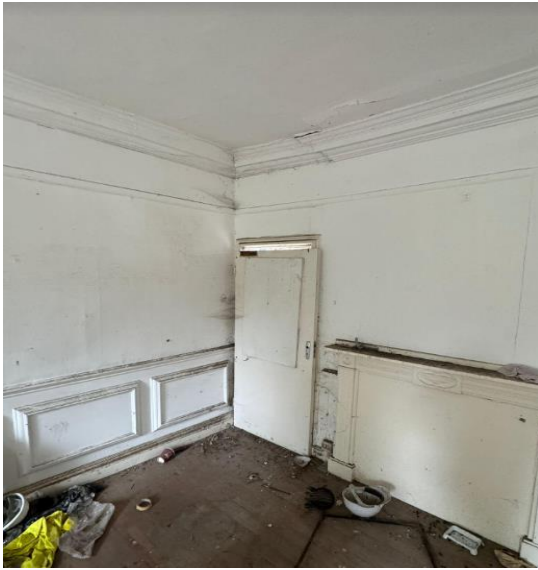
been constructed of stud walling (Figs. 35, 38 and 41). The southern, rear wall of the eastern room has a partly-concealed fireplace, which appears to be of early nineteenth-century date, with an ornamental overmantle (Fig. 40). It is probable that a corresponding fireplace exists, or existed, on the rear wall of the adjoining western room, which would have corresponded to that in the same location in the second-floor room above, and utilised the adjoining chimney-stack. Plasterwork on walls and ceilings appears to be in good condition, although there is a large hole in the lath and plaster surface of the eastern wall (Fig. 37). The wooden-boarded floor is in good condition, and appears to be original.

**Fig. 40:** View, looking south-east within the eastern first-floor room, with fireplace and inserted modern doorway.

- The repair of the hole in the east wall, in accordance with current sectoral guidance (see Wheatley 2014);
- The removal of the inserted kitchen space and partitions in the western room, and installation of a small screened-off service area, to be served by the adjacent hoist;
- Investigation of the suspected fireplace on the southern wall of the western room;
- Investigation of the fireplace on the southern wall of the eastern room;
- The cleaning and repainting of the sash windows, and associated features; and
- The replacement of modern doors with ones of appropriate historic pattern.

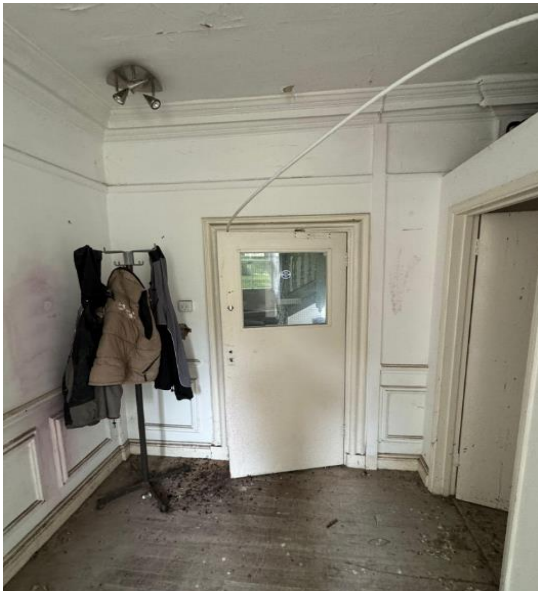
**Fig. 41:** View looking south within western first-floor room, with entrance doorway and inserted modern kitchen.

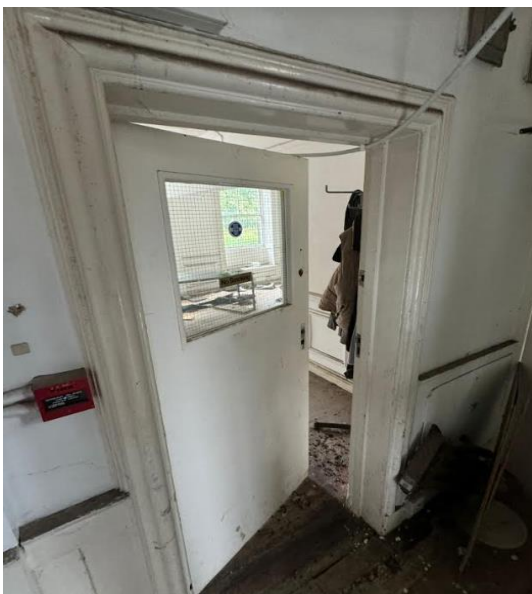
**Fig. 42:** View, looking north-east from the first-floor landing, of the doorway into the western room, with original door-frame and modern door.

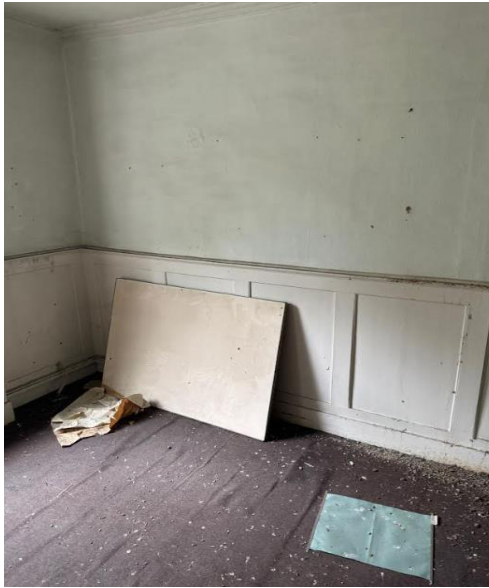
**Fig. 47:** View, looking north-east within the eastern second-floor room, with dado panelling and walls.

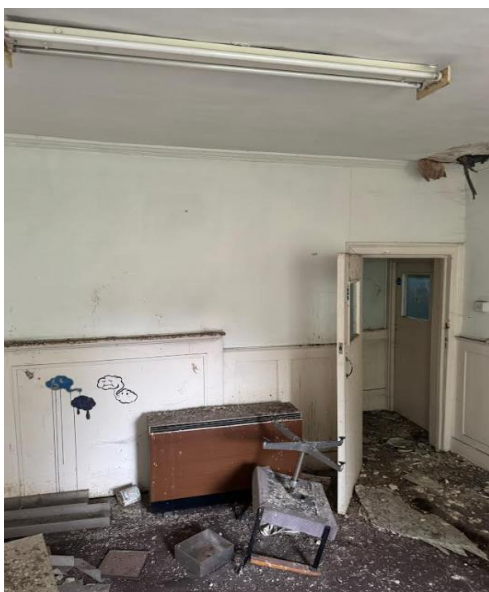
plain, with only a simple bevelled cornice (Fig. 49). The eastern room has a doorway opening on the southern side, which provide access to the second-floor landing. This has modern timber doors set within an original moulded door-frame. There is an early nineteenth-century fireplace in this rear wall, with a simple wooden surround and mantle-shelf. There is a connecting doorway between the eastern and western rooms, which contains a modern door. It is unclear whether this doorway opening is an historic feature.

**Fig. 49:** View, looking south in the eastern second-floor room, with fireplace and doorway.

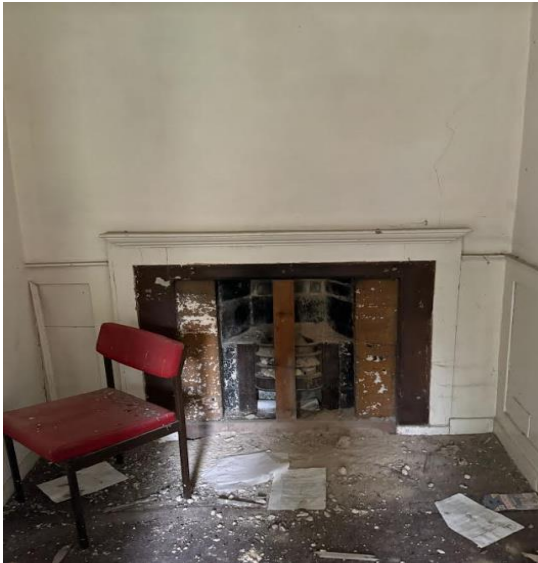
7.1 The treatment of the second-floor rooms is altogether simpler. These display lower ceiling heights and fewer surviving historic features, apart from the original sash window cases which, in common with the first floor, contain inserted nineteenth-century windows (Figs. 46 and 48). A small nineteenth-century iron grate on the south wall of the western, ie. right-hand, room has been inserted within an eighteenth-century fireplace (Fig. 50). Much plain dado panelling survives (Figs. 47 and 48).

**Fig. 50:** View, looking north, of the fireplace with inserted grate on the south wall of the western room.
