## WORKS IN THE FRONT GARDEN OF 50 MOUNT PLEASANT – Ongoing issue

From Conservation Officer, 11/04/2025

Oscar Wilson (for and on behalf of Pont + Wils Architects Ltd) Response dated: 25/04/2025.

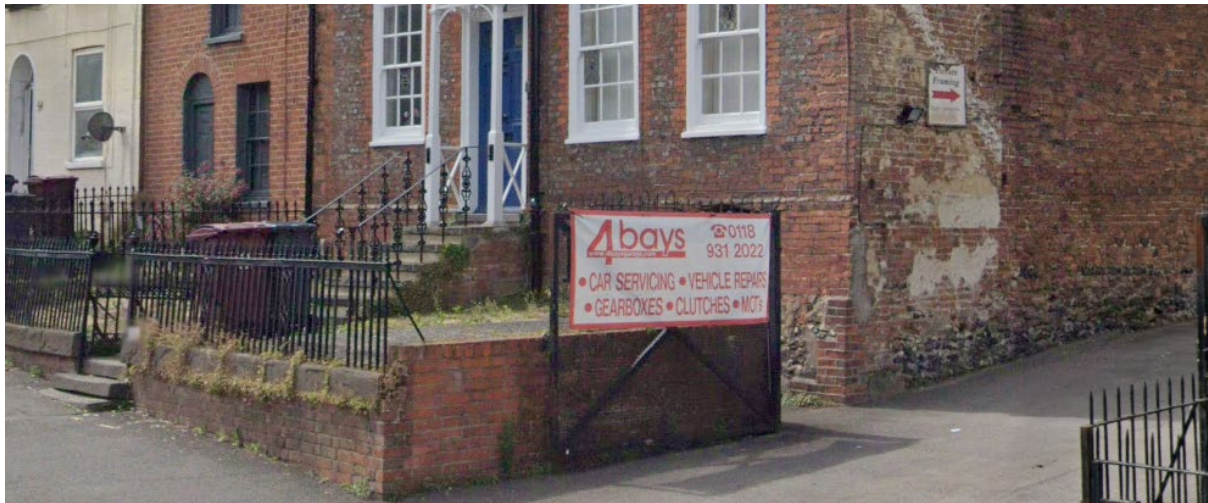
The officers visited the property in April 2024 and took the photo above. The front garden, its walls and the side elevation of the building looked intact and without any intervention. It appears as the same as the street view from 2021 below.

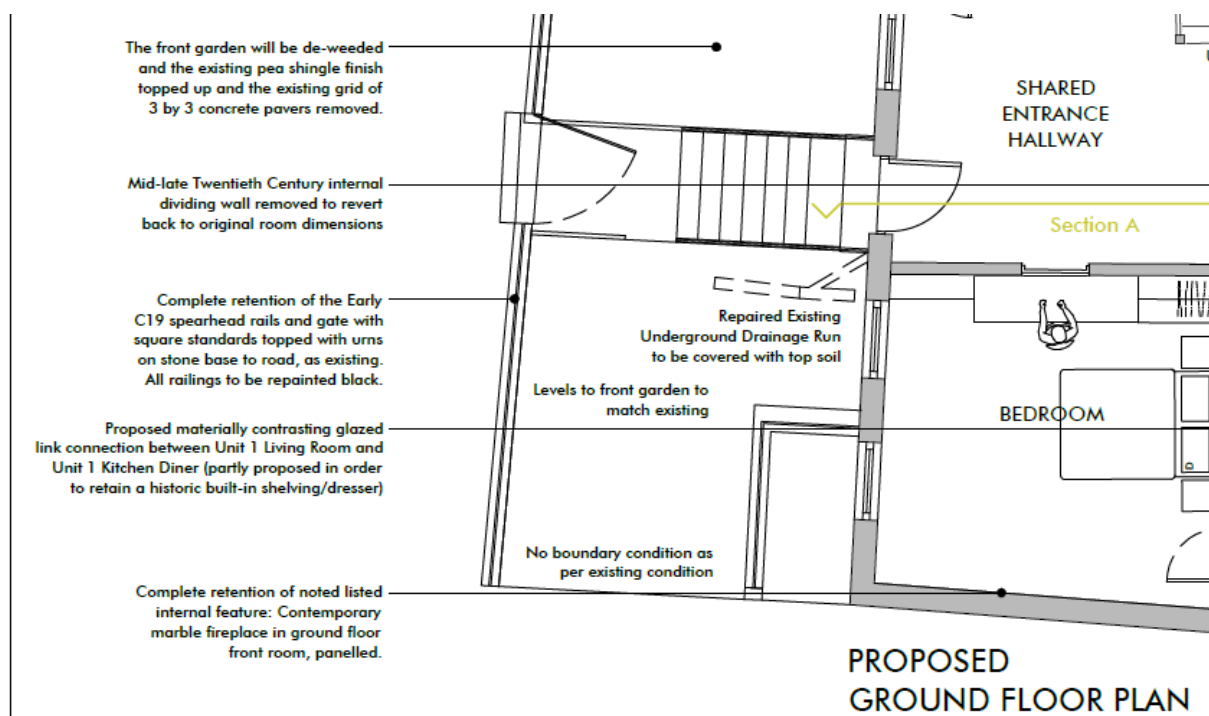
Following further requests from the Council, the planning officer received the ground floor plan below, which does not show all the work carried out. There is **no proper or sufficient information** and conservation approach for the unknown works, their impact or their remediation.

An amended set of proposed drawings for both PL/23/1865 and PL/23/1866 to cover the request for proper or sufficient information and conservation approach for the unknown works, their impact or their remediation.

Please take this document as the written statement as requested above. Alongside this as previously stated, amended proposed drawings and the structural report have also been submitted for your consideration, to be added to PL/23/1865 and PL/23/1866.
