# Structural Engineer's Report

For TH Estates

Ref: 1000/517

- 1.2 Problems and concerns:** A structural survey of the areas of the house adjacent to external and enabling works for signs of structural distress to the original structure of the house.

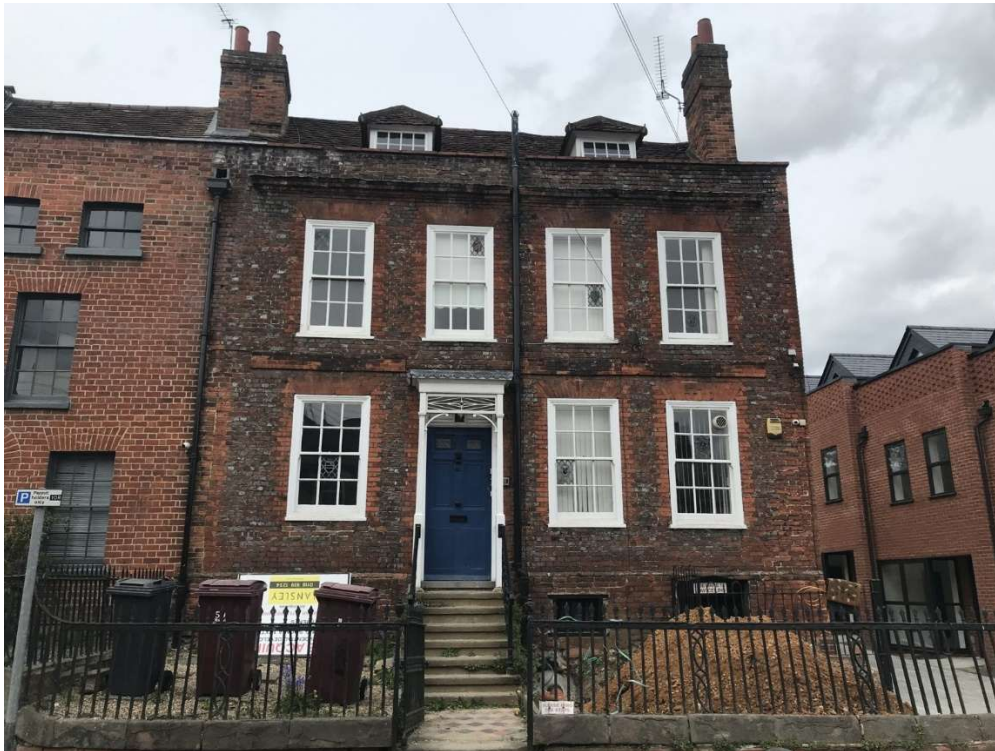
- 2.1 The property is a four storey house, expected to be originally detached, including a lower Ground floor beneath half of the property. The building is grade II listed and is expected to date from the Georgian or early Victorian era. The house had been extended to the rear over a single storey on one half of the rear elevation.
