***Project ref:TV230727***

# ***CCTV Survey Report***

**CLIENT: ACORN CARE AND EDUCATION LTD**

**SITE: Pheonix College**

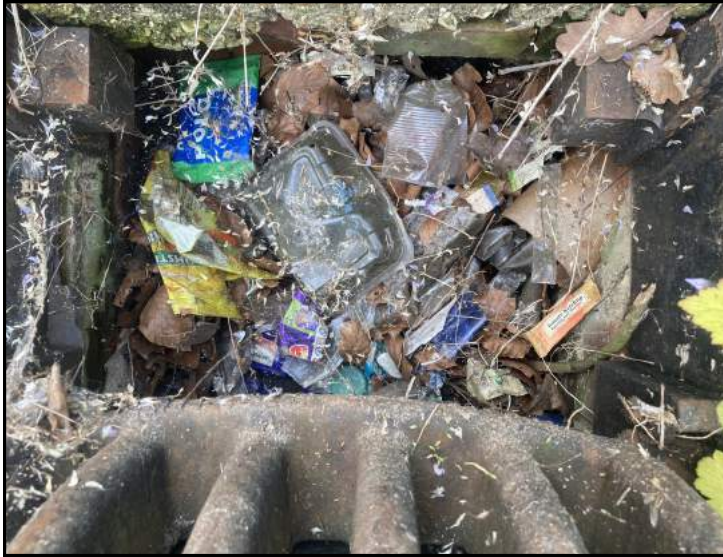
GULLY 1 - DEBRIS FILLED

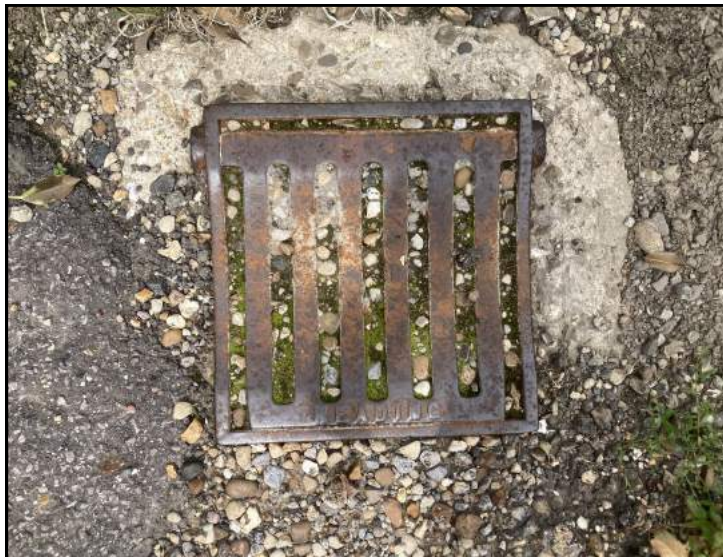
GULLY 2 - DEBRIS FILLED

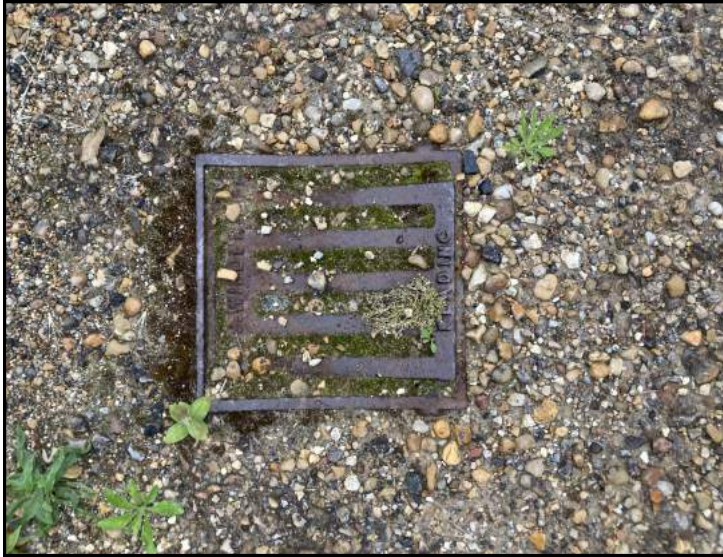
GULLY 4 - DEBRIS FILLED

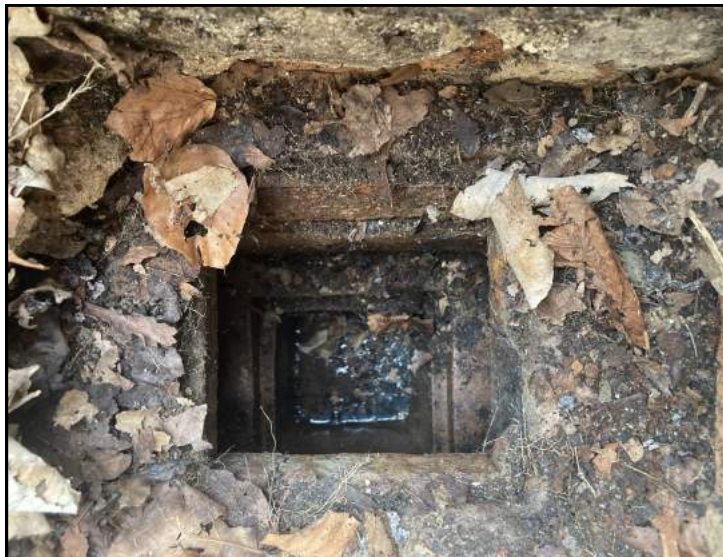
GULLY 5. TRAPPED - NO CCTV

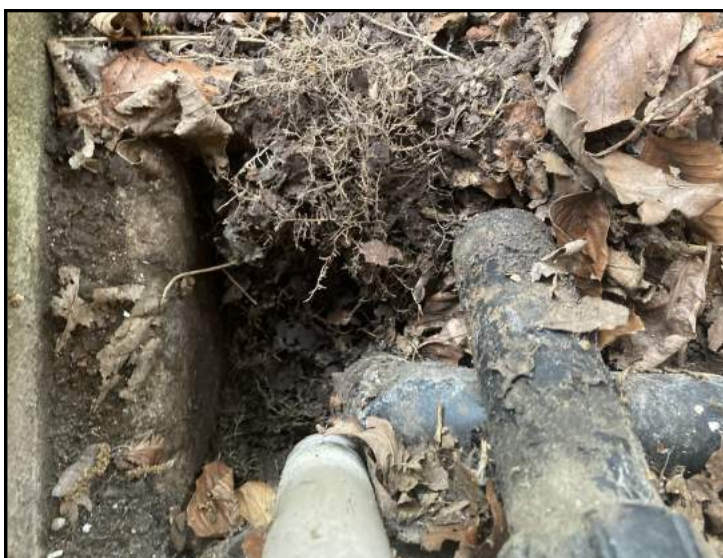
GULLY 6 - DEBRIS FILLED

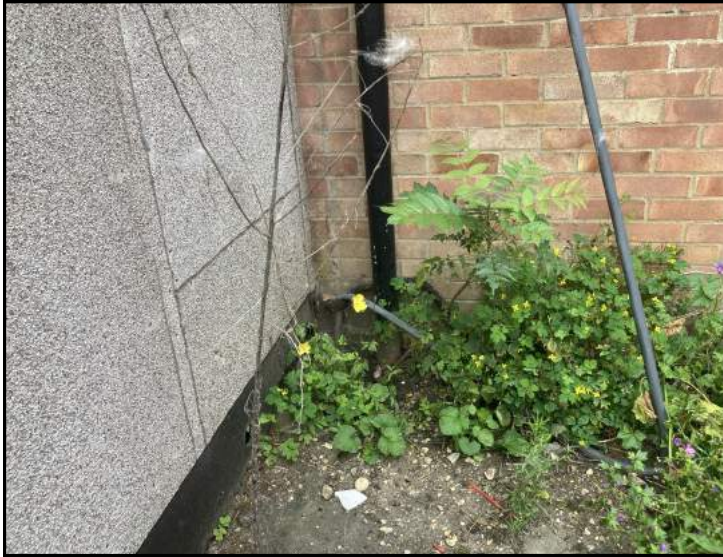
RWP 3 -  
APPEARS TO BE UNCONNECTED

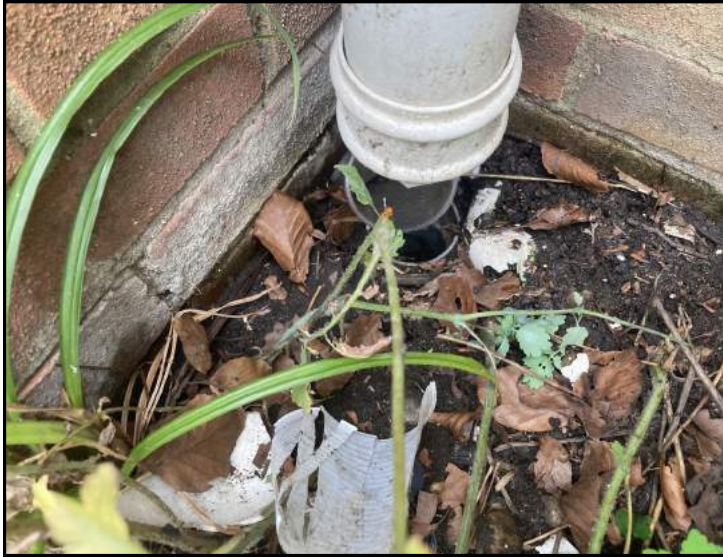
RWP 6. 65mm PVC OUTFALL.  
UNABLE TO CCTV

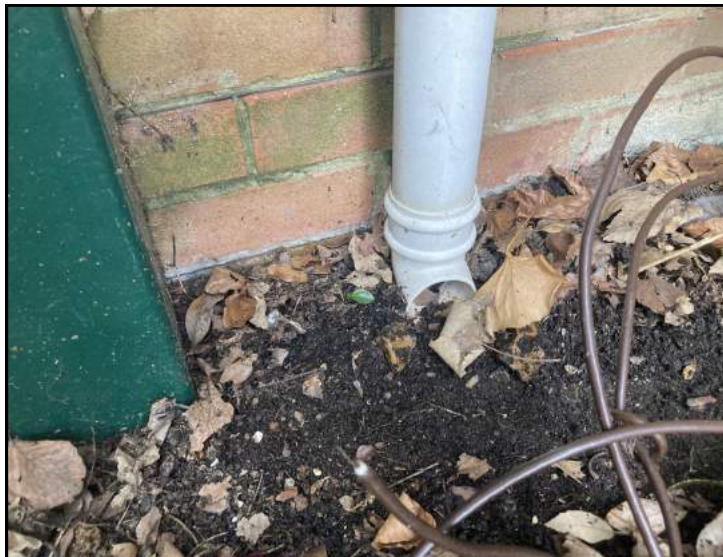
RWP 7 - ONTO GROUND

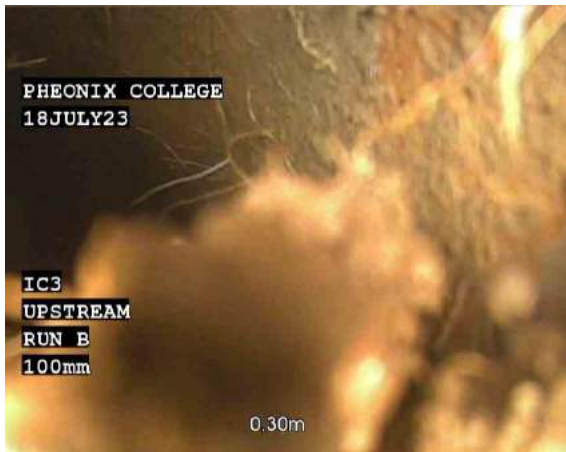
1, 00:00:01, 0.30 m  
Settled deposits, hard or compacted, 15% cross-sectional area loss, start

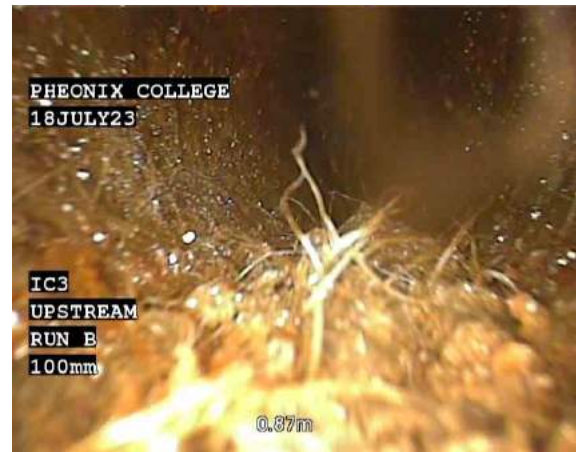
2, 00:00:10, 0.87 m  
Settled deposits, hard or compacted, 5% cross-sectional area loss, start

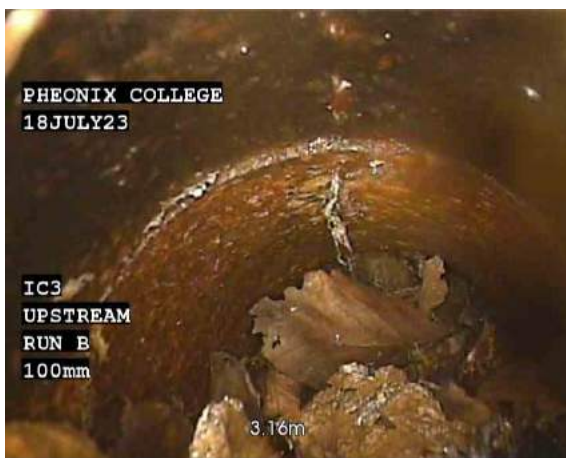
3, 00:00:22, 3.16 m  
Settled deposits, hard or compacted, 80% cross-sectional area loss

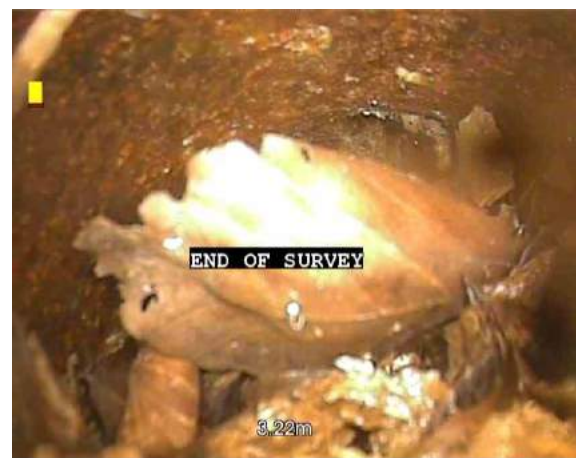
4, 00:00:28, 3.22 m  
Survey abandoned, Unable to continue due to debris

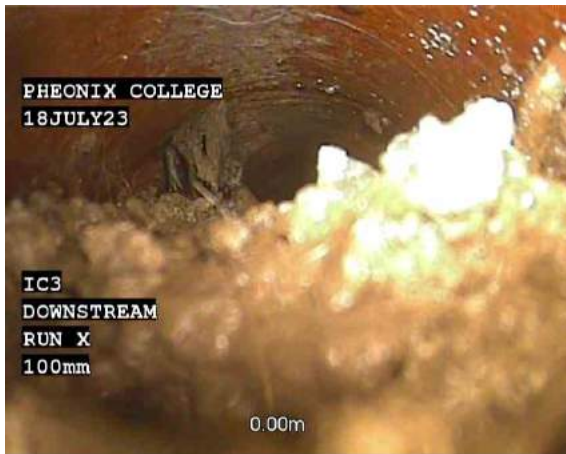
1, 00:00:00, 0.00 m  
Settled deposits, hard or compacted, 50% cross-sectional area loss, start

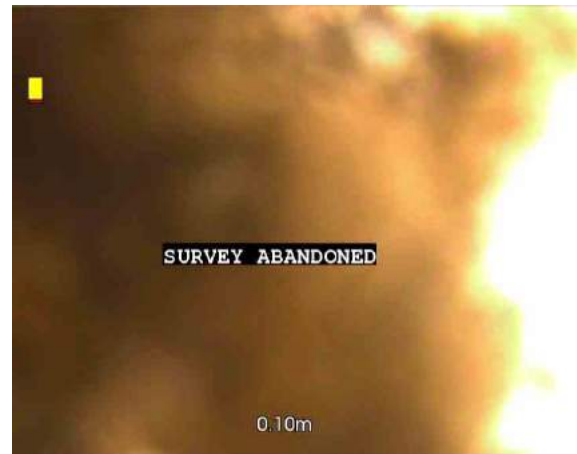
2, 00:00:19, 0.10 m  
Survey abandoned, Unable to pass due to silt deposits

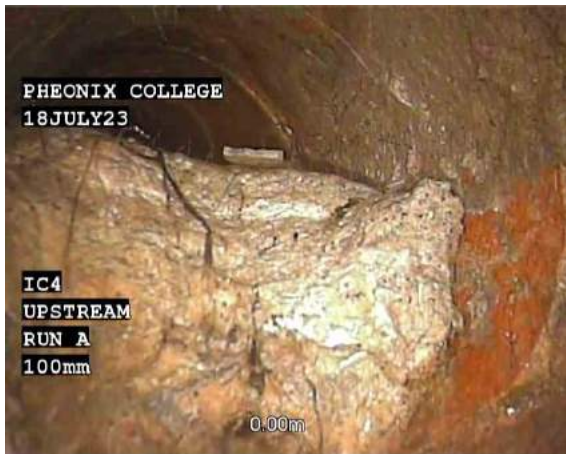
1, 00:00:00, 0.00 m  
Settled deposits, hard or compacted, 60% cross-sectional area loss, start

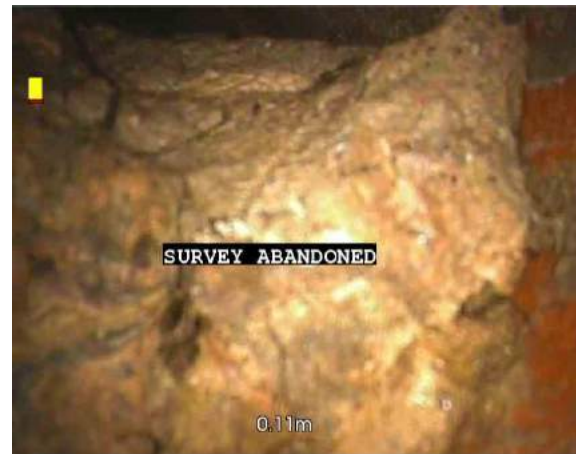
2, 00:00:13, 0.11 m  
Survey abandoned, Unable to pass due to silt deposits

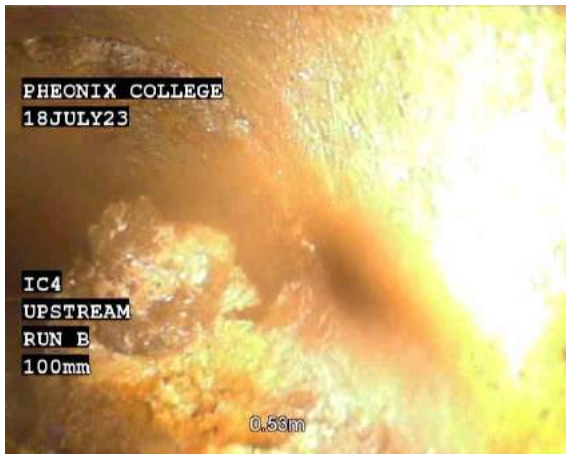
1, 00:00:07, 0.53 m  
Settled deposits, hard or compacted, 50% cross-sectional area loss, start

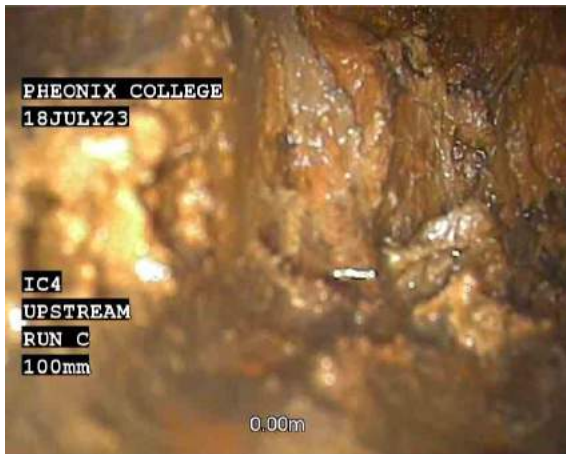
1, 00:00:01, 0.00 m  
Settled deposits, hard or compacted, 60% cross-sectional area loss, start

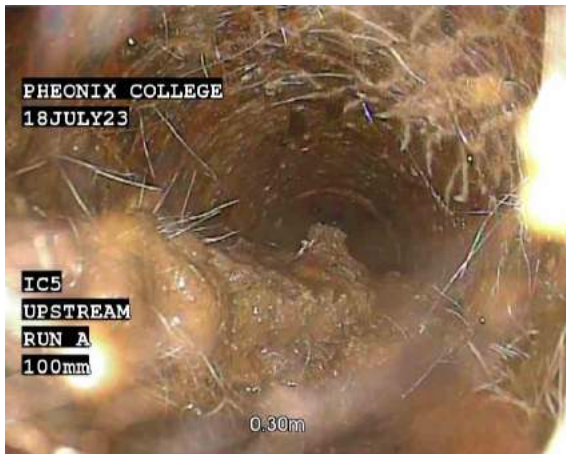
1, 00:00:00, 0.30 m  
Settled deposits, hard or compacted, 30% cross-sectional area loss, start

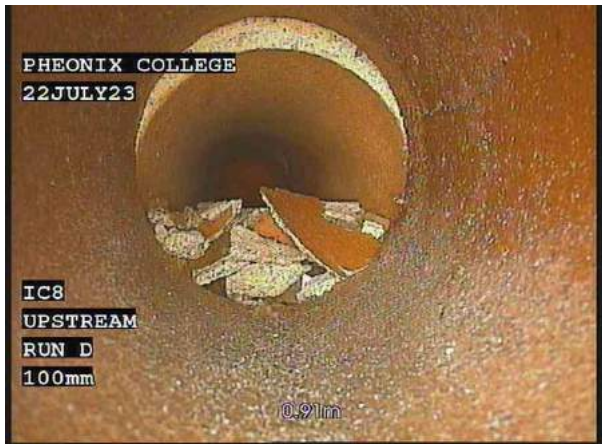
1, 00:00:25, 0.91 m  
Settled deposits, hard or compacted at joint, 20%  
cross-sectional area loss

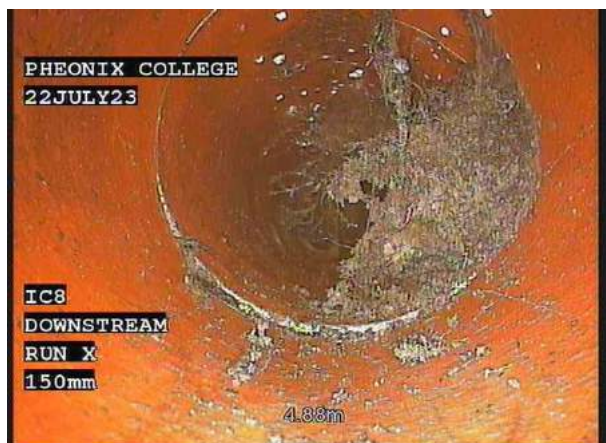
1, 00:00:26, 4.88 m  
Roots, mass at joint, 25% cross-sectional area loss

| Section number | Upstream manhole | Flow direction | Downstream manhole | Recommendations |
|---|---|---|---|---|
| 17 | IC8 | Downstream | IC11 | Clear by specialist root cutting and repair by lining (if viable) |

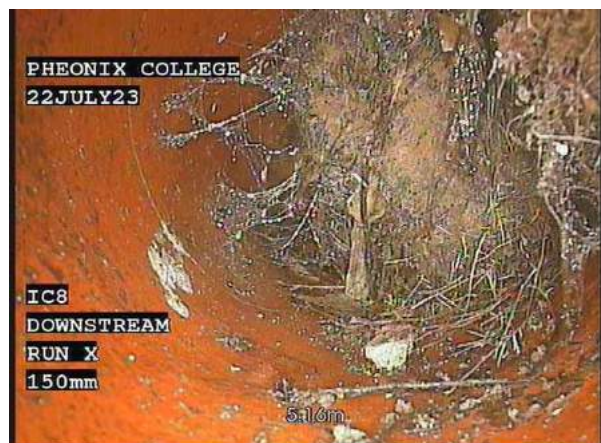
2, 00:00:41, 5.16 m  
Roots, mass, 80% cross-sectional area loss

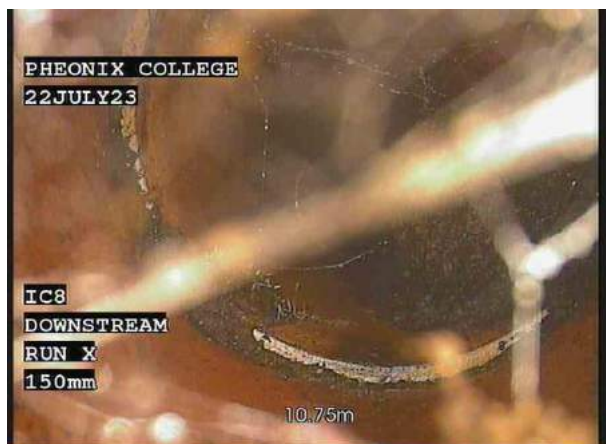
3, 00:02:12, 10.75 m  
Settled deposits, hard or compacted at joint, 20% cross-sectional area loss

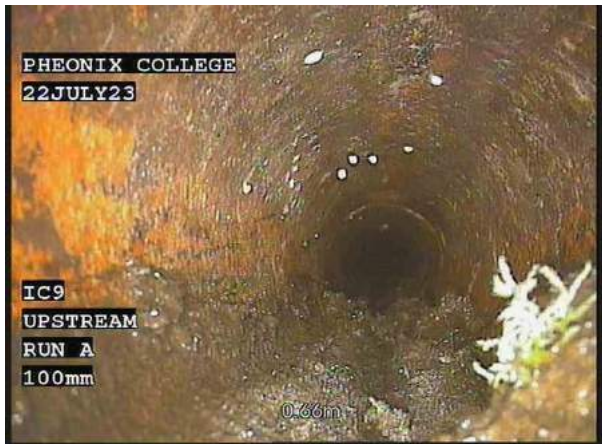
1, 00:00:08, 0.66 m  
Settled deposits, hard or compacted, 5% cross-sectional area loss, start

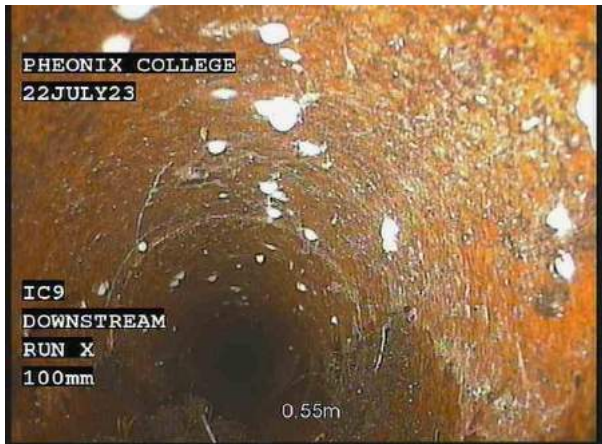
1, 00:00:10, 0.55 m  
Settled deposits, hard or compacted, 5% cross-sectional area loss, start

| Section number | Upstream manhole | Flow direction | Downstream manhole | Recommendations |
|---|---|---|---|---|
| 19 | IC9 | Downstream | IC10 | Repair defect(s) by lining |

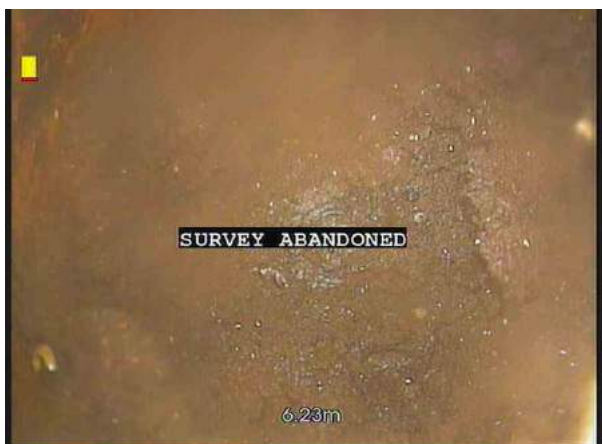
3, 00:01:37, 6.23 m  
Survey abandoned, Unable to pass due to silt deposits
