## Window Condition Survey at

191 Oxford Road  
Reading  
RG1 7UZ

### Metropolitan Thames Valley

Tel: [01689 885080](tel:01689885080)  
Email: [elliekeattch@effefftee.co.uk](mailto:elliekeattch@effefftee.co.uk)  
Date: 21/07/2025  
Project No: T1-7039

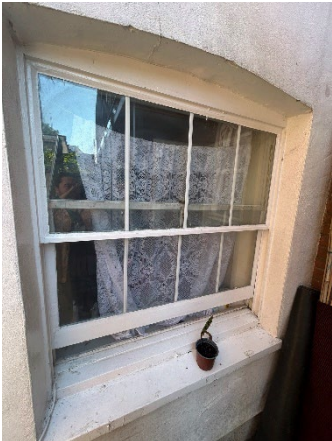
| Photo Name | Photograph |
|---|---|
| External condition of rear sash window. | |

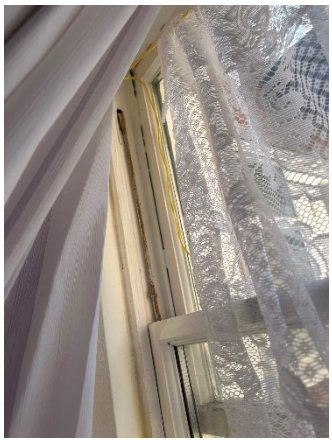
| Photo Name | Photograph |
|---|---|
| Internal condition of rear sash window including double glazing. | |

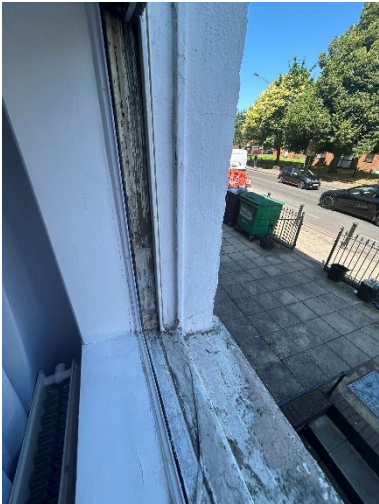
| Photo Name | Photograph |
|---|---|
| Internal condition of front sash timber window including close up of box sash. | |

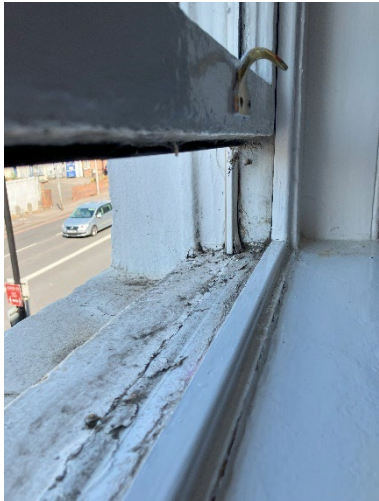
| Photo Name | Photograph |
|---|---|
| Internal condition of front sash timber window including bottom cill and frame. | |

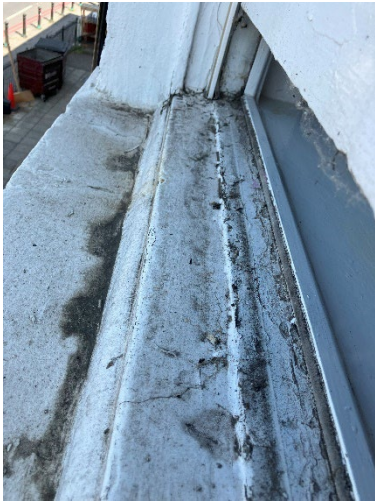
| Photo Name | Photograph |
|---|---|
| Internal condition of front sash timber window including bottom cill and frame. | |

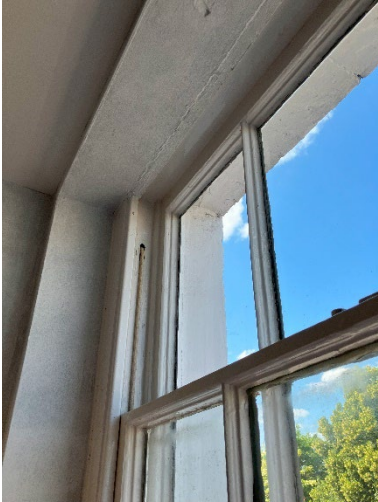
| Photo Name | Photograph |
|---|---|
| Internal condition of front sash timber window including upper sash. | |

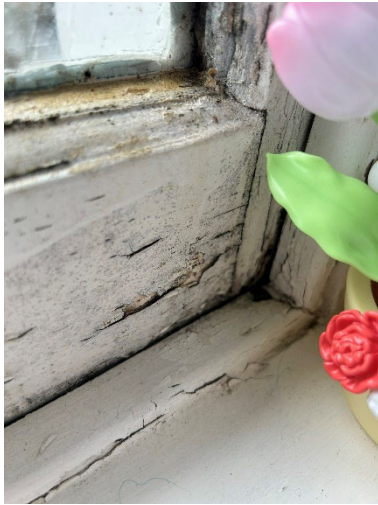
| Photo Name | Photograph |
|---|---|
| Internal condition of front sash timber window including decay of bottom rail. | |

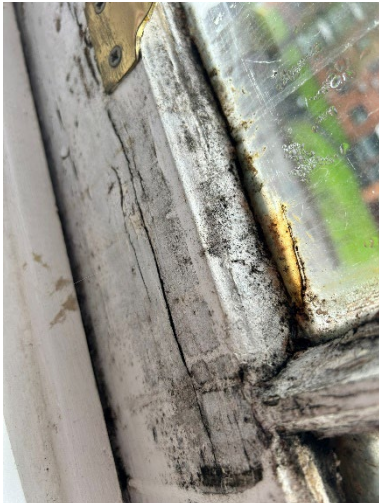
| Photo Name | Photograph |
|---|---|
| Internal condition of front sash timber window including decay of bottom rail. | |

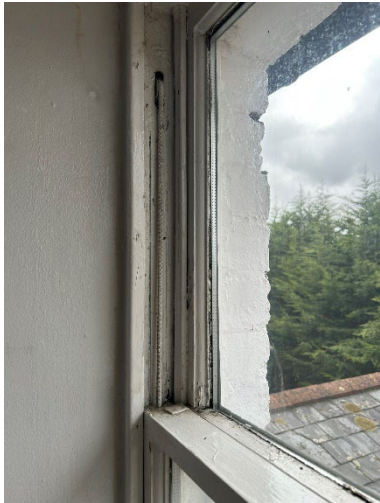
| Photo Name | Photograph |
|---|---|
| Internal condition of rear timber sash window including sash pulley cord. | |
