# Your survey report

43 Church Road, Caversham, Reading, Berkshire,  
RG4 7AG

22nd April 2025

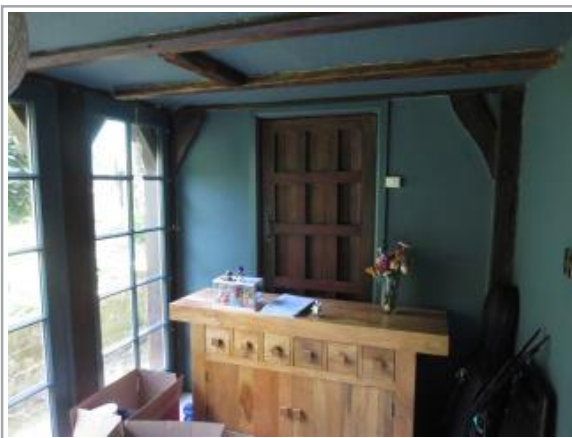
Door to garage.

Significant damp was noted within the garage and utility room.

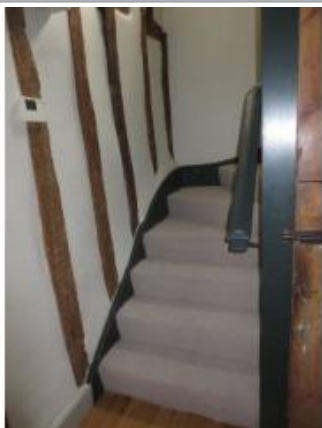
Stairs to bed 2

The stairs to second floor are steep with a handrail and should only be undertaken with good light and with care to prevent slips and falls.

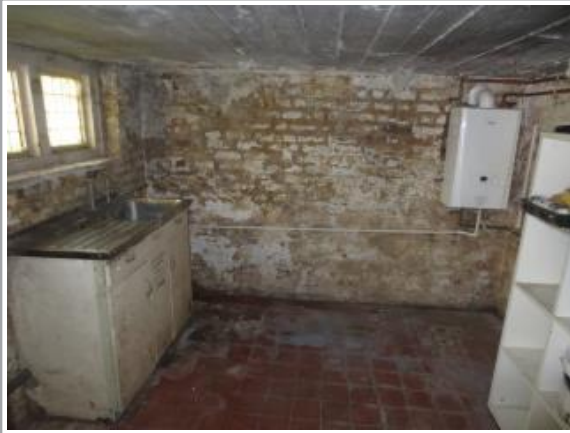
Gas boiler utility

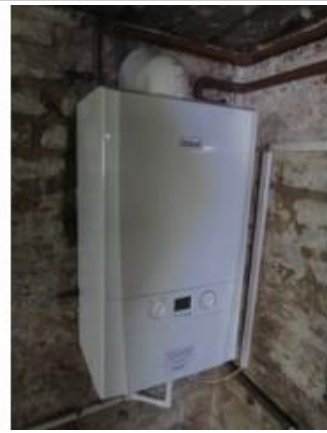
Gas boiler

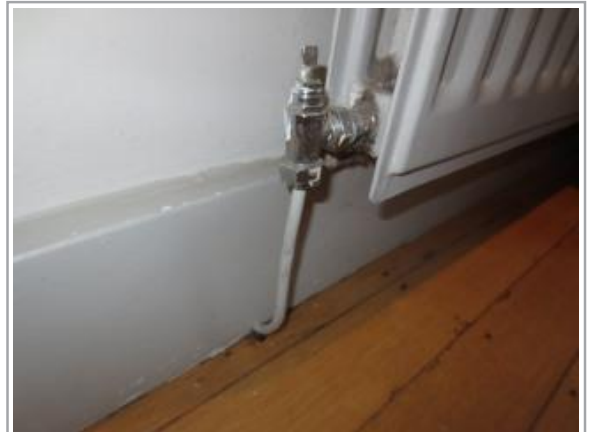
Micro bore pipes

You may wish to consider upgrading the central heating system, radiator and plumbing to more conventional small bore copper pipes.

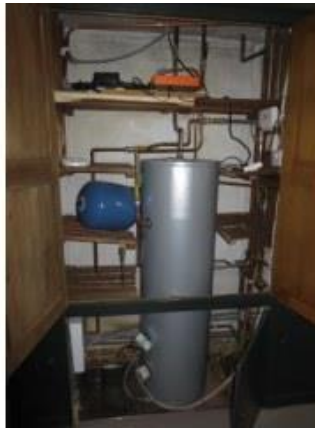
Hot water tank

If the gas boiler and pressurised hot water cylinder have not been tested within the last 12 months then we recommend that you instruct a suitably competent Gas Safe registered engineer to inspect both the boiler and pressurised hot water cylinder.

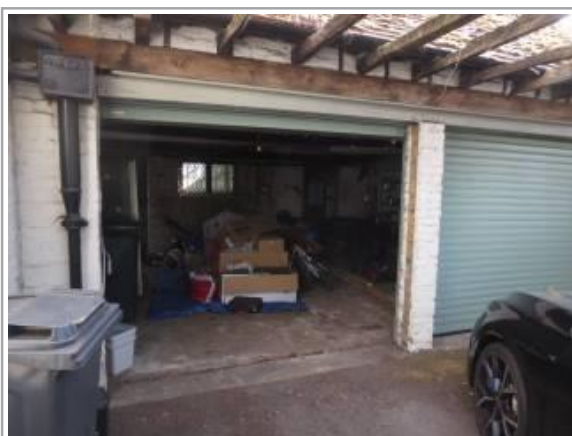
The garage and utility room are in poor and neglected condition with very significant damp to walls. You will note that the utility room and the side garage is constructed beneath ground level and significant retained earth exists to the side right of the garage and right and rear of the utility room.

Timber decay was noted to the partition dividing the garage and utility room. Timber decay should be anticipated within the garage. Costs for remedial work are likely to be high.

Garage

The garage side door into the sitting room is not a self closing fire door and we recommend that this is installed with Listed Building consent.
