# Asbestos Refurbishment/Demolition Survey for Reading Borough Council

Whitley Wood Community Centre  
Copenhagen Close  
Reading  
RG2 8UH

Project Number: AS13954

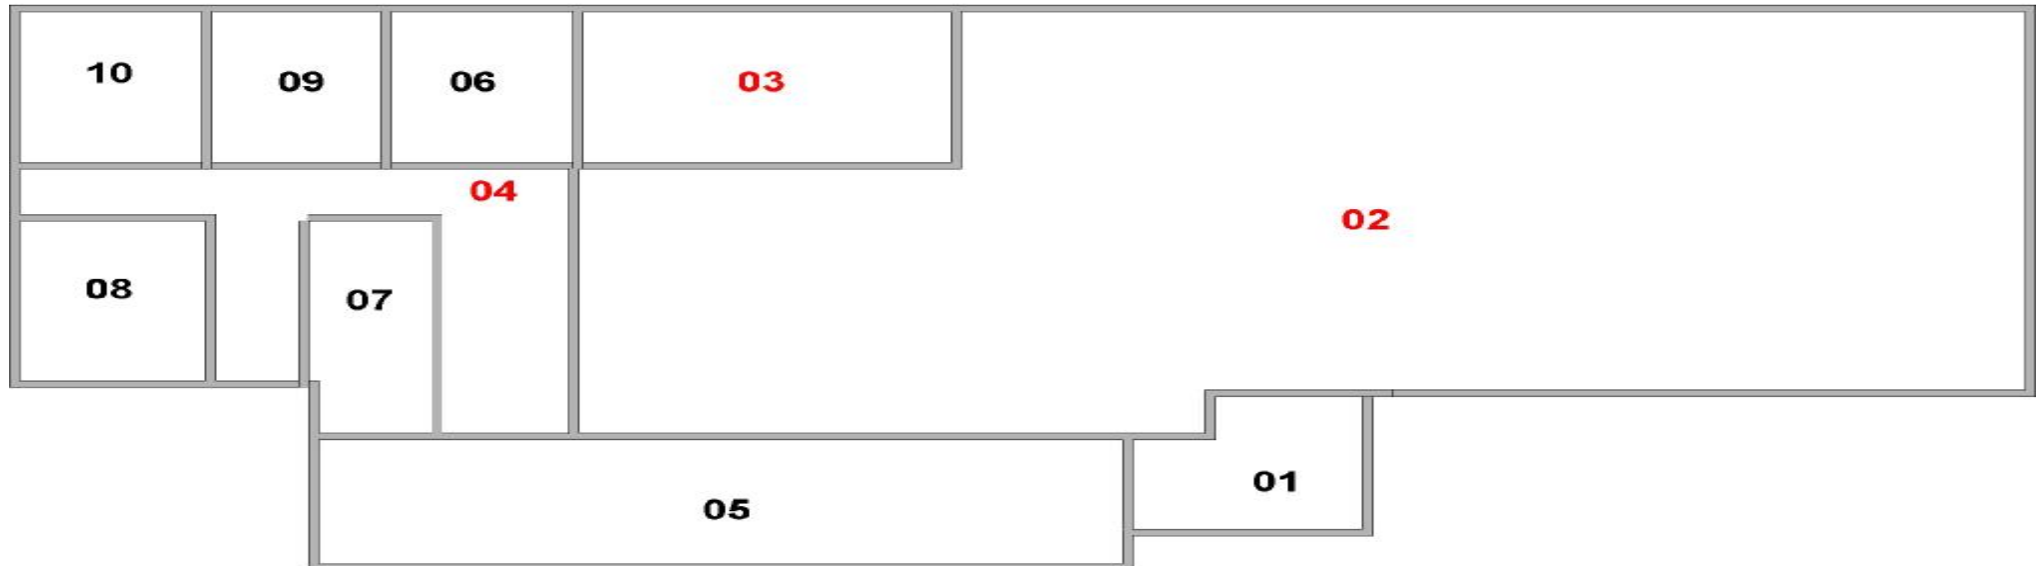
11

**Limited access into wall cavities and behind cladding to walls within areas where sprayed coating is present due to risk of disturbing possible ACM's. Presumed residue and overspray to walls behind cladding and within cavities.**
