**17 Conisboro Avenue, Reading RG4 7JB**

# **Arboricultural impact assessment and tree protection measures v5 (October 2025)**

**Site inspected on 5<sup>th</sup> & 9<sup>th</sup> September 2023**

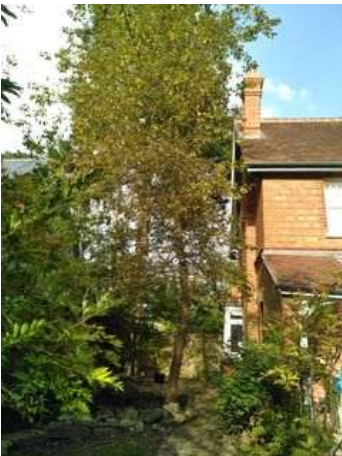
| Ref. | Species | Photo | Photo | Photo |
|---|---|---|---|---|
| T018 | Goat Willow<br>( <i>Salix caprea</i> ) | | | |

| Ref. | Species | Location | Structure | Num. Stems | DBH (cm) | General Observations | RPA | Recommendations | Retention category |
|---|---|---|---|---|---|---|---|---|---|
| T018 | Goat Willow<br>( <i>Salix caprea</i> ) | North boundary | Tree | 1 | 20 | <ul style="list-style-type: none"> <li>Fair condition</li> </ul> | 2.4m radius<br>18.1m <sup>2</sup> | N/A | C |

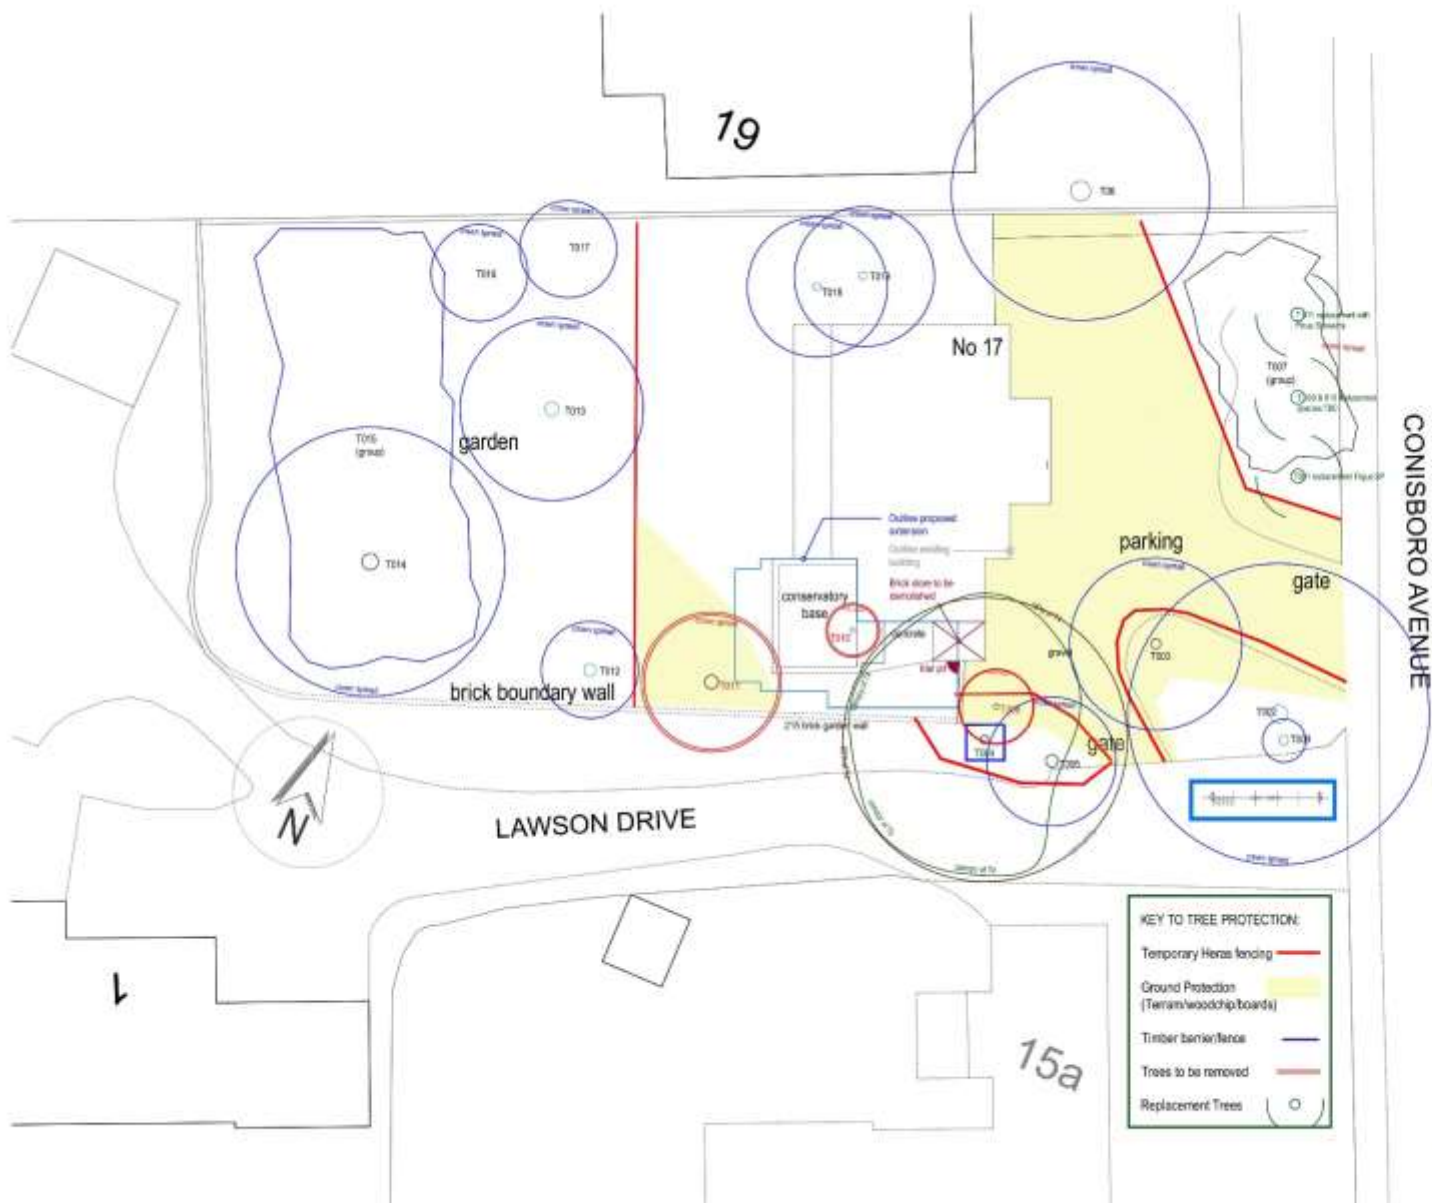
PROJECT: Extensions & Alterations  
 SITE: 17, Conisboro Avenue  
 Caversham, RG4 7JB  
 ORG TITLE: Tree Protection Plan  
 SCALE: 1:200 @ A3  
 DATE: JUNE 2025  
 DRG. NO.: 2279.22 L

This protective area (as seen in drawing 2279.22L) will also need to surround lime tree T4 as work will be required within the RPA. When the piles are being installed (see below for specific protective measures to be implemented during the installation of pile foundations), as little of the load spreading material as possible is to be removed (some boards may need to be cut) in order to facilitate the work whilst continuing to protect as large an area as possible. Site supervision will be required

Revision L has removed T1 from the plan as it has been removed from site

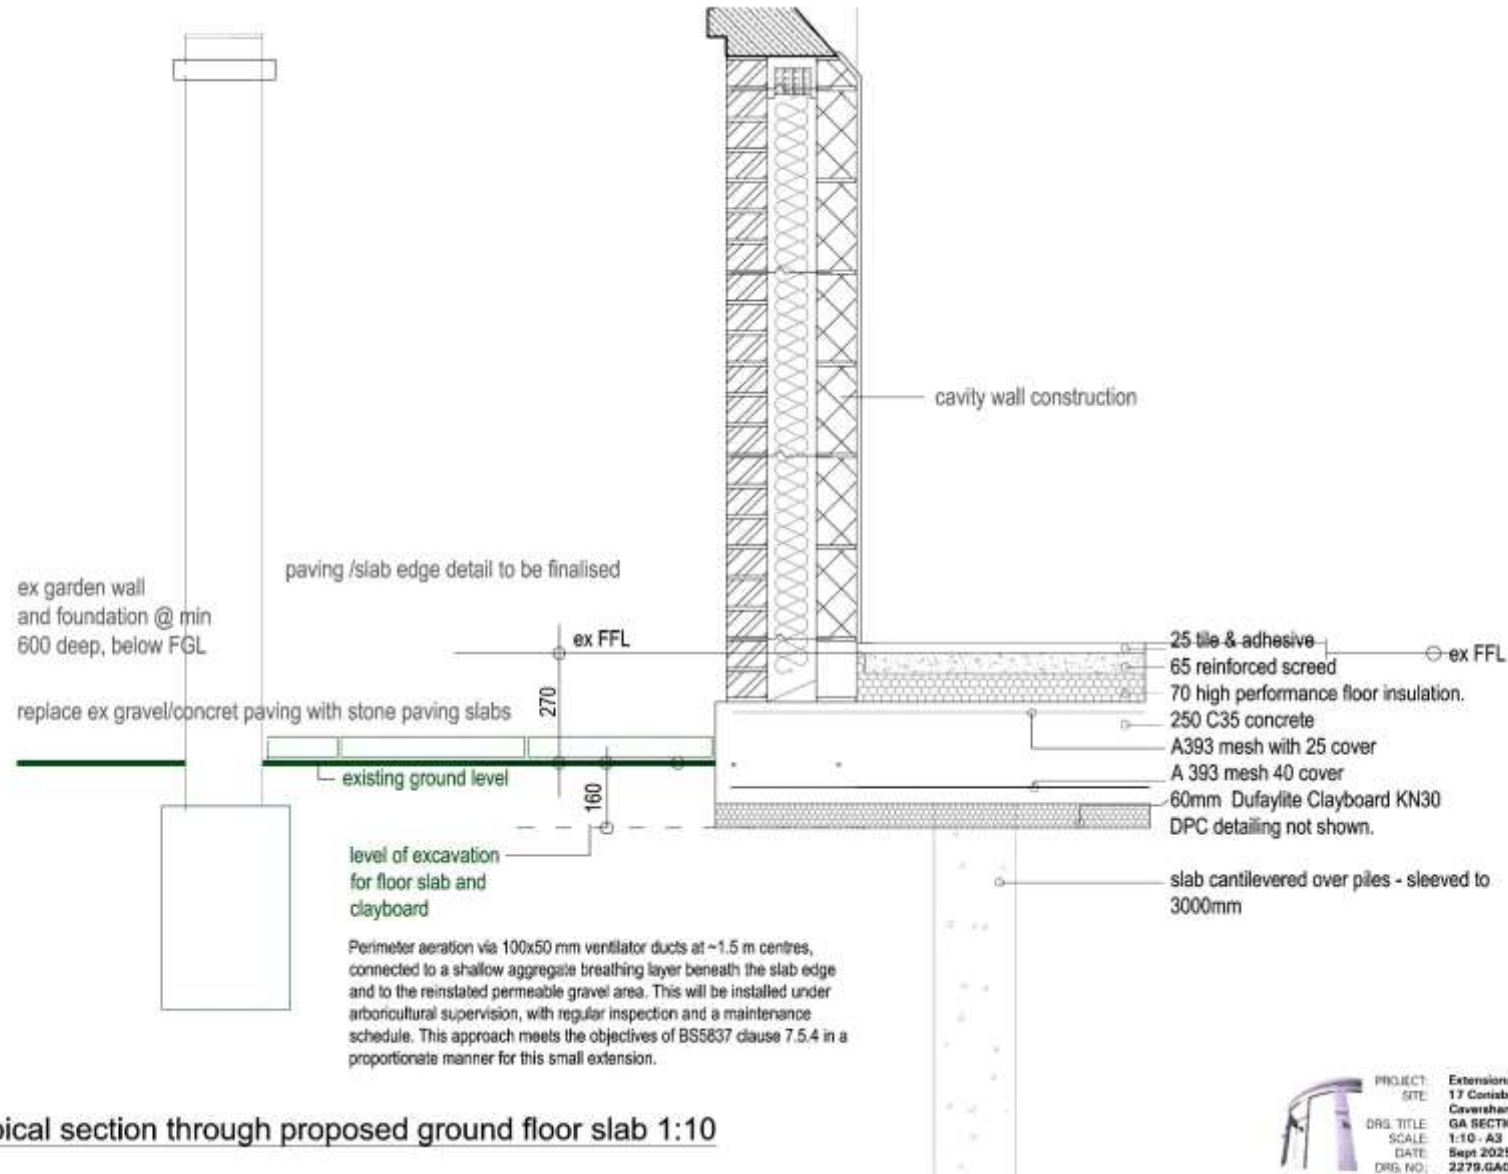
typical section through proposed ground floor slab 1:10

The most significantly affected tree to be retained is Lime T4 which will require foundations well within its RPA. In order to minimise the impact of the foundations to T4, pile foundations in conjunction with a shallow concrete slab will be used rather than traditional concrete filled trenches. This will allow the majority of the roots to remain undisturbed and still allow for the free flow of water and oxygen beneath the newly built structure thereby retaining the soil's viability.

A trial trench was dug along the full width of the RPA and no significant roots were found down to a depth of 220mm (see appendix at end of document) below ground level meaning the excavation for the concrete slab at 160mm below ground level will not sever or disturb major roots within the RPA (see drawings 2279.GA06F and 2279.34C).
