# Tree Condition Survey Report (VTA)

**Site:** Forbury Retail Park, Kenavon Dr, Reading RG1 3HS

**Client:** JLL

| <i>GC Document Reference</i> | J251017 | | |

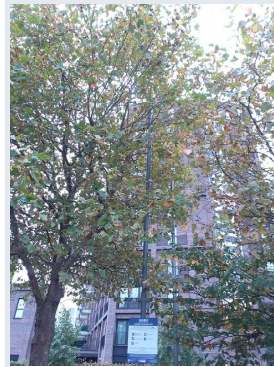
### London plane Tree ID #13

| Tree / Group ID | Common Name | Work Task | Work Priority | Description | Tag No |
|---|---|---|---|---|---|
| 13 | London plane | Crown Lift to Statutory Height Over path 2.5m, 5.2m Over Road | Within 6 - 12 Months | Crown lift to clear the footpath and road.<br>No access to tag<br>W3W:///frost.grab.trash<br>Traffic management recommended | no access to tag |
