41, Eastern Avenue  
Reading  
RG1 5RX

## Structural feasibility report

Clive Hudson Associates  
Consulting Structural & Civil Engineers

Jan 2026  
Project Ref: 256939

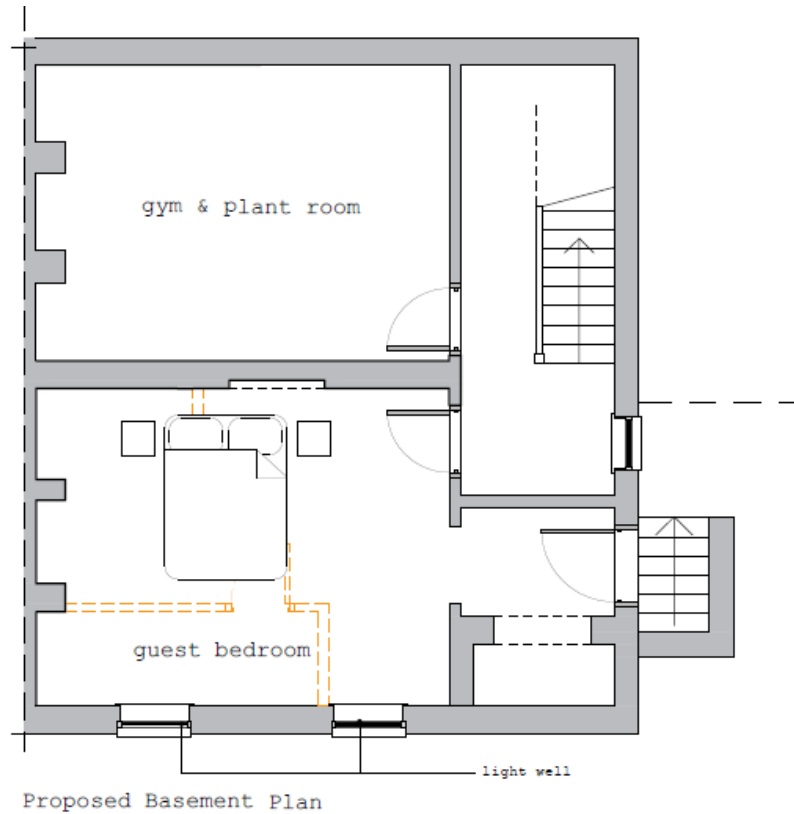
Figure 8. Proposed basement plan – extracted from Colony Architects drawing 03-11.

- i. The architectural drawings for the basement indicate that the proposed alterations comprise the removal of internal partitions from within the front room, and the insertion of two lightwells in the front wall (Fig. 8).
- ii. From the inspection, the partitions are clearly not historic. The east/west partition is of stud construction, while the partition towards the front elevation is of blockwork construction.
- iii. The ground floor construction comprises timber joists that span north-south, with internal support provided by two downstand timber beams that span east-south. Both beams are supported by the north/south blockwork partition (Fig. 9).

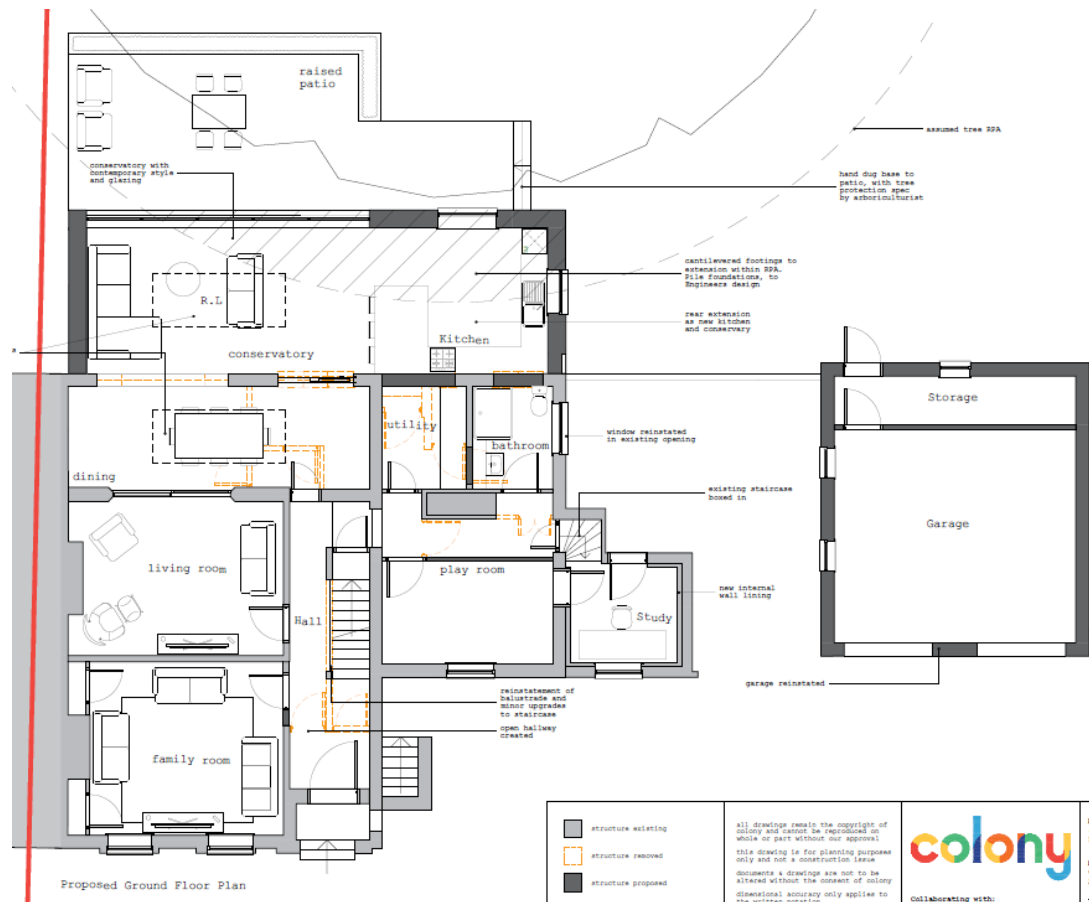
Figure 12. Proposed ground-floor plan – extracted from Colony Architects drawing 03-10.

i. The architectural drawings for the ground floor (Fig. 12) indicate that the proposed alterations include:

- the installation of a new partition to subdivide the existing bedroom into a playroom, with a separate corridor to the proposed bathroom,
  - the creation of a new opening between the proposed playroom and study,
  - the insertion of a new rooflight in the existing flat roof, and the
  - the creation of a new window in the east wall of the proposed study.
- ii. As the new rear extension lies within the No-Dig Construction zone, we would recommend that the new foundations for the extension be piled, either incorporating an integrated reinforced concrete ground-floor slab or utilising a reinforced concrete ground-beam arrangement with a separate or an integrated floor structure. This will require a suitable geotechnical investigation to be carried out (by others) to advise on the appropriate pile design/parameters.

To minimise the risk of differential movement between structural elements founded on different substrates/foundations, we would recommend that additional internal support be introduced within the new extension to carry the new first-floor wall, rather than relying on the existing wall for support.

While not a structural issue in itself, the construction of the new extension is likely to fall within the scope of the 1996 Party Wall Act. As a result, we would recommend that advice be sought from a competent Party Wall Surveyor at an early stage.

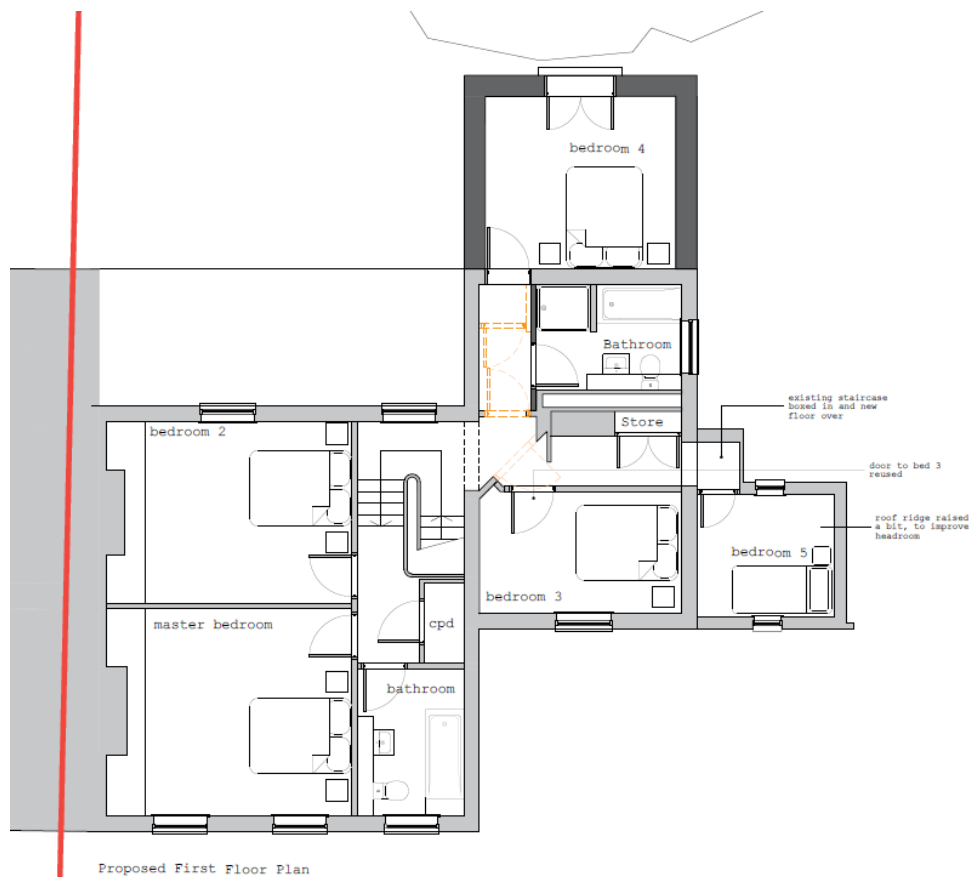
Figure 18. Proposed first-floor plan – extracted from Colony Architects drawing 03-10.

- i. The architectural drawings for the first floor (Fig. 18) indicate that the proposed alterations include:
  - The addition of a 4<sup>th</sup> bedroom to the east of the existing bathroom,
  - The introduction of new stud partitions and the removal of existing stud partitions,
  - The raising of the ridge over the proposed bedroom 5, and
  - The formation of a new opening in the existing rear wall to allow access to the new bedroom.

None of these raises structural concerns. The creation of new openings will naturally require new lintels to be introduced. We would recommend that the floor and ceiling levels in the proposed corridor and bedroom 5 be confirmed before the submission of the listed building consent application.

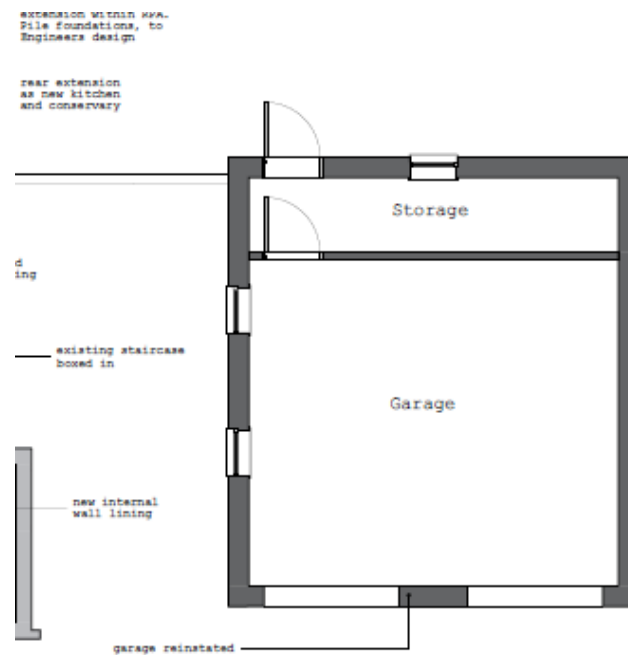
Figure 19. Proposed garage floor plan – extracted from Colony Architects drawing 03-10.

- i. The architectural proposals include a new garage adjacent to the southern boundary. The new garage will be single-storey with a duo-pitched roof. As the new garage lies within a No-Dig Construction zone, we would recommend utilising piled foundations with an integrated reinforced concrete ground-floor slab to support the superstructure, as recommended by SJ Stephens Associates. This will require a suitable geotechnical investigation to be carried out (by others) to advise on the appropriate pile design/parameters.

- ii. Although it is not a structural issue, per se, we would recommend that the widths of the openings be confirmed before the listed building consent application is submitted, as they appear to be relatively narrow, in our opinion.

- iii. While it is not a structural issue per se, the construction of the new garage is likely to fall under the 1996 Party Wall Act. As a result, we would recommend that advice be sought from a competent Party Wall Surveyor at an early stage.
