# Site Investigation Report

129603.1.USI

## Job Summary

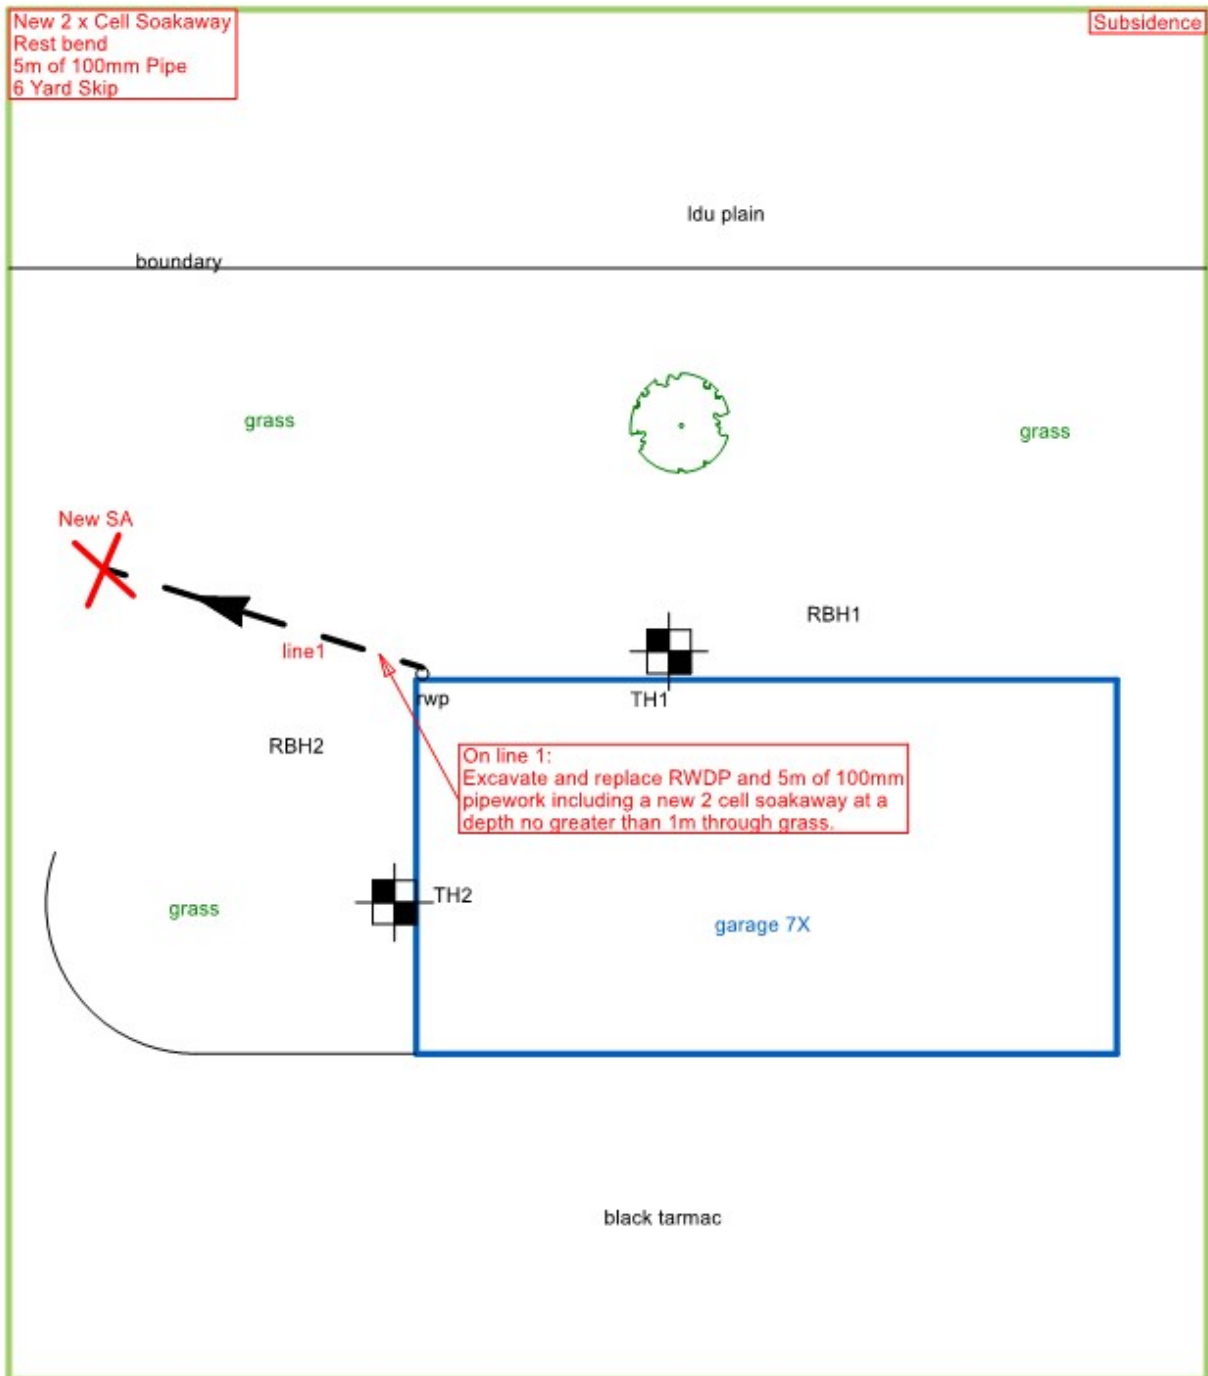
## FRONT OF PROPERTY

New 2 x Cell Soakaway  
Rest bend  
5m of 100mm Pipe  
6 Yard Skip

Subsidence

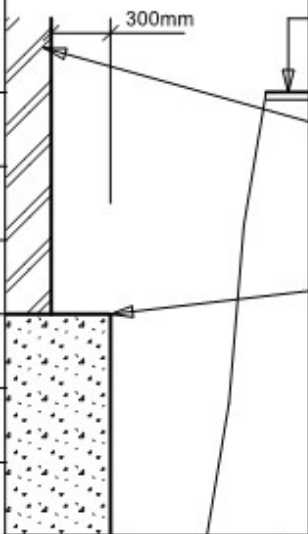
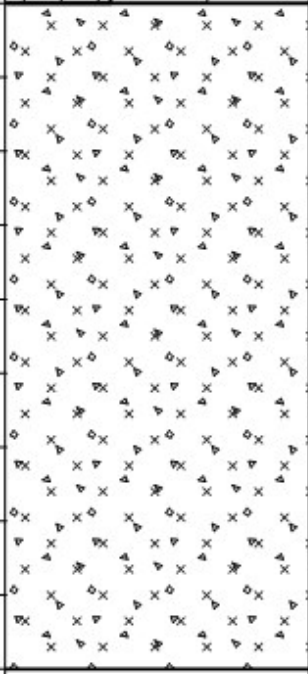
# Trial Hole Log No.1

Location: Rear wall of the garages

| Depth<br>(m) | Symbolic Log | Strata Description | Insitu Tests | | Soil<br>Sample | Root<br>Sample |
|---|---|---|---|--|---|---|
| 0.0 | | Ground Level<br>Grass<br>Brickwork<br>Concrete | | | | |
| 0.5 | | Brown slightly clayey silty fine to medium<br>gravelly SAND | 64kpa | | Soil<br>@ 0.6m | Root<br>@ 0.8m |
| 1.5 | | TRIAL HOLE TERMINATED | | | | |
