CLIENT  
**University of Reading**

PROJECT  
**The Fernery at the Acacias**

TITLE  
**Metalwork Repairs 1**

DRAWING NUMBER  
**242925-PUR-01-XX-DR-A-3005**

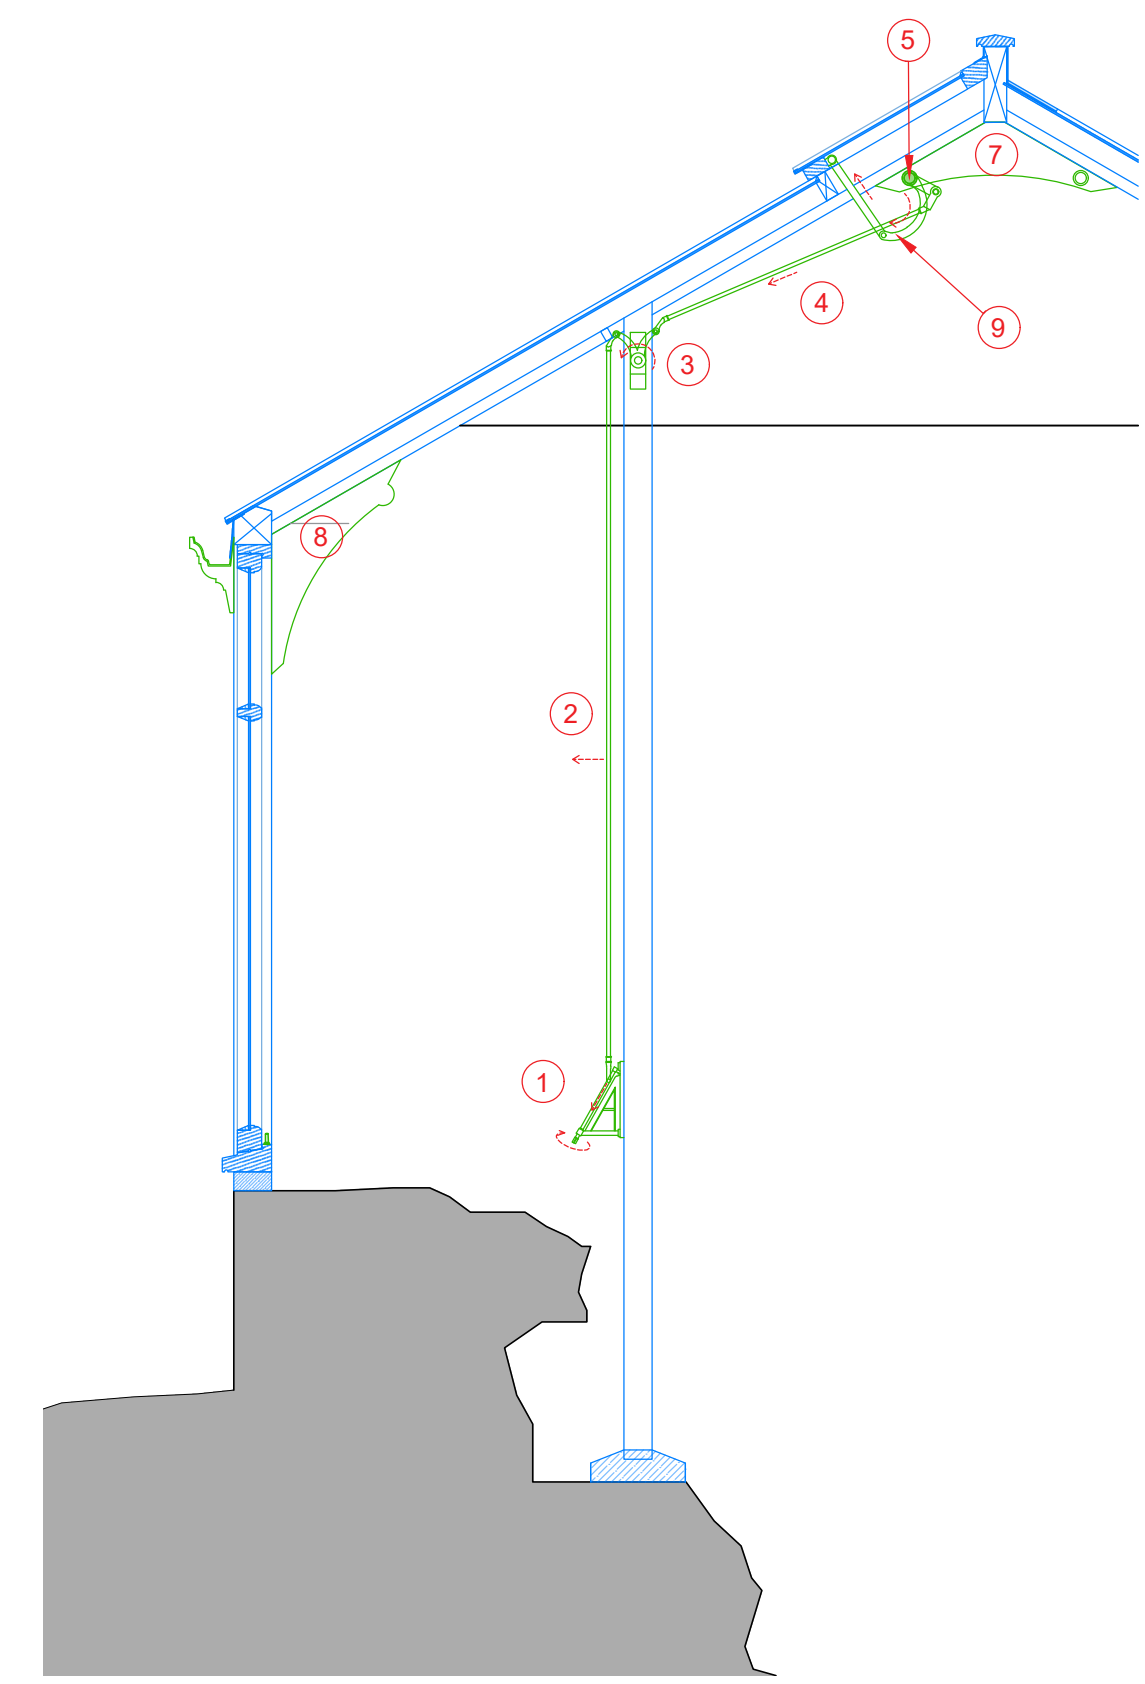
1 Ventilating Mechanism in Closed Position  
3005 1:20@A1

Total 2 no. winches required, both existing ones intact, one with threaded coupling missing.

Vertical connecting shafts have broken off from both sets. Replace 2 no. mild steel operating / connecting shafts from winch to ventilator arms.

Total 2 no. bellcranks required, one intact with lever, one has lever half broken off.

At least one rod is intact with clevis joints to both ends. Ease and adjust. Clean flaking paint with manual tools and treat for rust. Redecorate to match existing.

One rod may be missing, allow for replacement in mild steel, decorate in black to match existing, with associated clevis joints to both ends.

Allow for straightening of existing main vent rods, which are slightly bowed when removed. 2 no. in total, one to north wing and one to west wing.

Total 2 no. mounting plates needed, one to each wing, at hip.

Repair 2 no. cast iron winches with likely replacement mild steel threaded rolls - Ease and adjust threaded rod. Allow for stabilisation if any cracks are showing on cast iron winch prior to moving any parts. Clean flaking paint with manual tools and treat for rust. Redecorate to match existing.

Source for salvaged Whitworth (BSW) coupling nut matching existing where possible. Allow for new coupling to be made from mild steel if no existing piece can be found, to match existing.

Braze broken lever arm is missing piece can be found. Allow for fabricating and bolting new steel arm is original piece cannot be located once leaves are cleared, with associated clevis joint to rod.

Ease and adjust both bell crank levers. Allow for stabilisation if any cracks are showing on cast iron prior to moving any parts. Clean flaking paint with manual tools and treat for rust. Redecorate to match existing.

Clean flaking paint with manual tools and treat for rust. Redecorate to match existing.

Replace any missing length /section with mild steel in matching diameter, thread type on the ends, and lengths between joints. Joined to existing sections with threaded coupling matching existing.

Allow for replacement of 1 piece in mild steel matching existing (only one intact plate was identified on site visit on the 28th January 2026, the second piece is presumed to be concealed under leaf debris - to be confirmed once ground has been cleared).
