Archway Heritage

# Appendix 11

## Yeomanry House

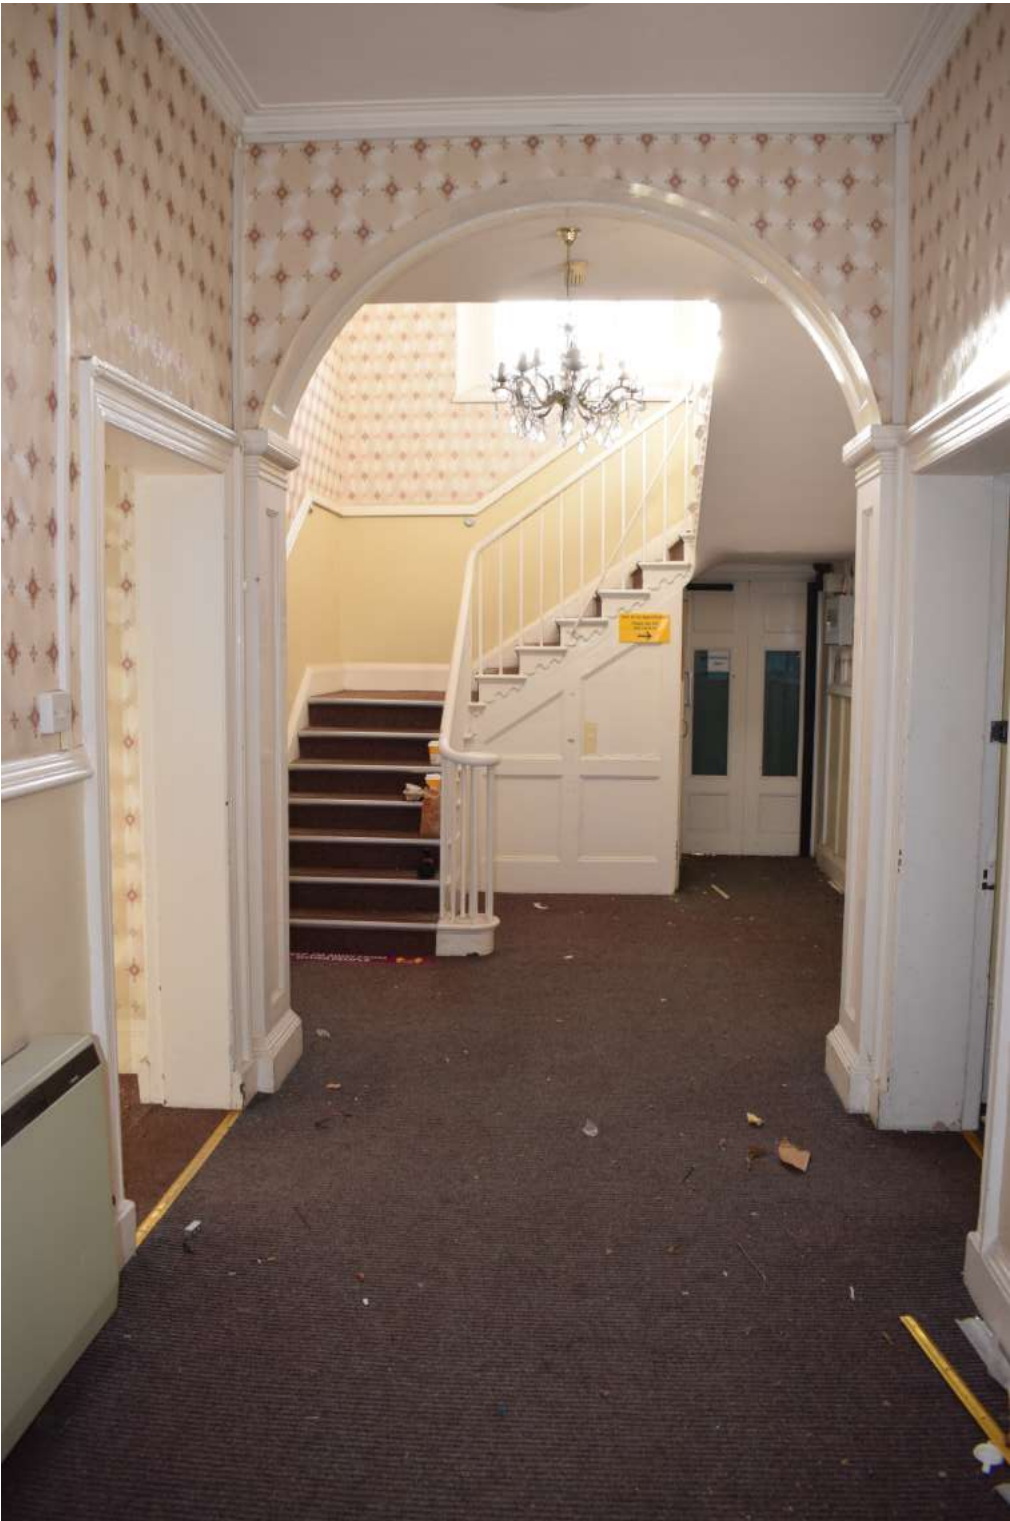
Plate 1  
General photographs of the entrance hallway illustrating the presence of non-decorative coving, relatively decorative, low-profile skirting, and a historically retained dado rail.

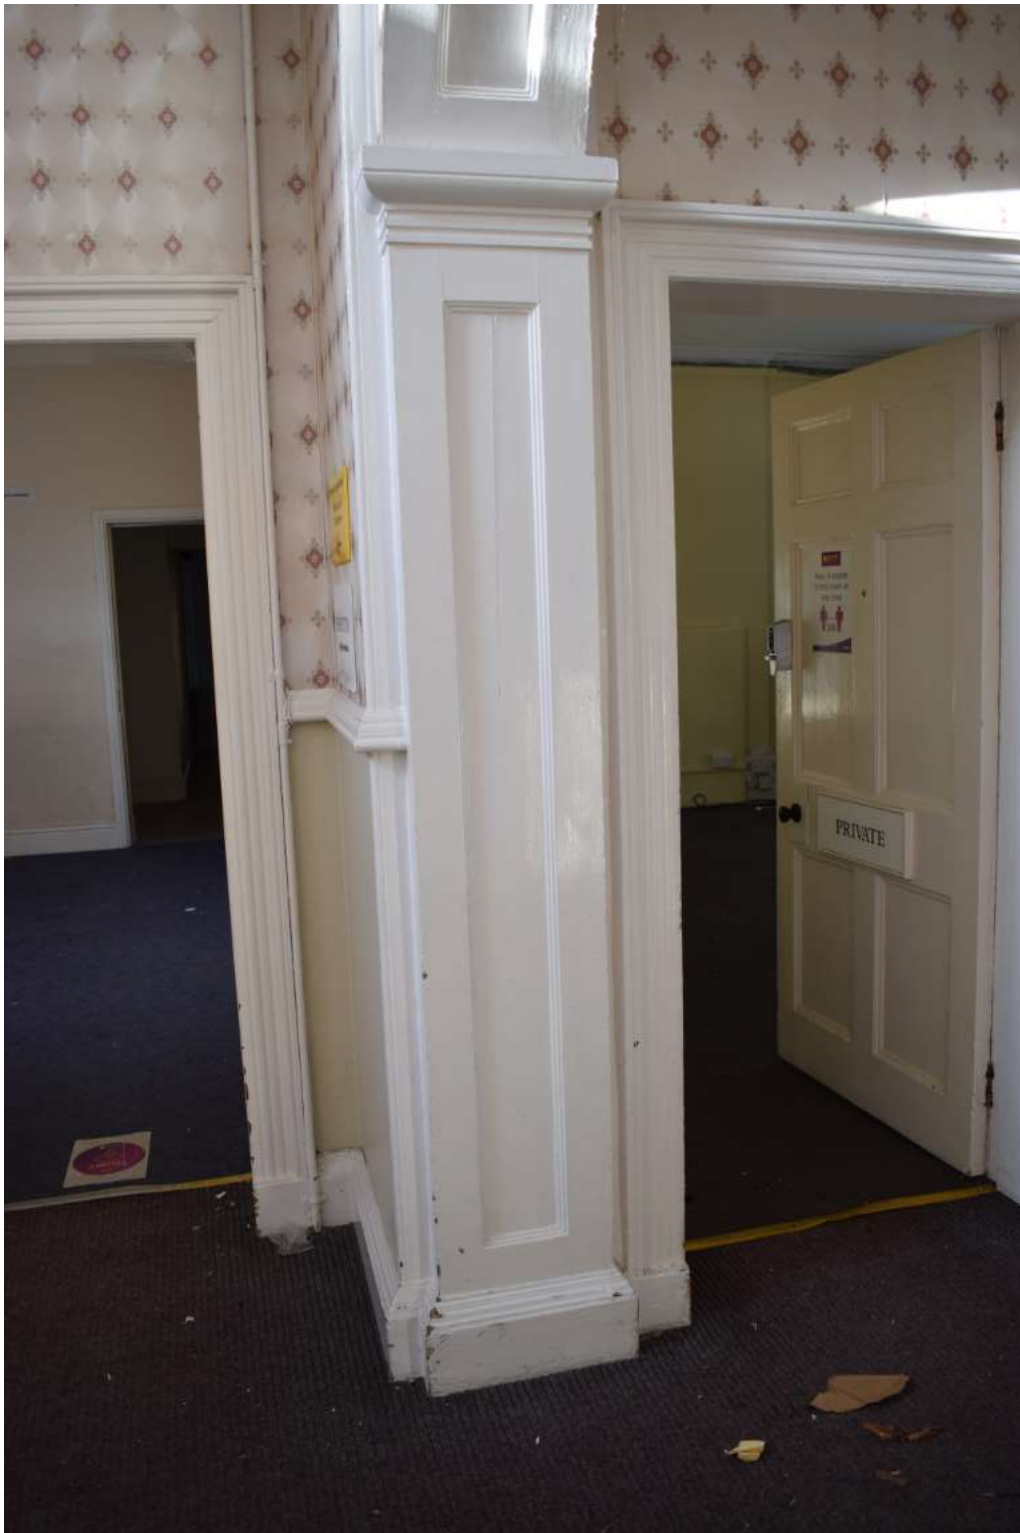
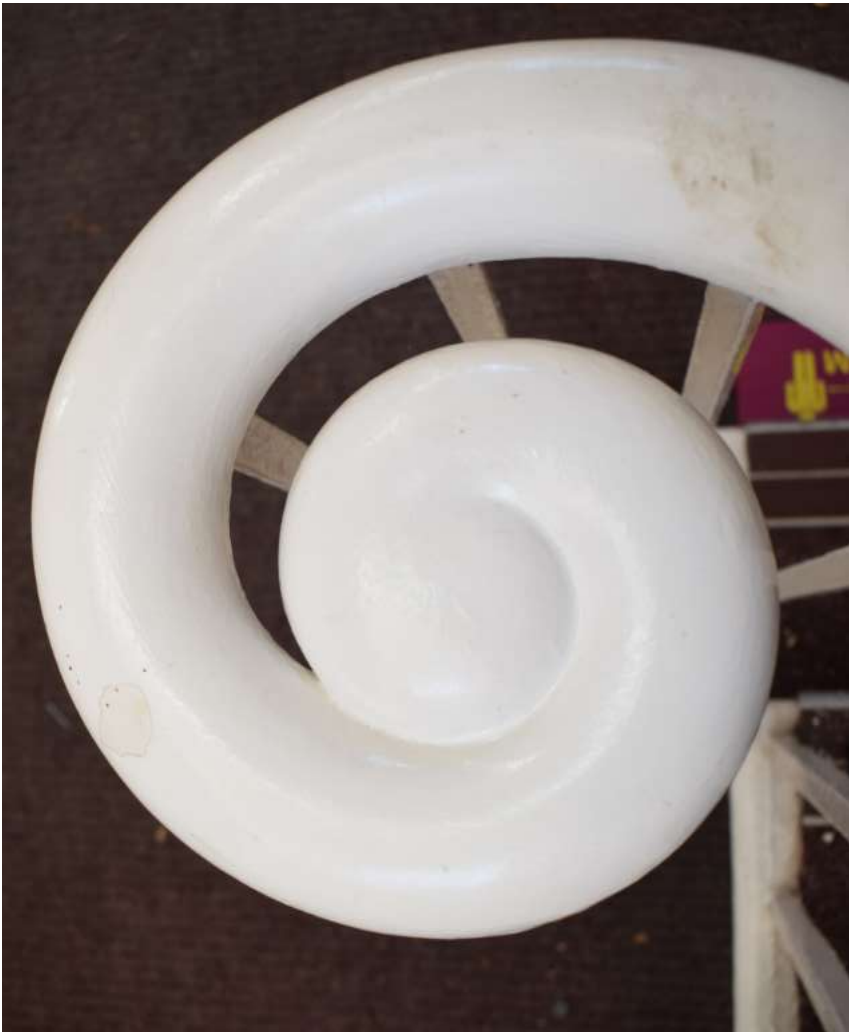
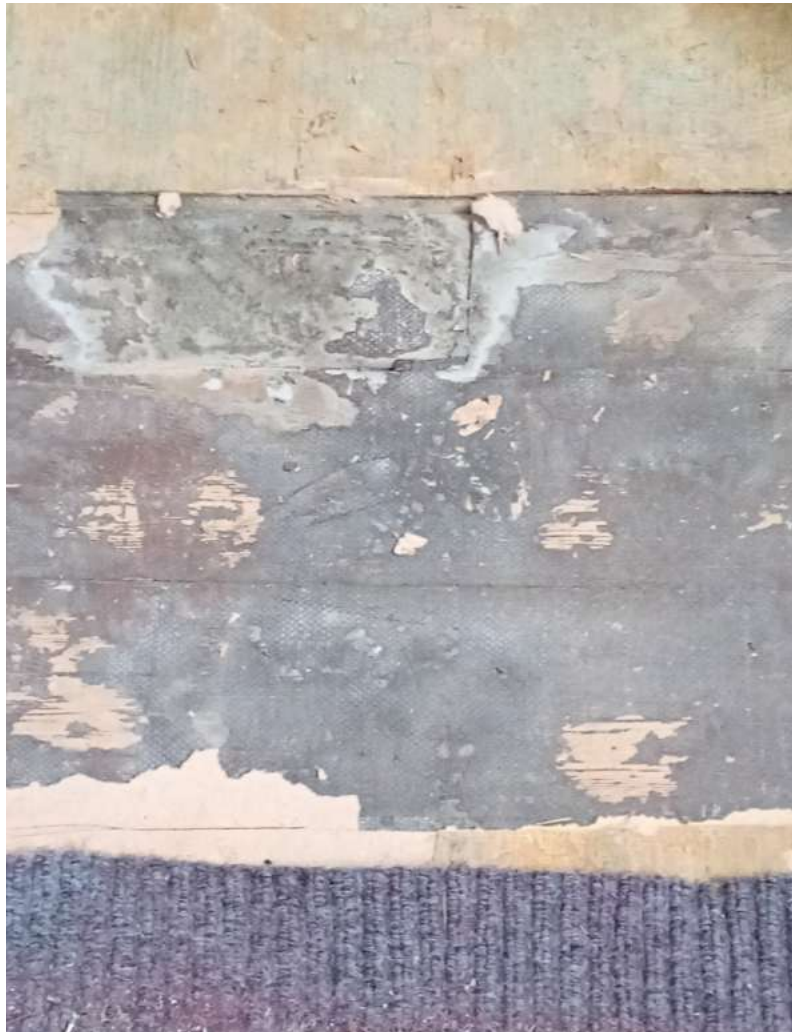
Plate 2  
Detailed image of the pilaster structure flanking the arch, comprising a plinth, a fluted/panelled shaft, and a decorative capital. Inset: Detail of the Newel Post, the primary vertical structural element at the base of the main staircase and timber flooring.

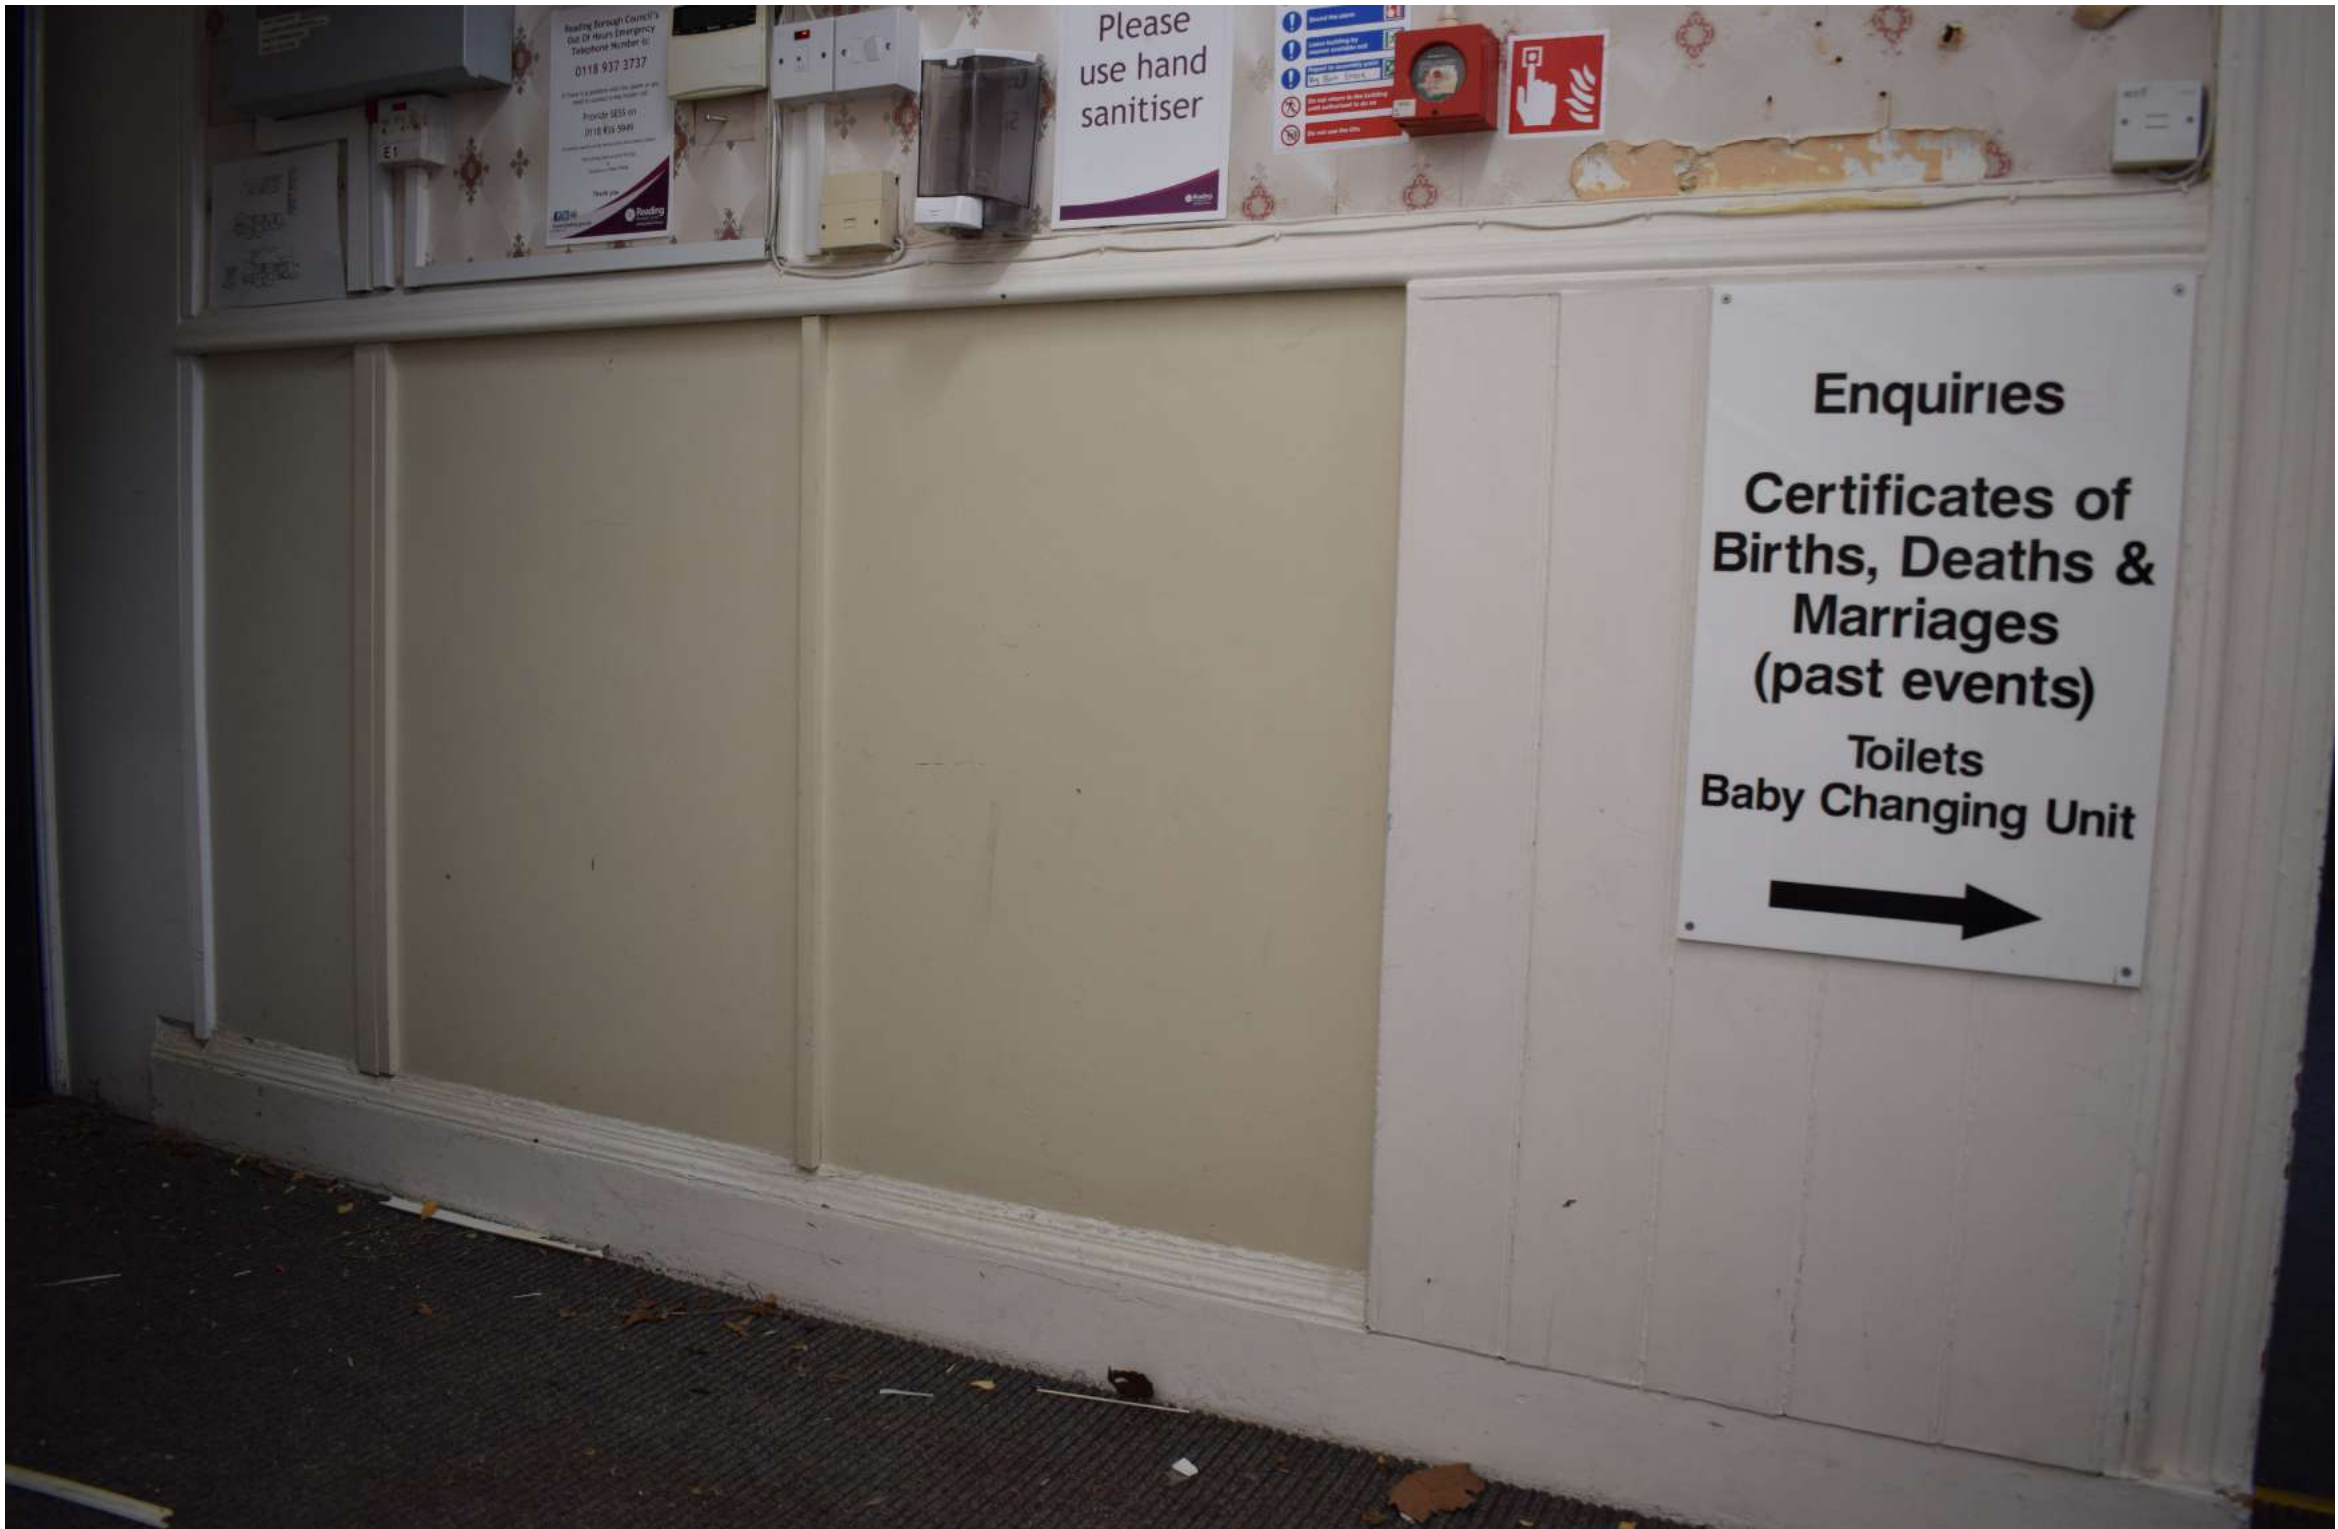
Plate 3  
Detailed image confirming the apparent absence of wall panelling below the existing dado rail height.

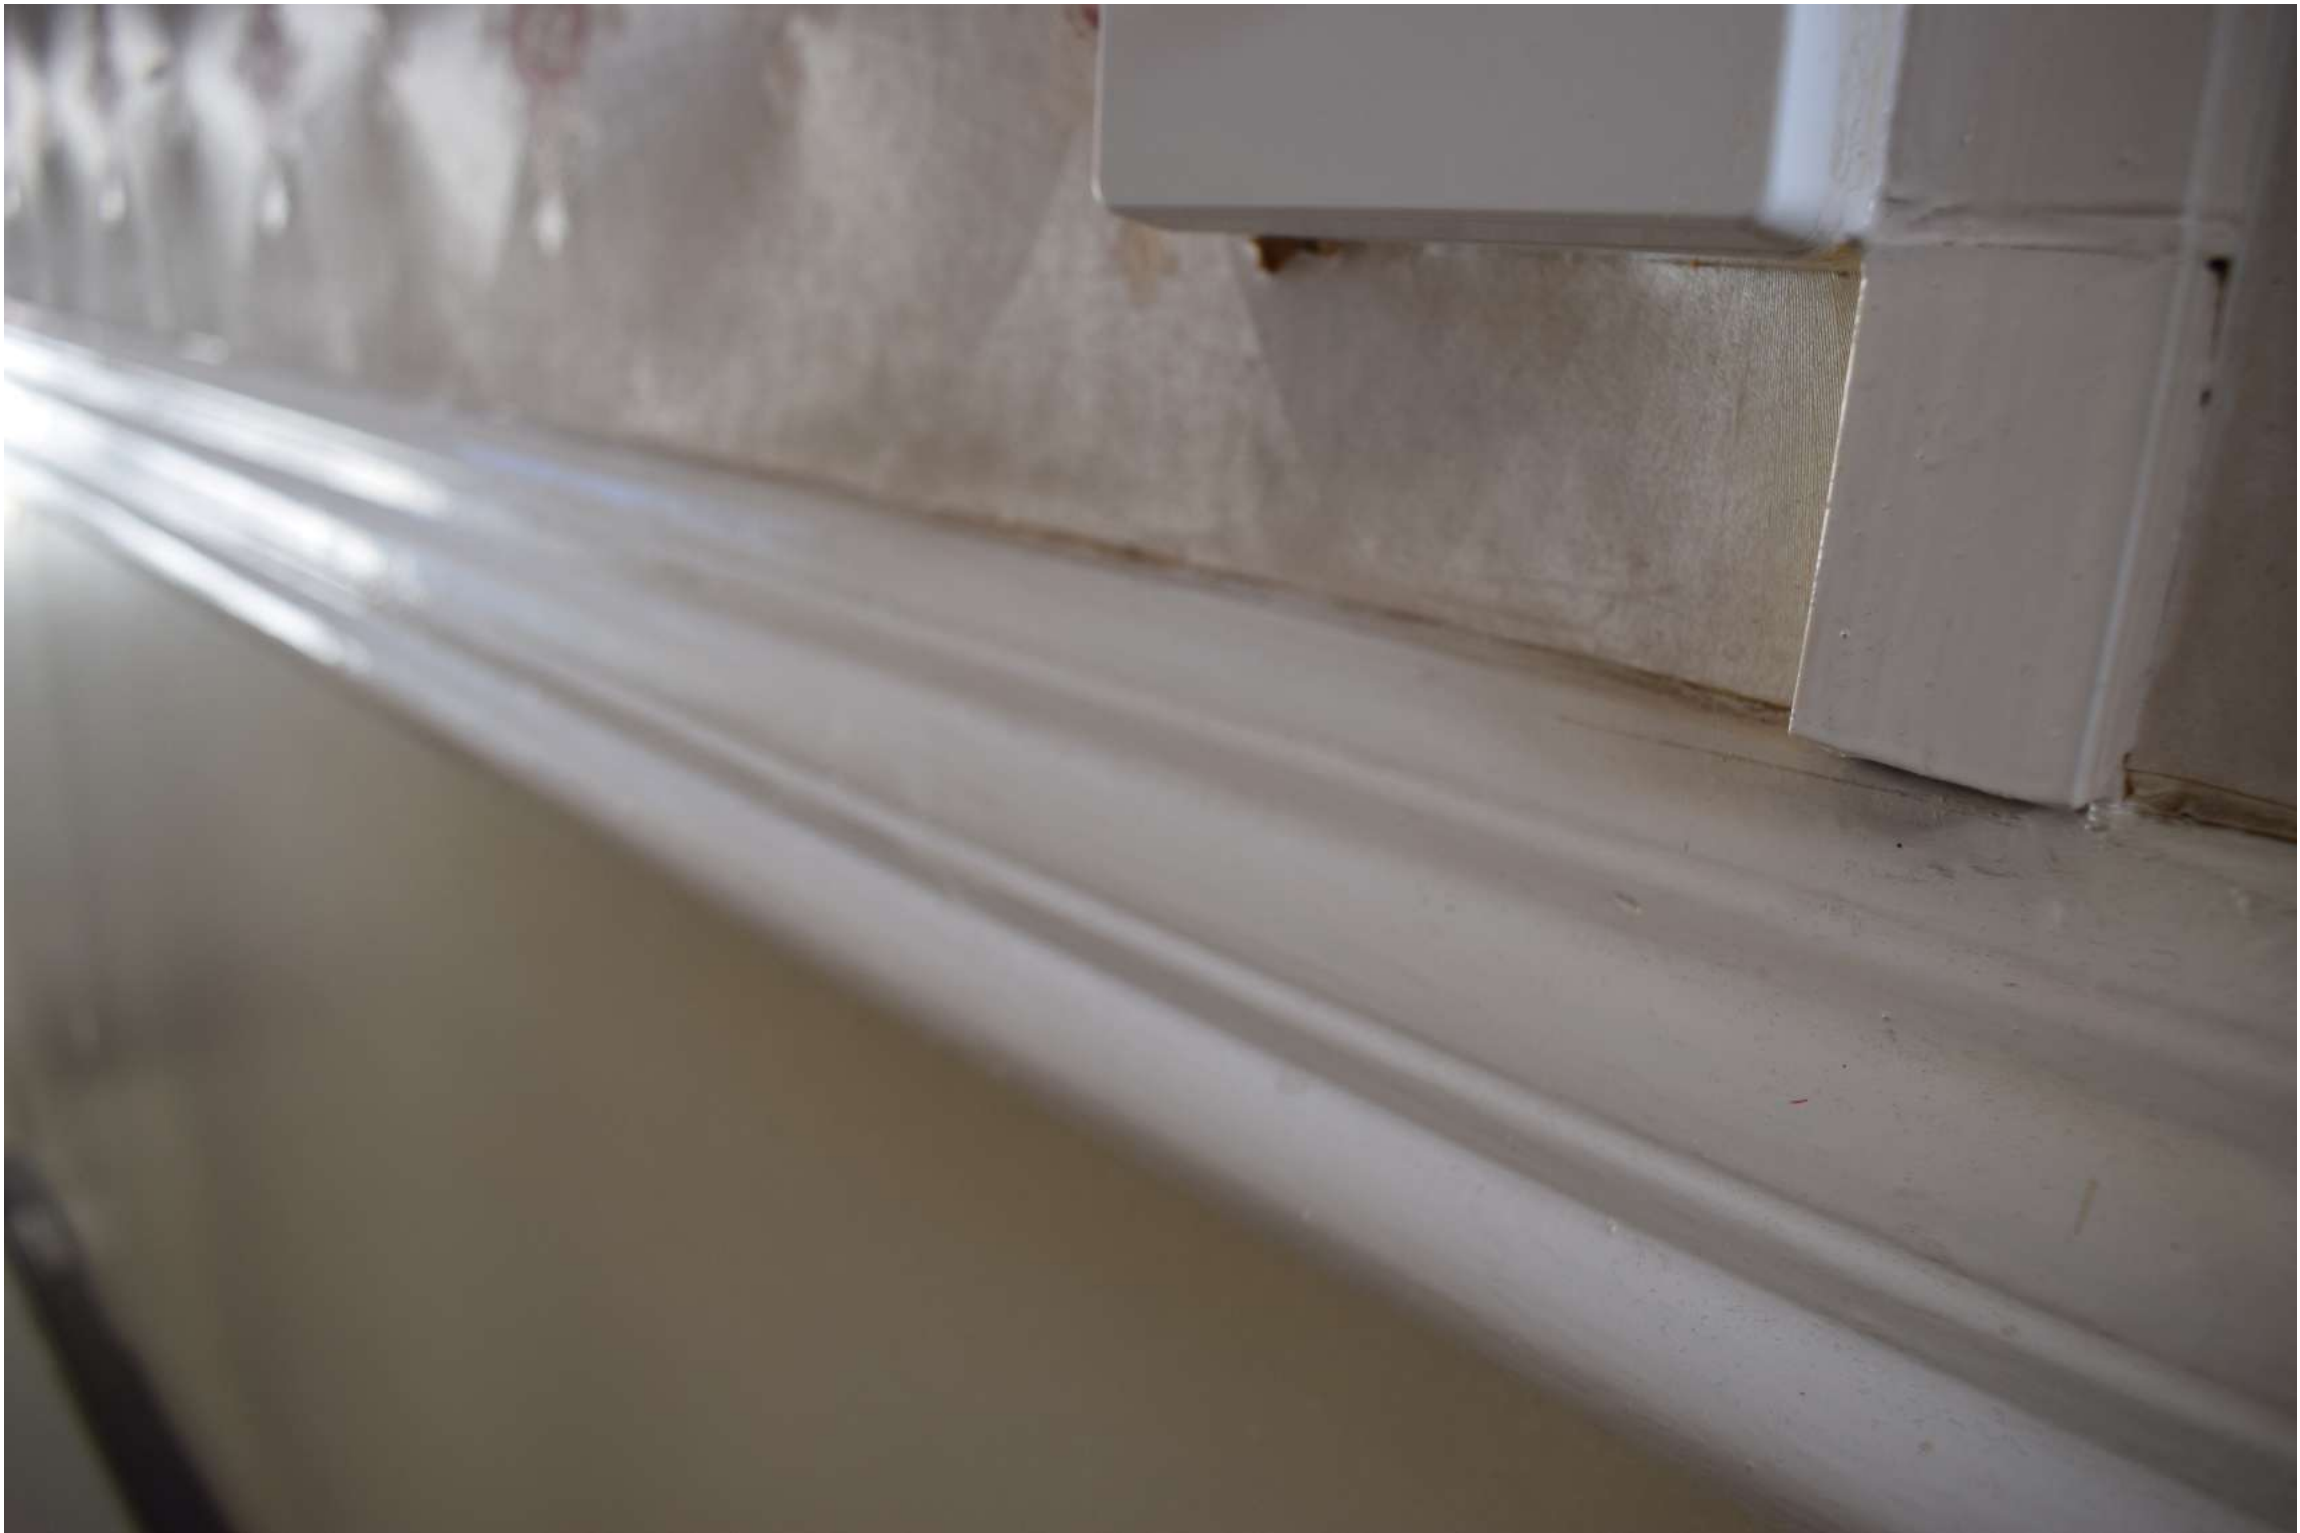
Plate 4

Detailed image of the dado rail, historically installed at 900mm–1000mm (3–3.3 feet) to mitigate scuffing damage to wall finishes, functioning as both a protective and decorative element dividing the dado from the upper wall section.

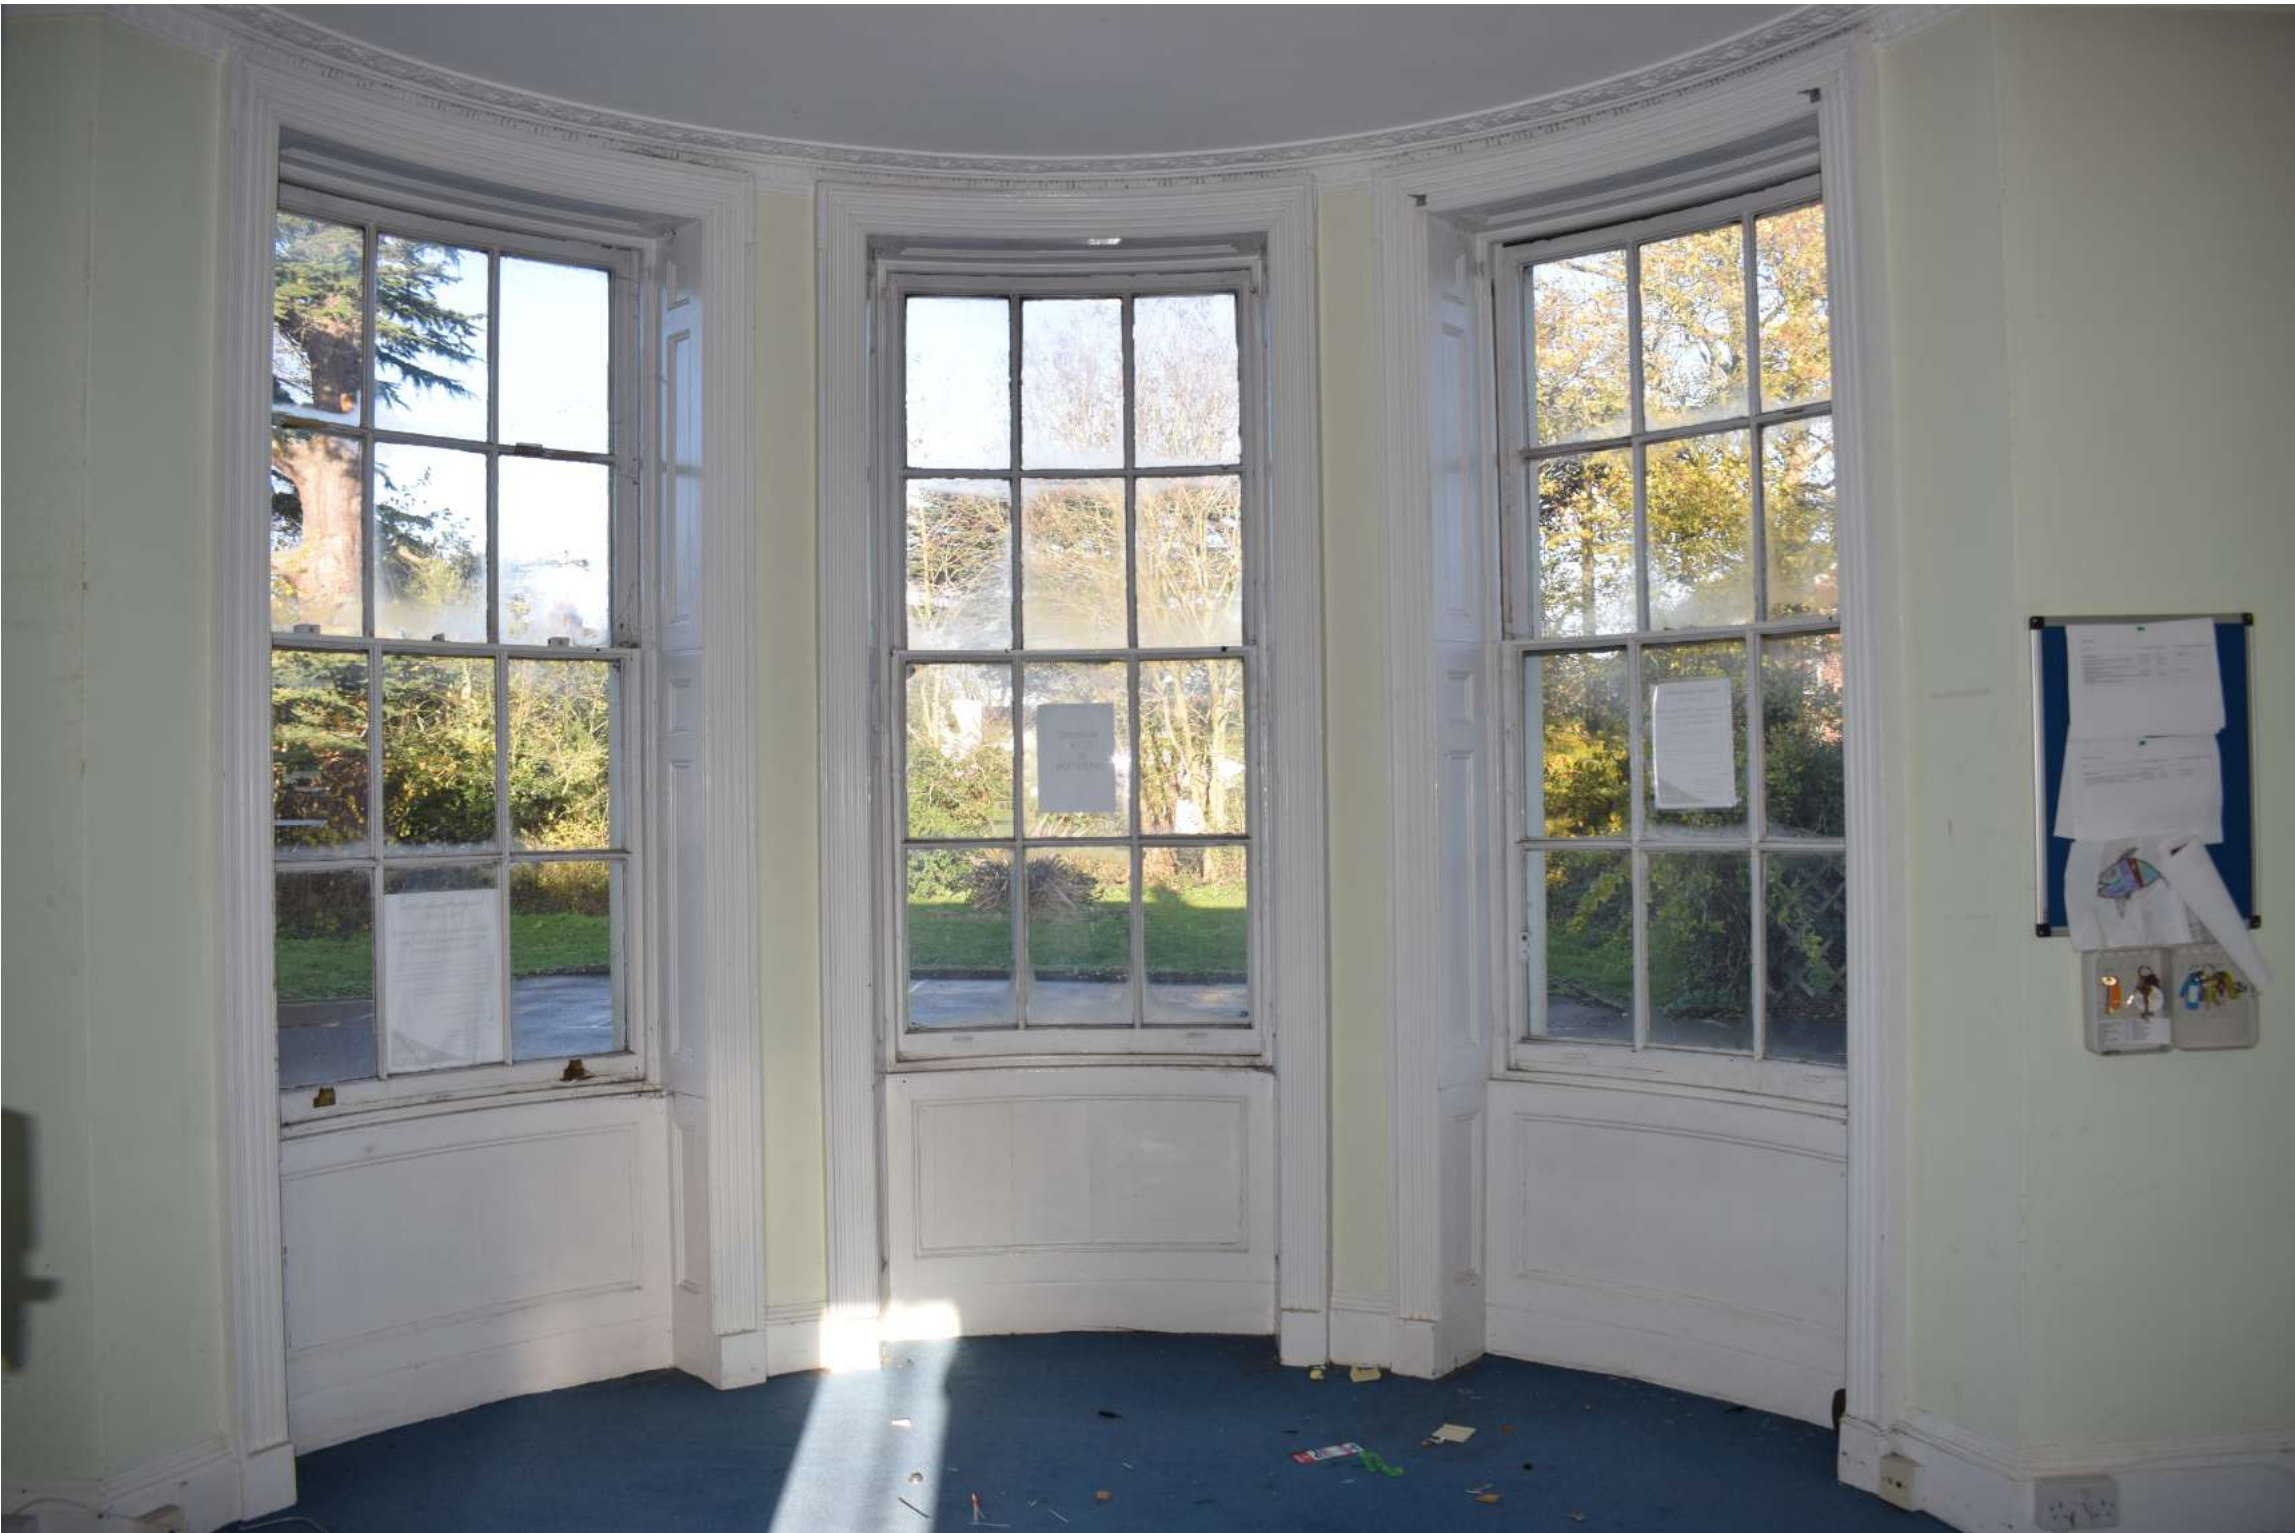
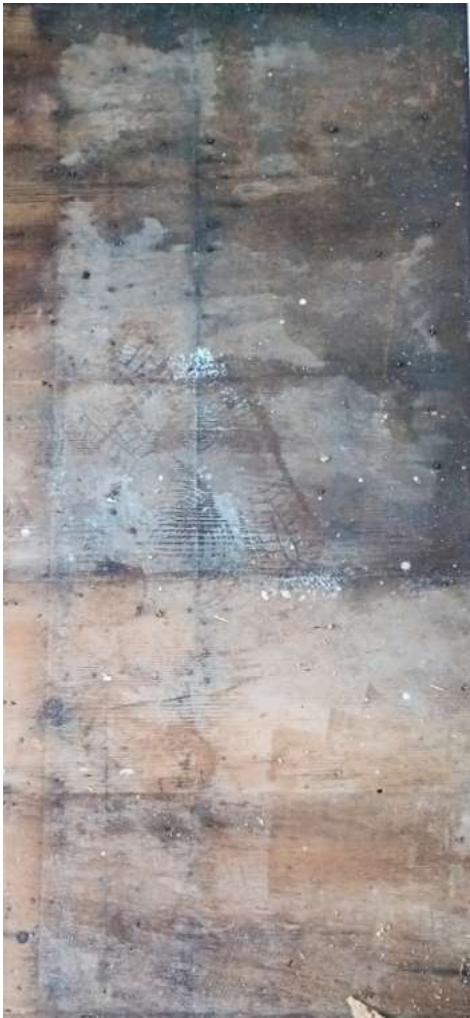
Plate 9  
Specific view of the low-profile skirting, cornice work, and fenestration provided by the characteristic bow windows featuring six-over-six sash units and tri-folding shutters. Inset: a detail of the timber flooring.

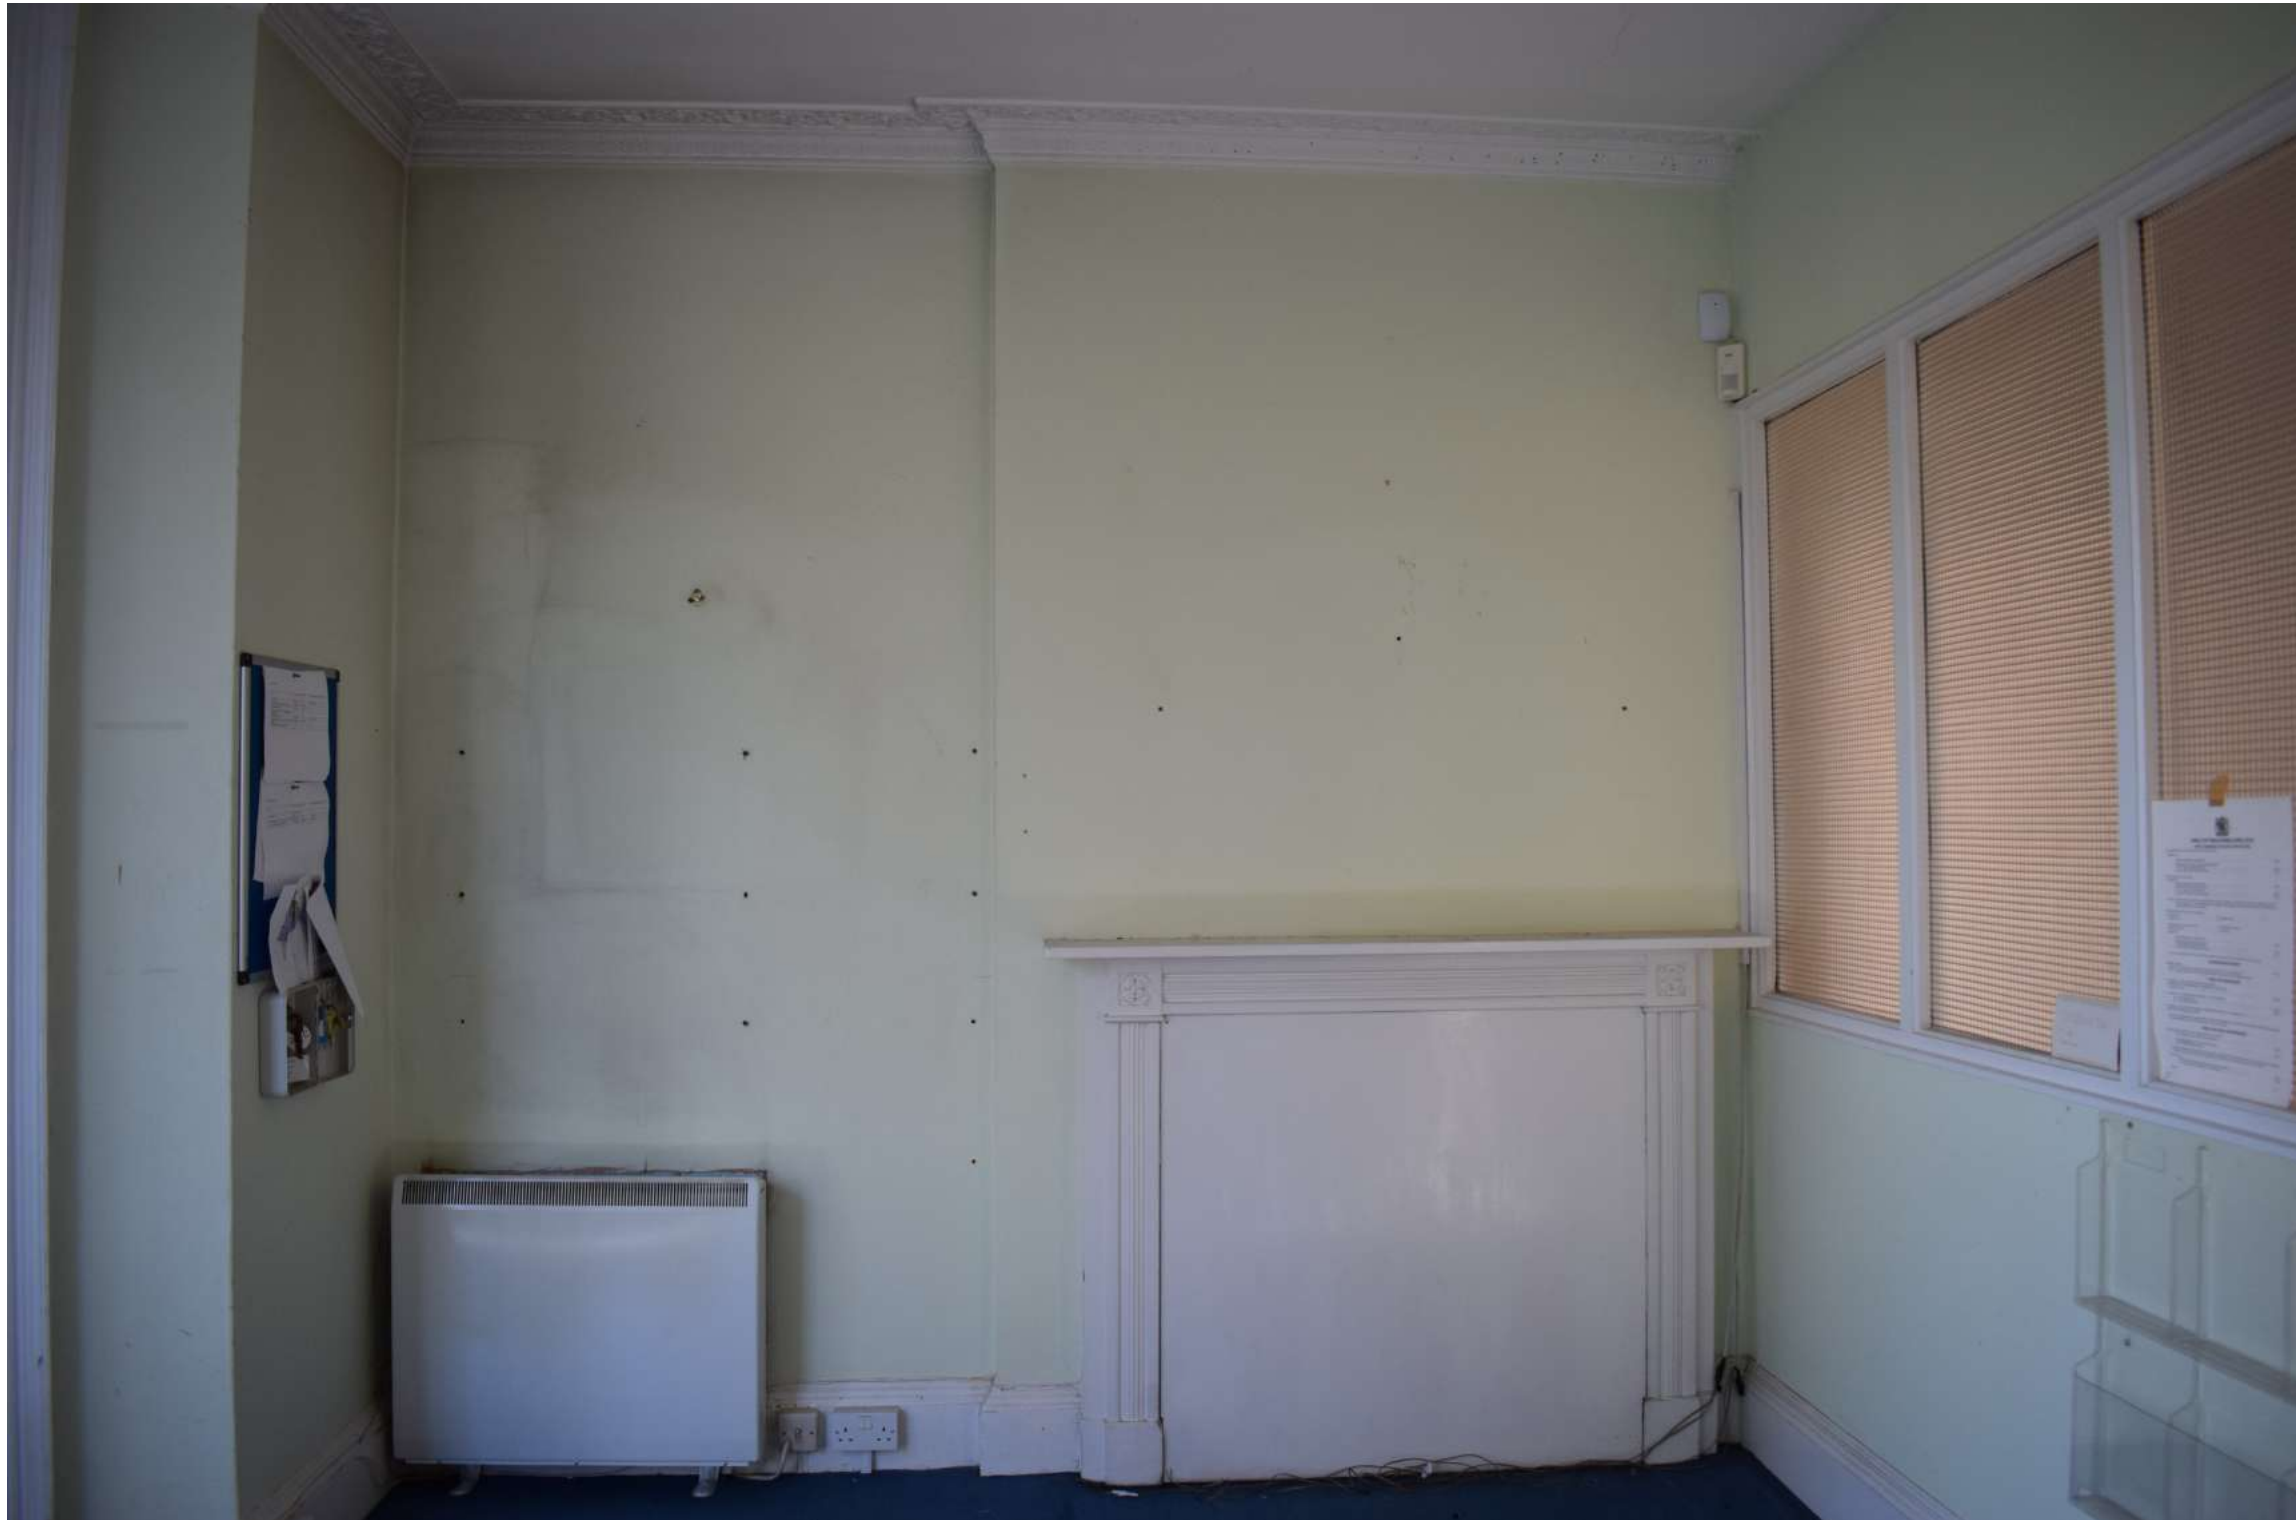
Plate 10

The general room view including the low-profile skirting, cornice work, and the presence of a fire place.

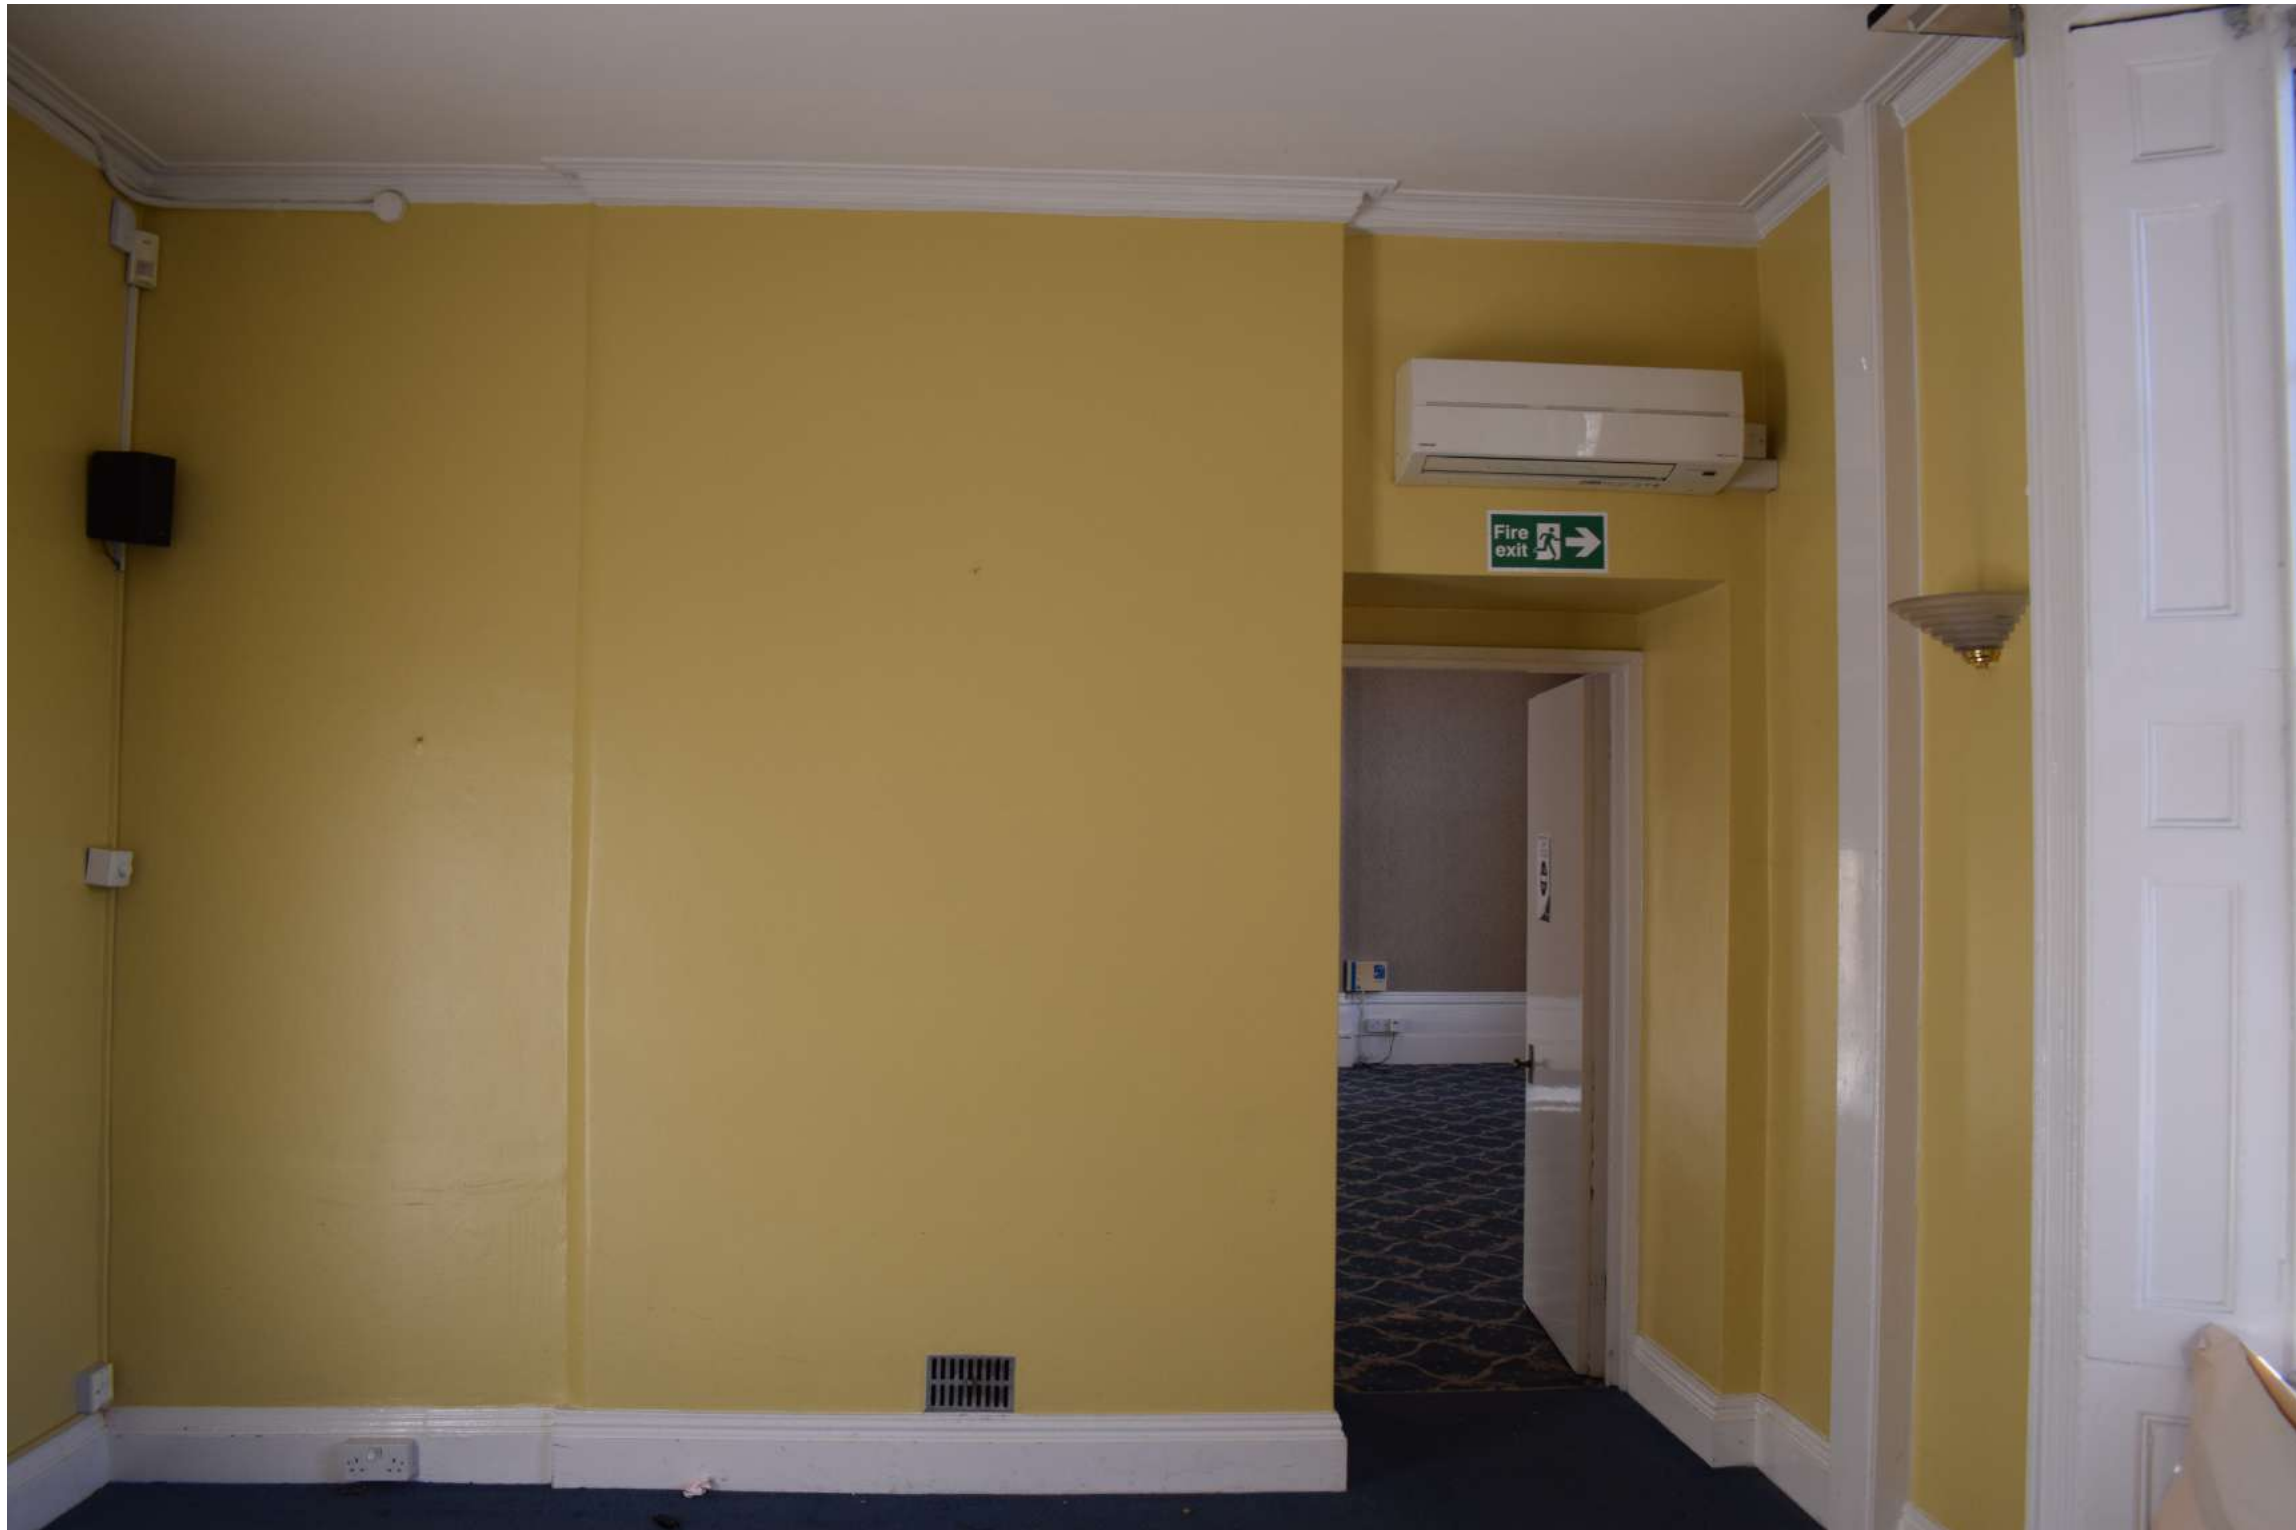
Plate 13

The general room view showing the low-profile skirting, cornice work, and the presence of a fire place.
