Archway Heritage

# Appendix 11

## Yeomanry House

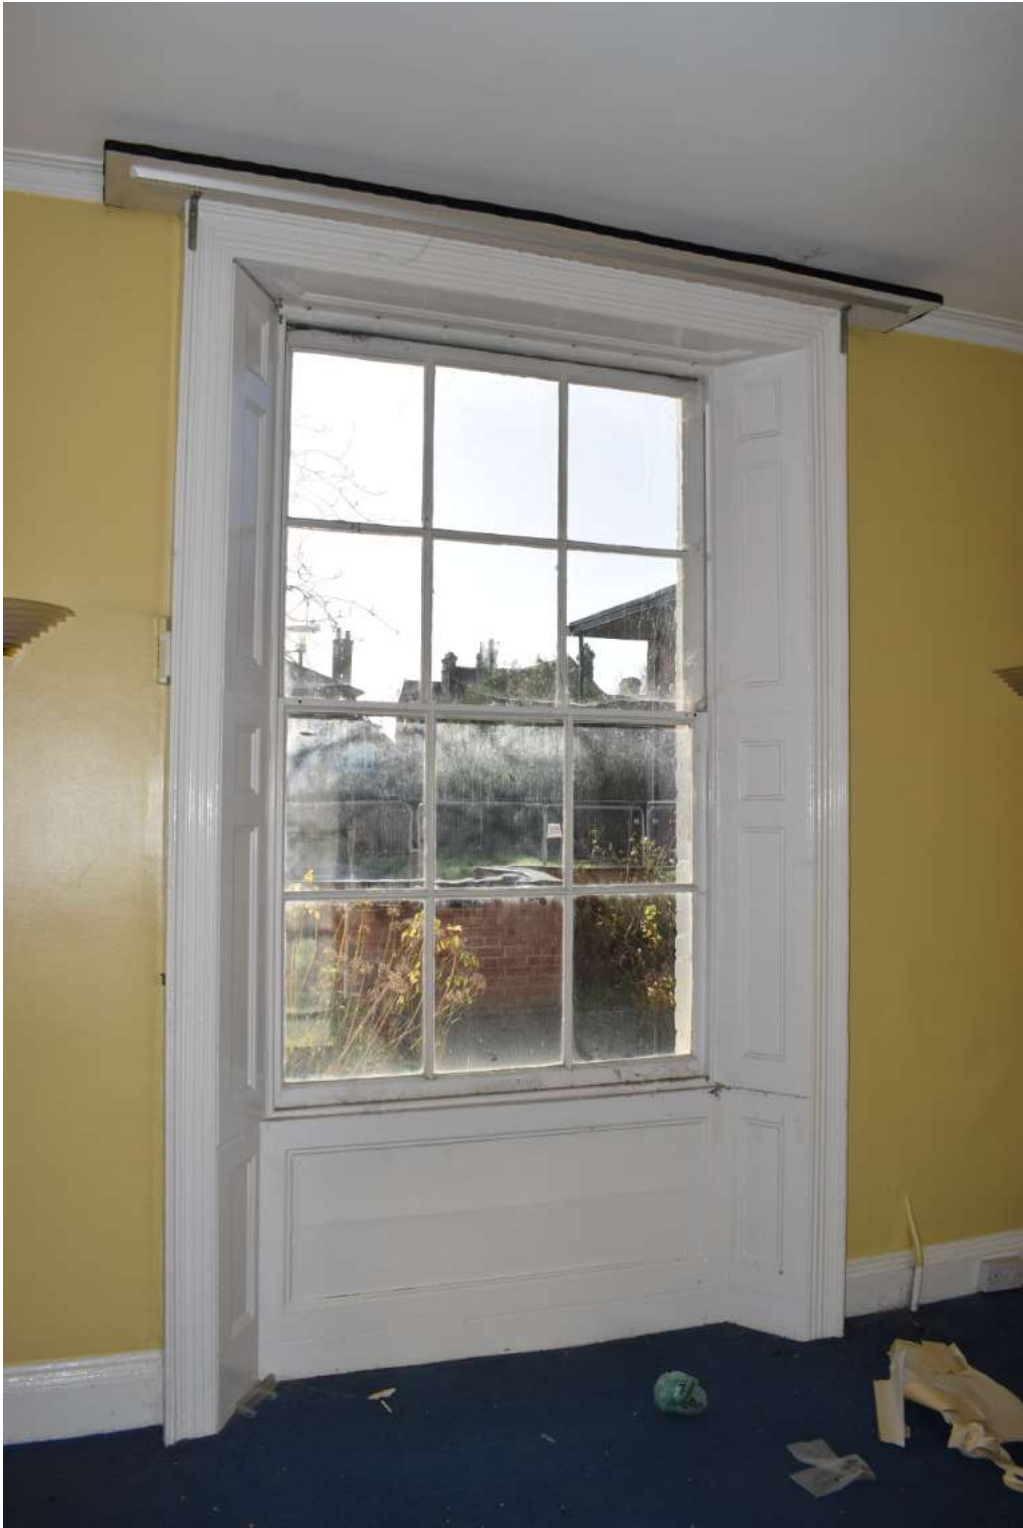
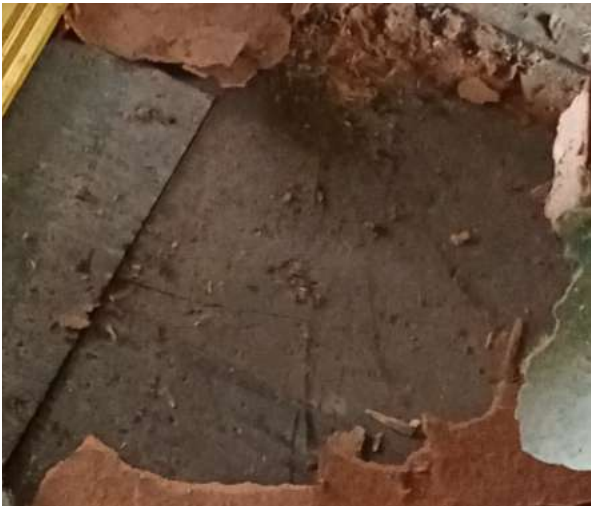
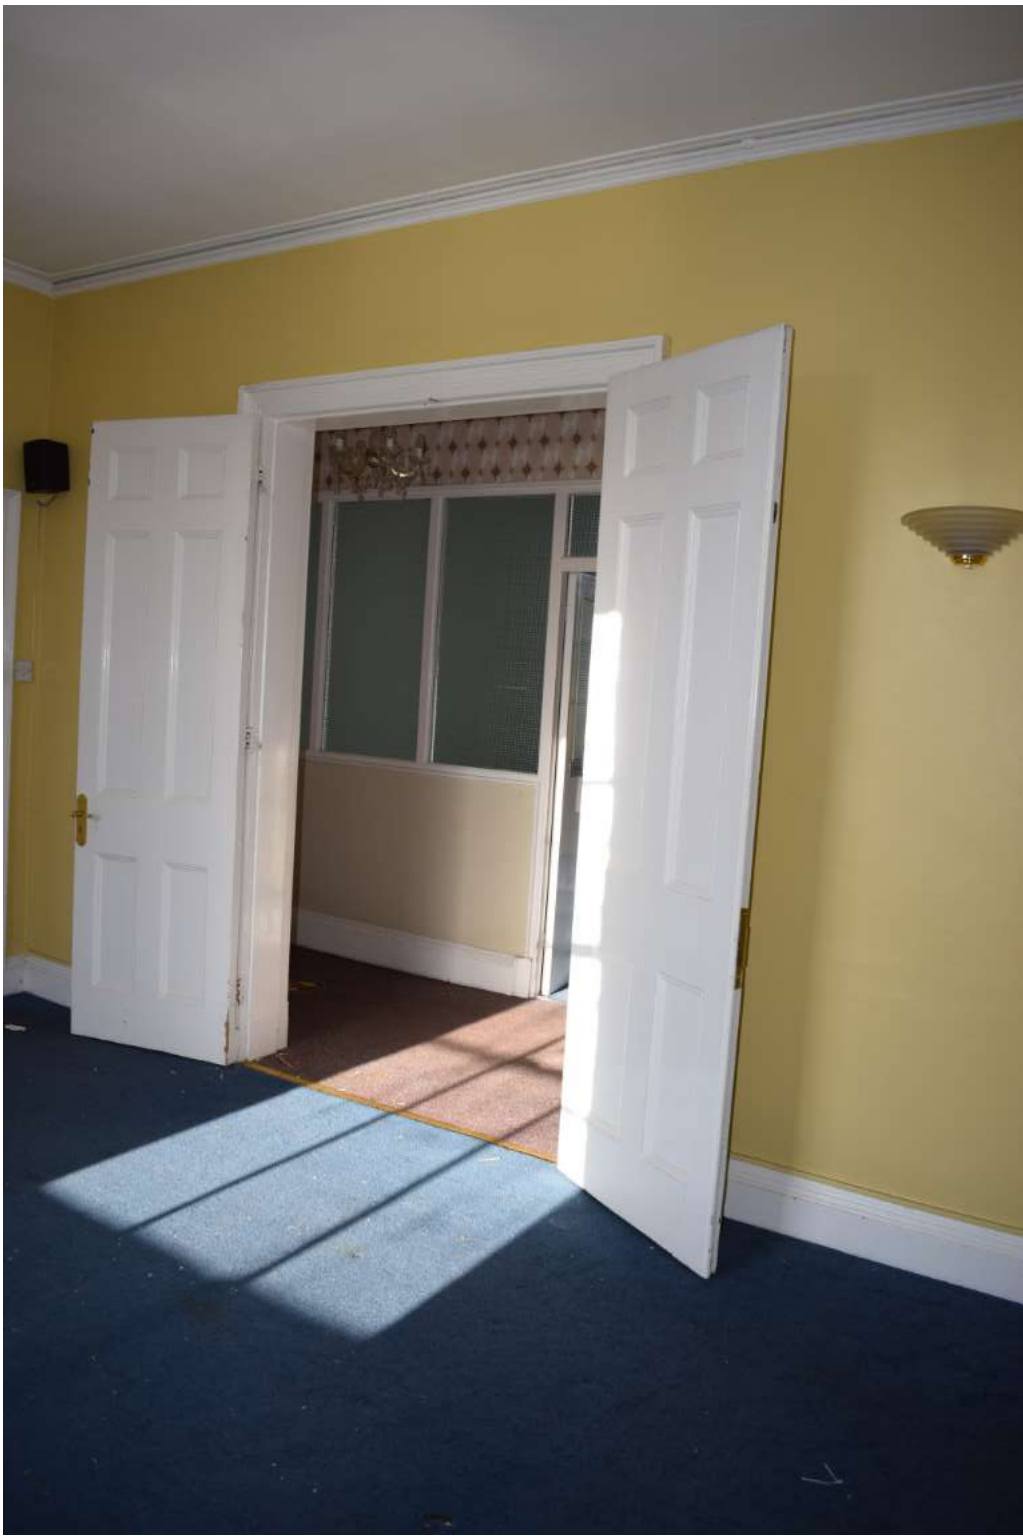
Plate 16

Architectural detail: Specific view of the comparatively low skirting, an absence of wall rails, and a relatively plain, non-decorative cornice profile. The room provides access to the drawing room. Inset: a detail of the timber flooring.

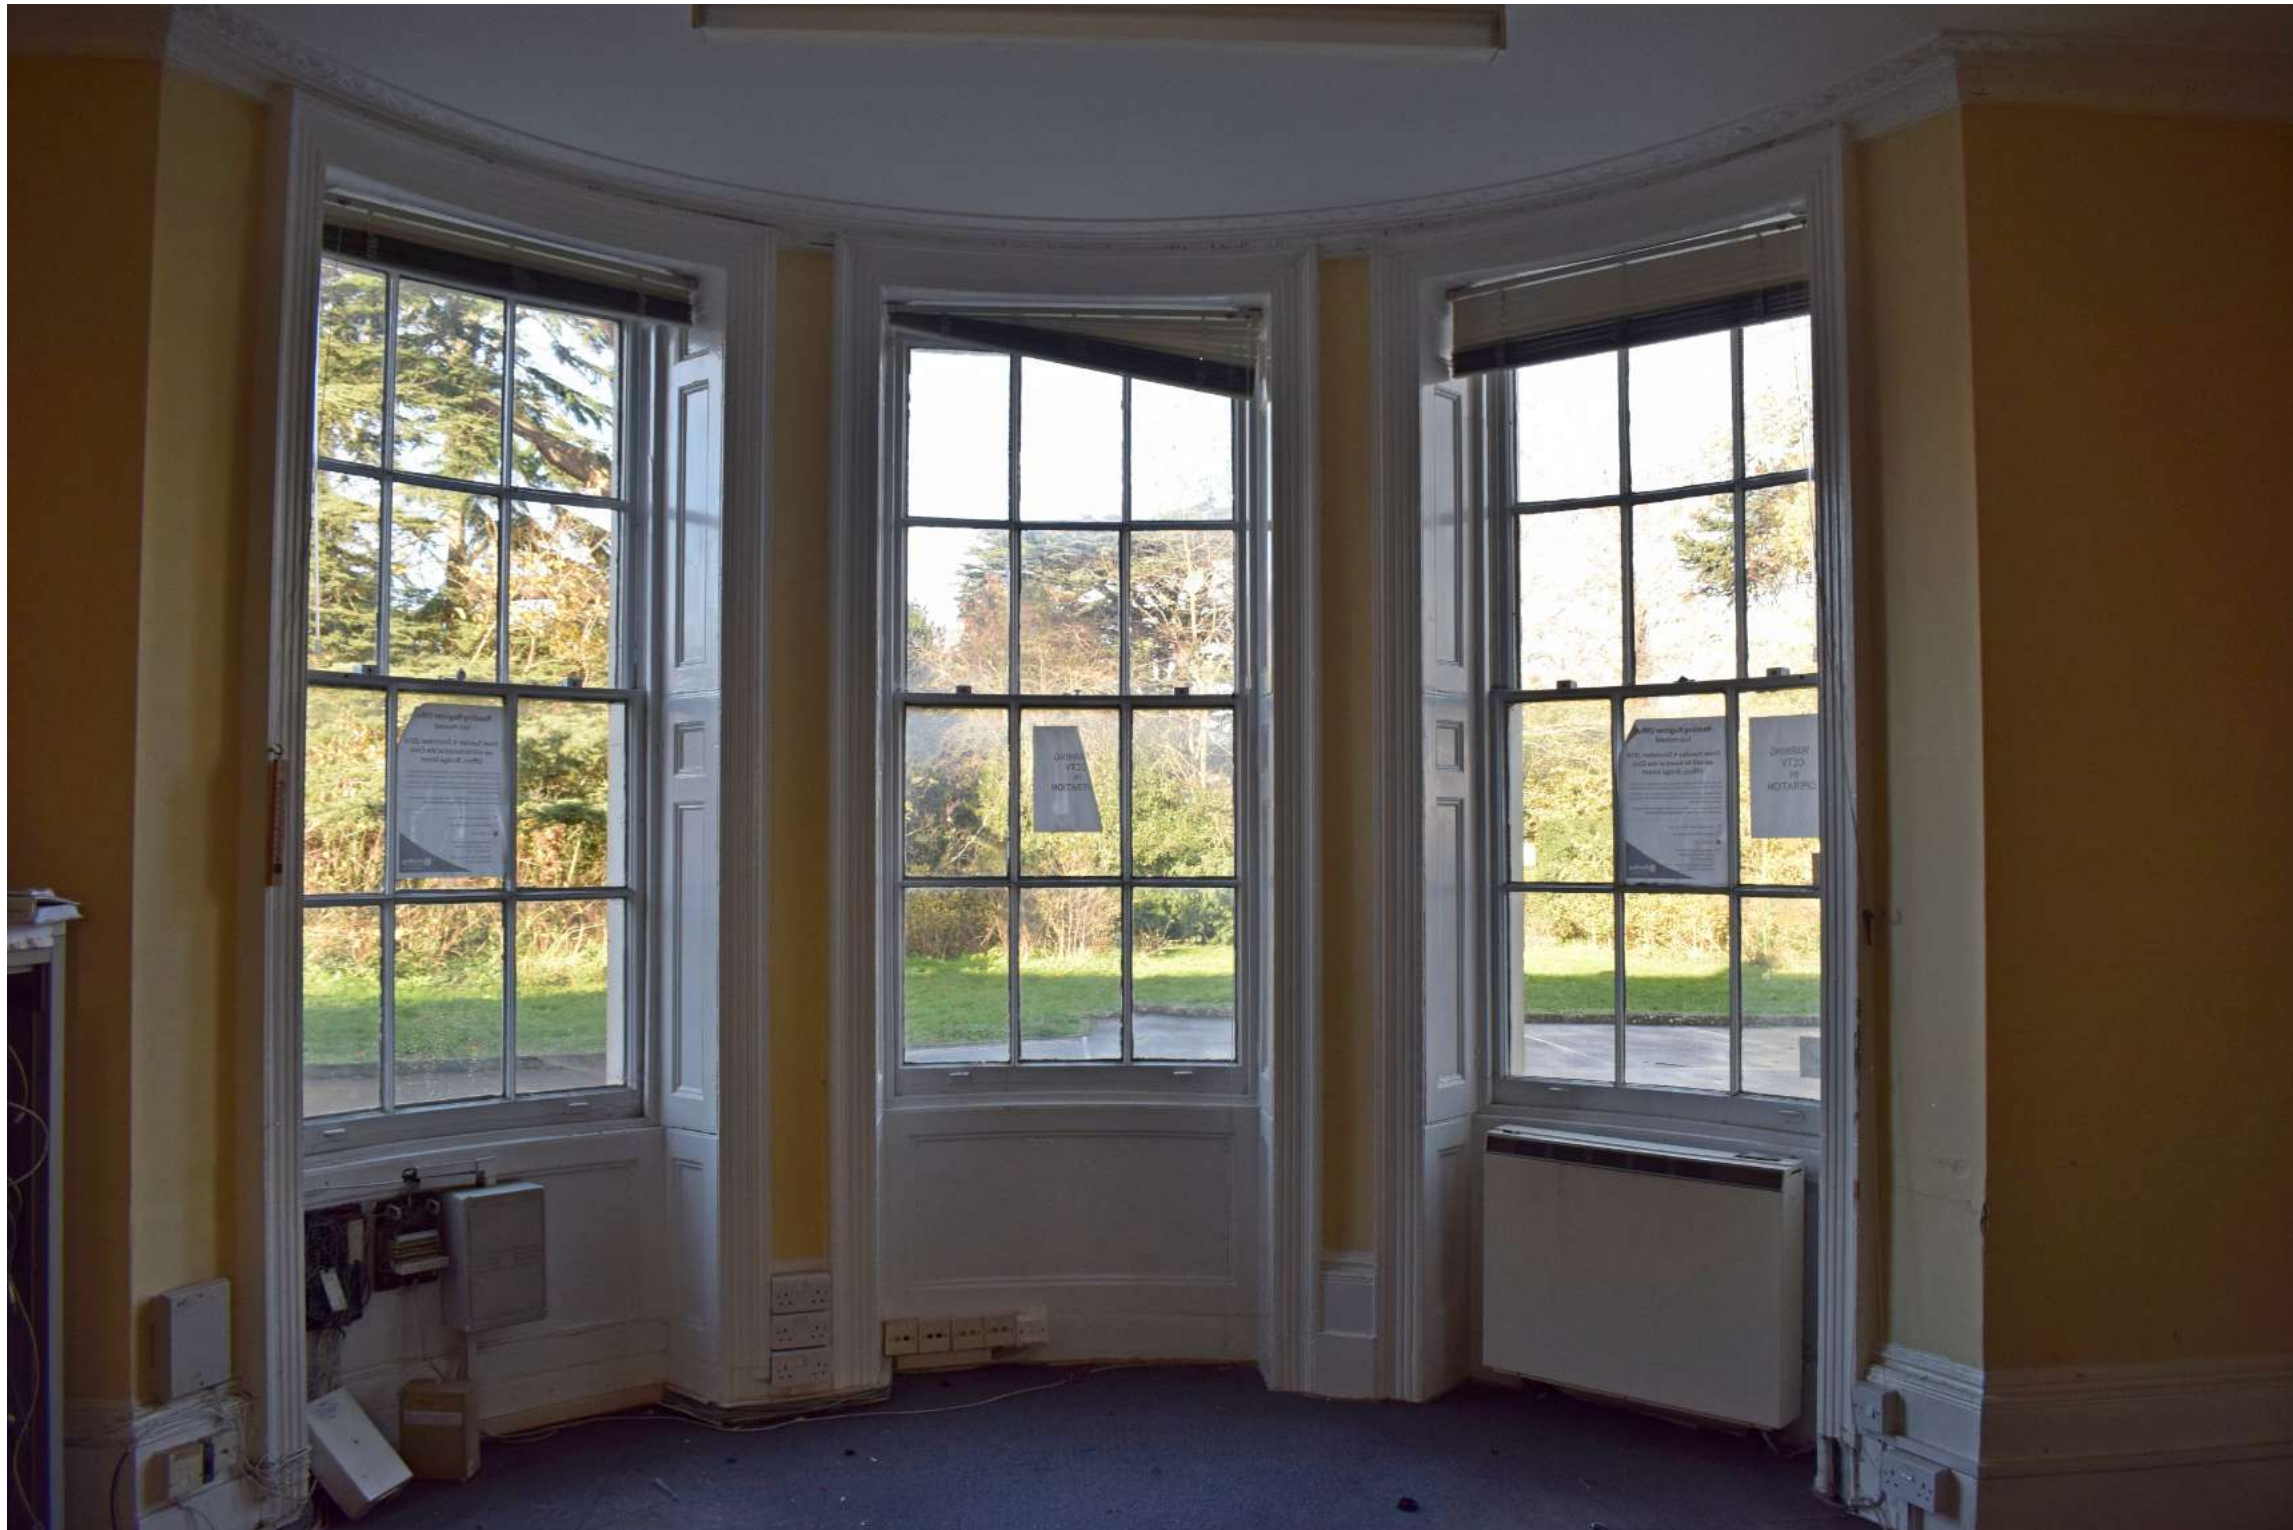
Plate 17

Architectural detail: Specific view of the three bow windows each have six over six sashes with tri-folding shutters.

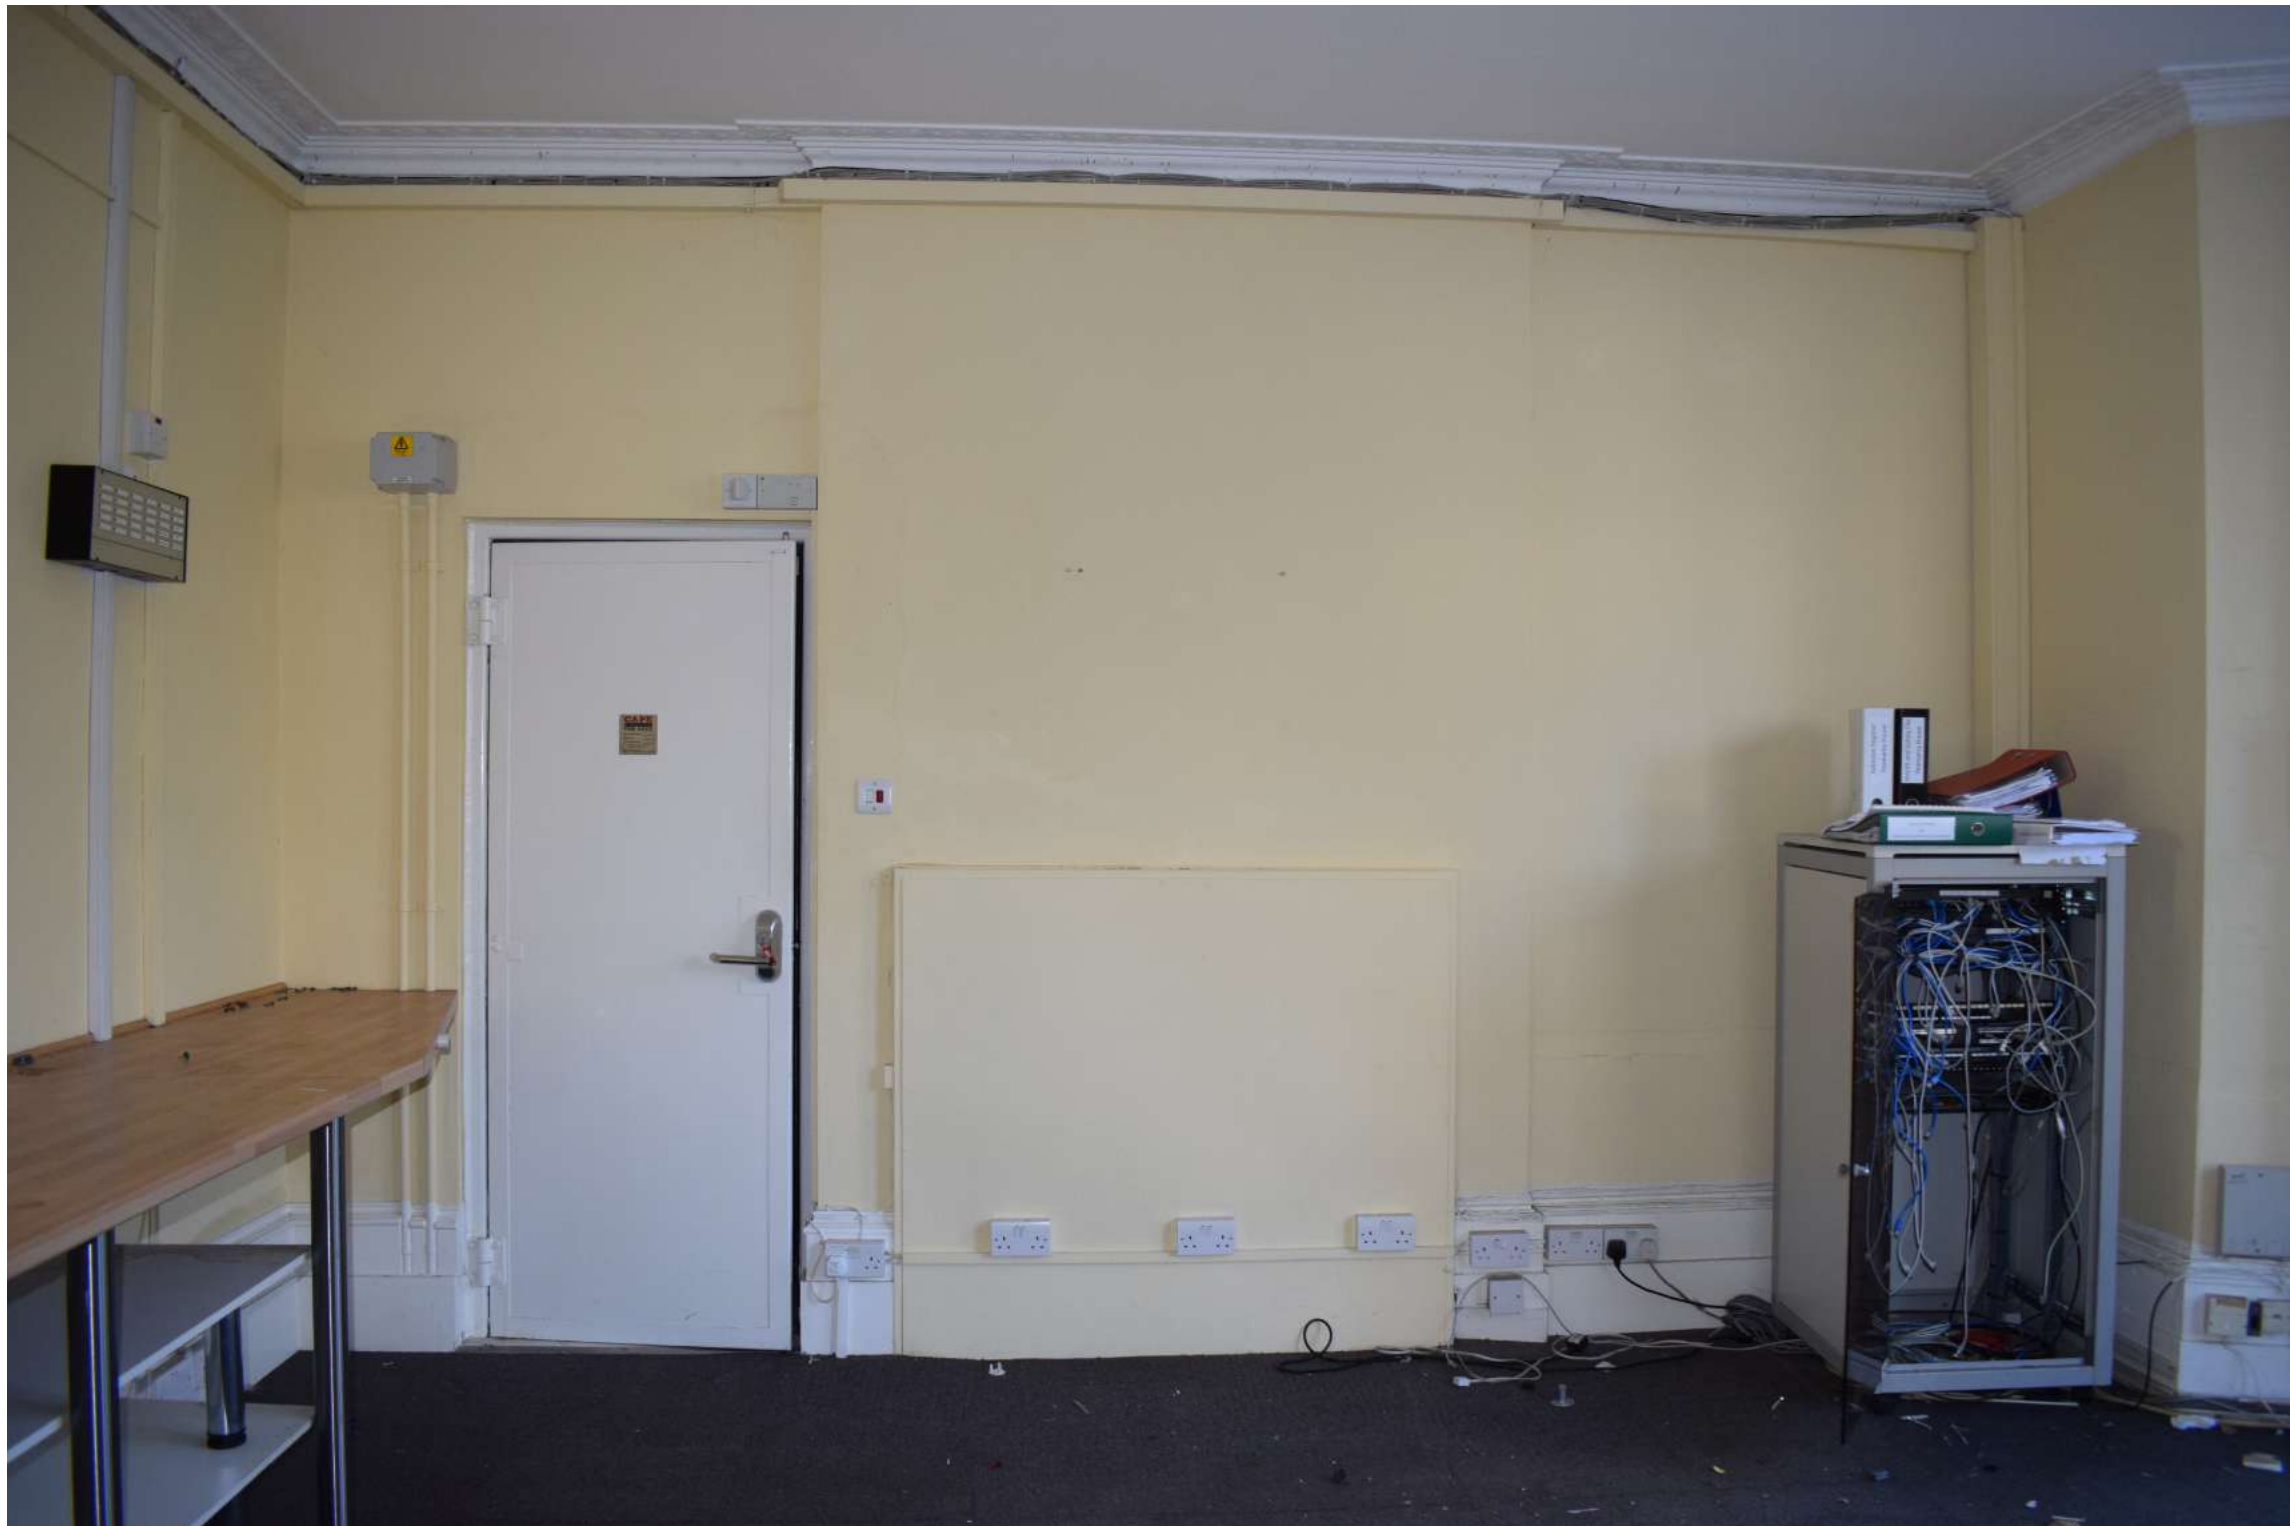
Plate 18

This room has highly decorative cornicing, a fireplace and extremely high skirting but lacks a dado rail.

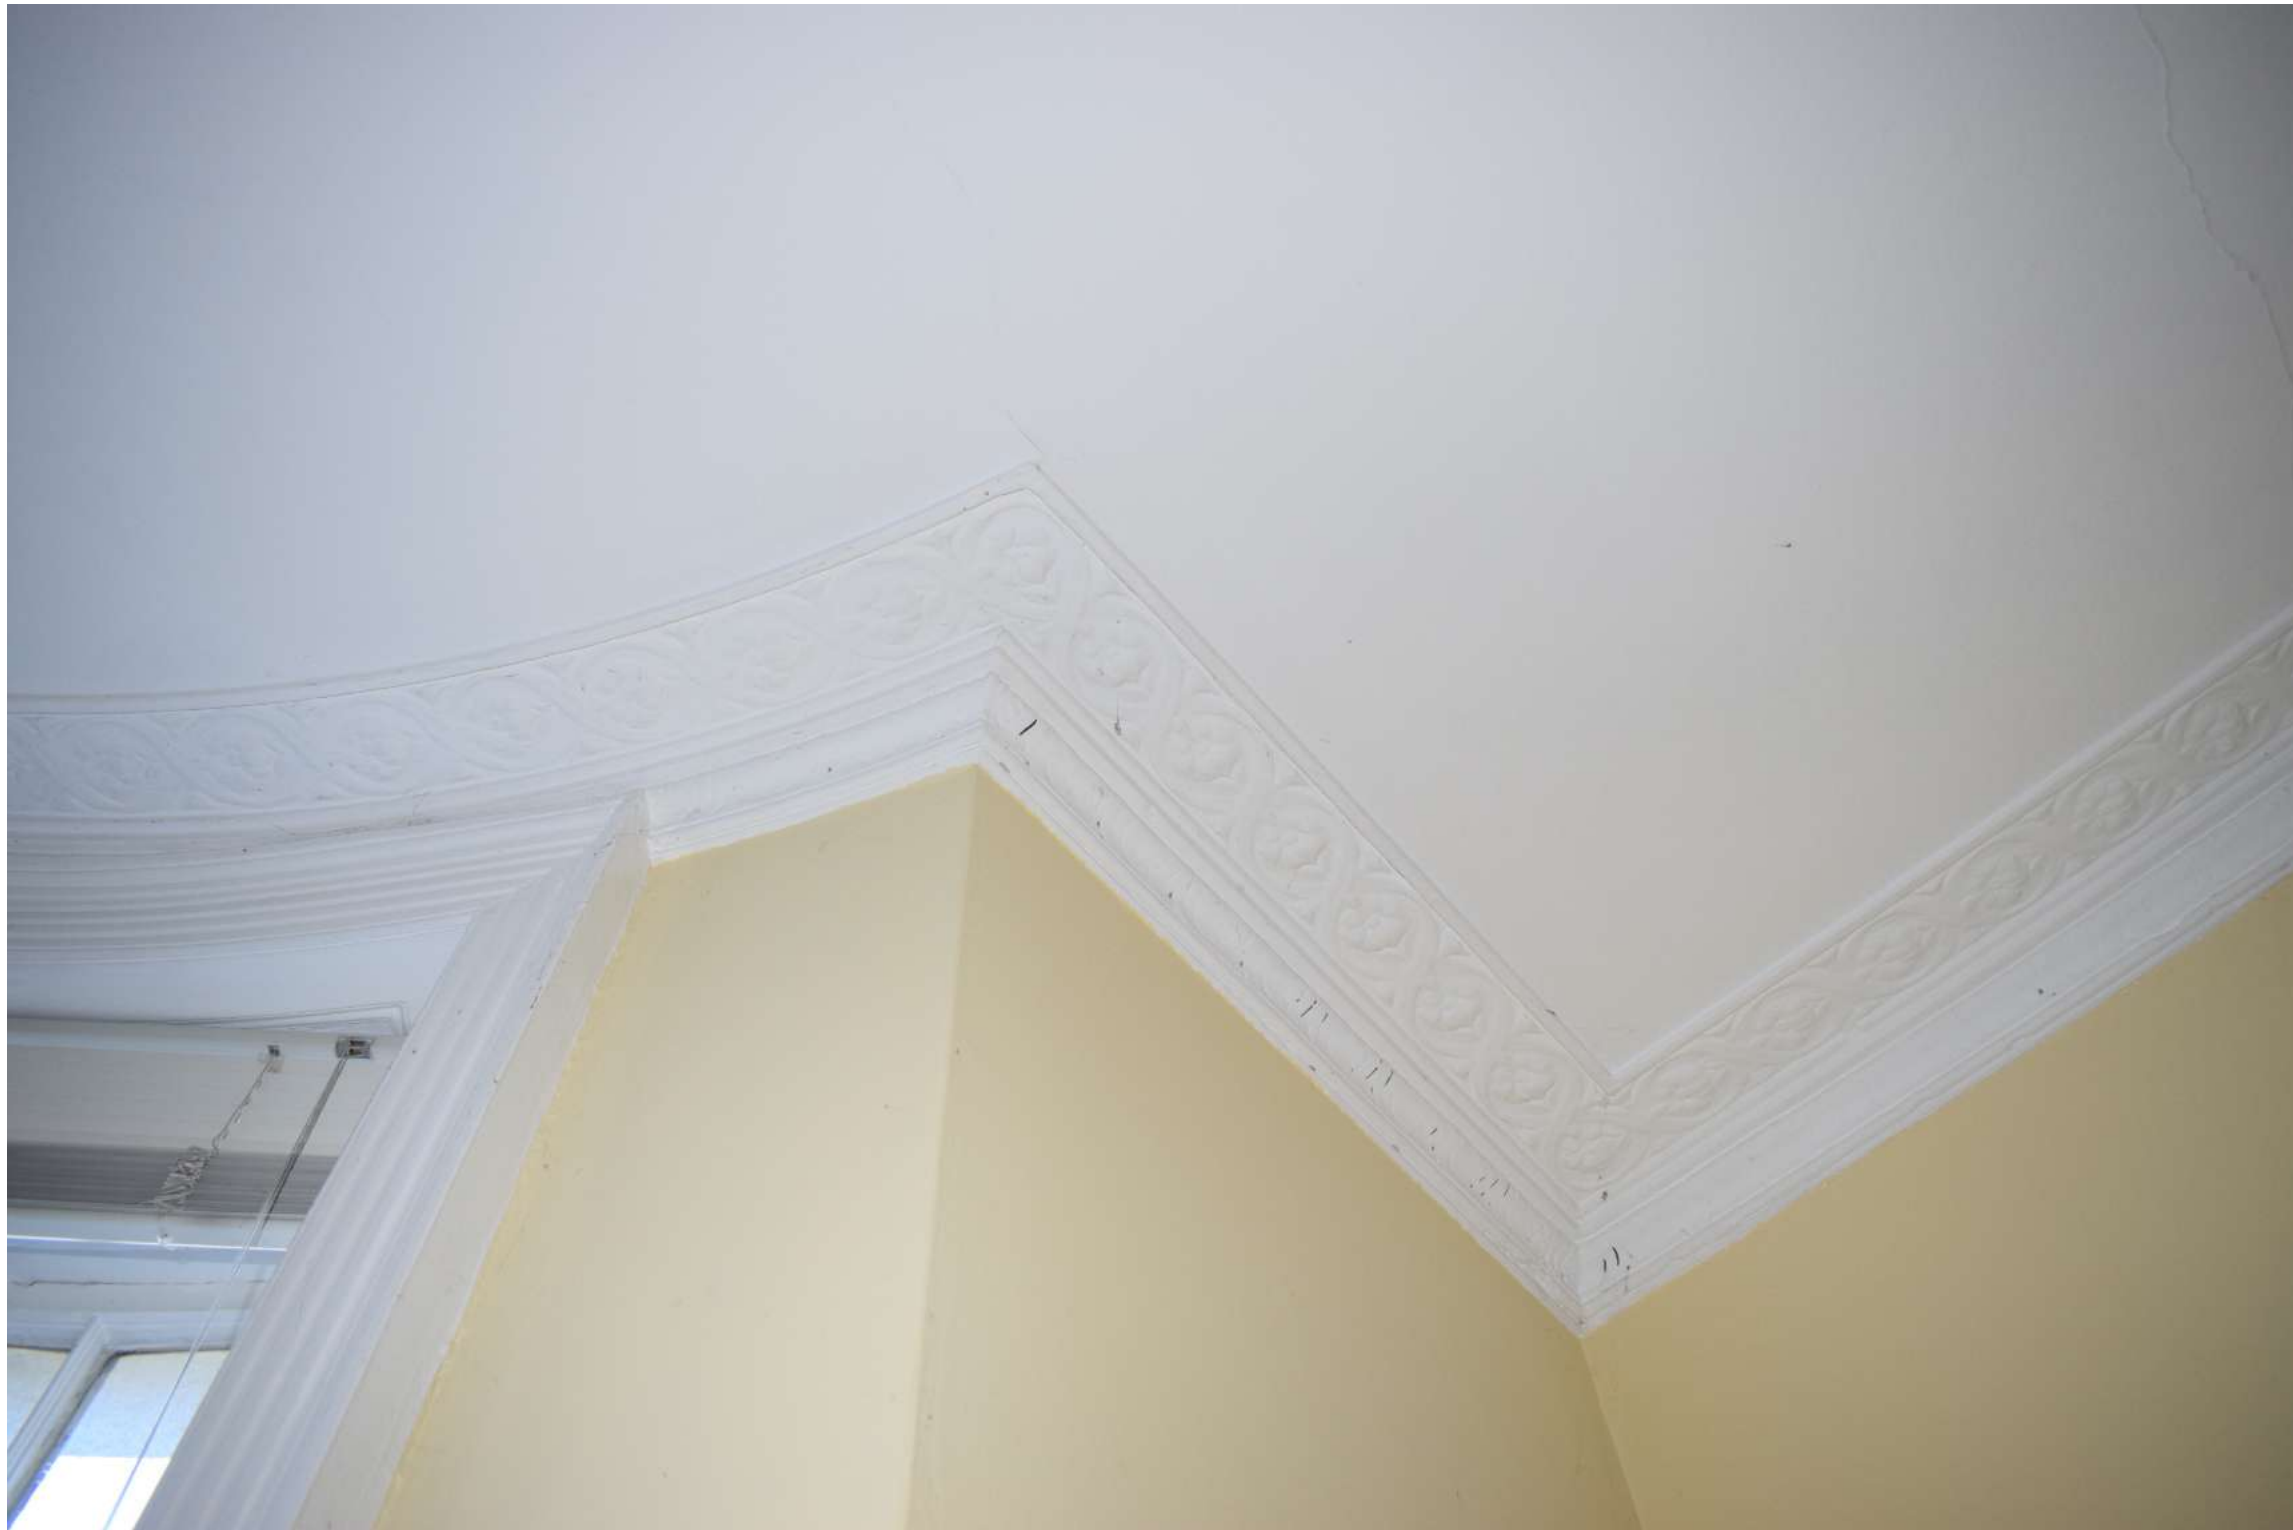
Plate 19

Architectural detail: Specific view of the highly decorative cornicing, traditionally made from plaster of intricate flower patterns, and Egg-and-Dart decorative detailing. This motif is one of the most classic and enduring patterns in Western architecture and is very common in highly decorative Georgian, Victorian, and Edwardian cornices across the UK.

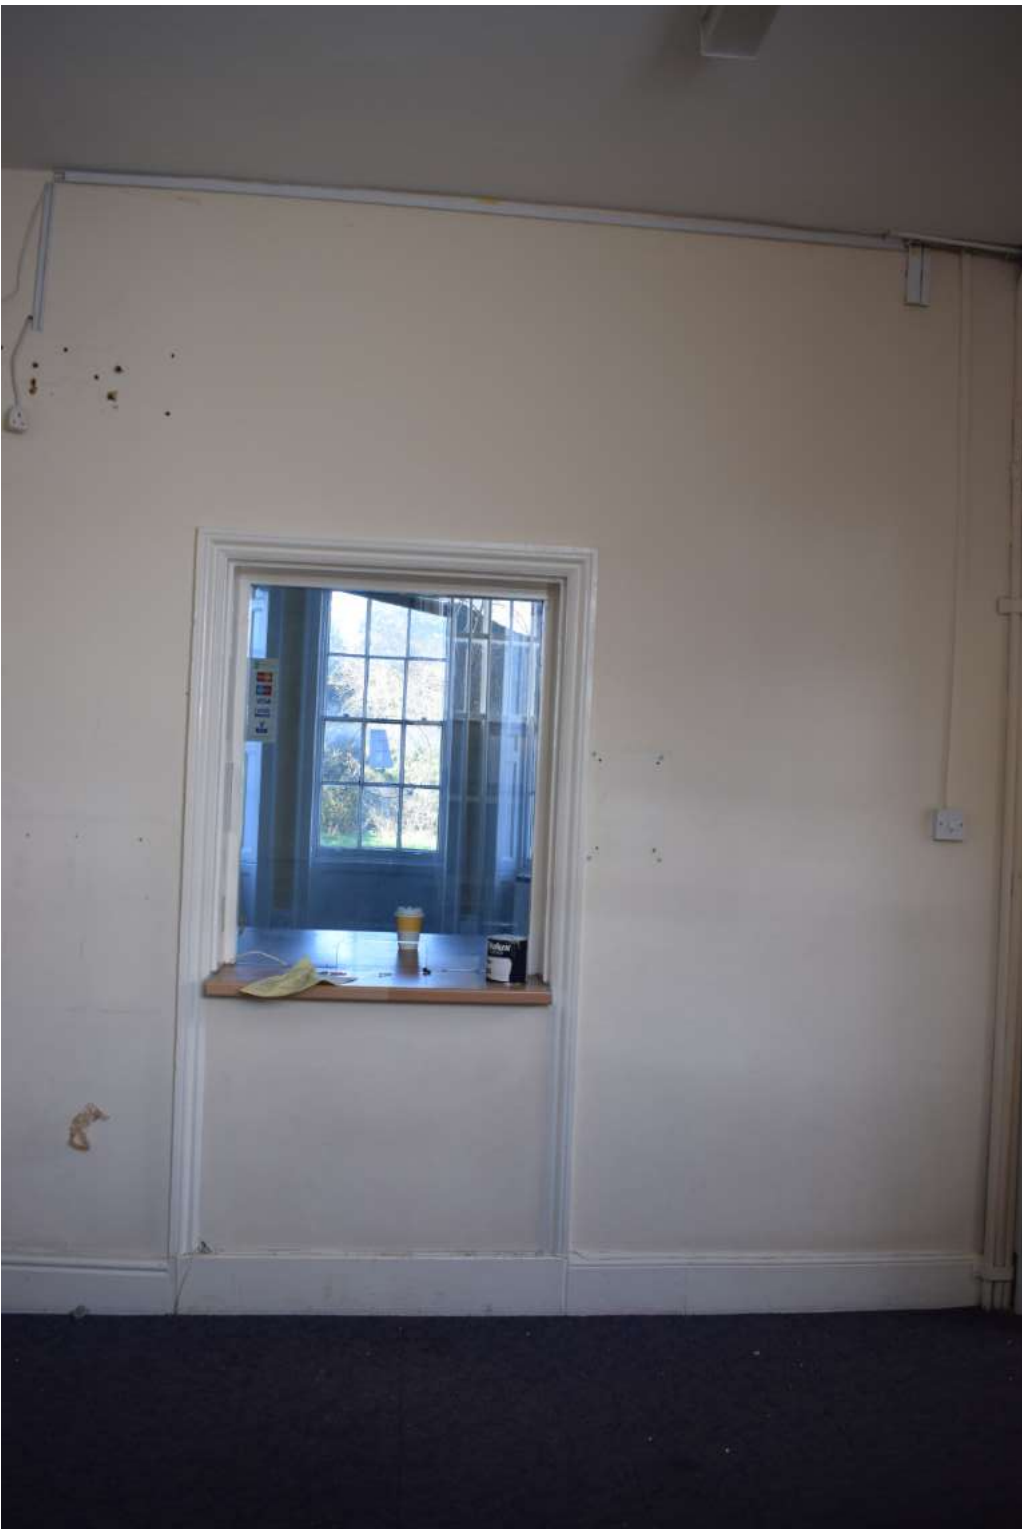
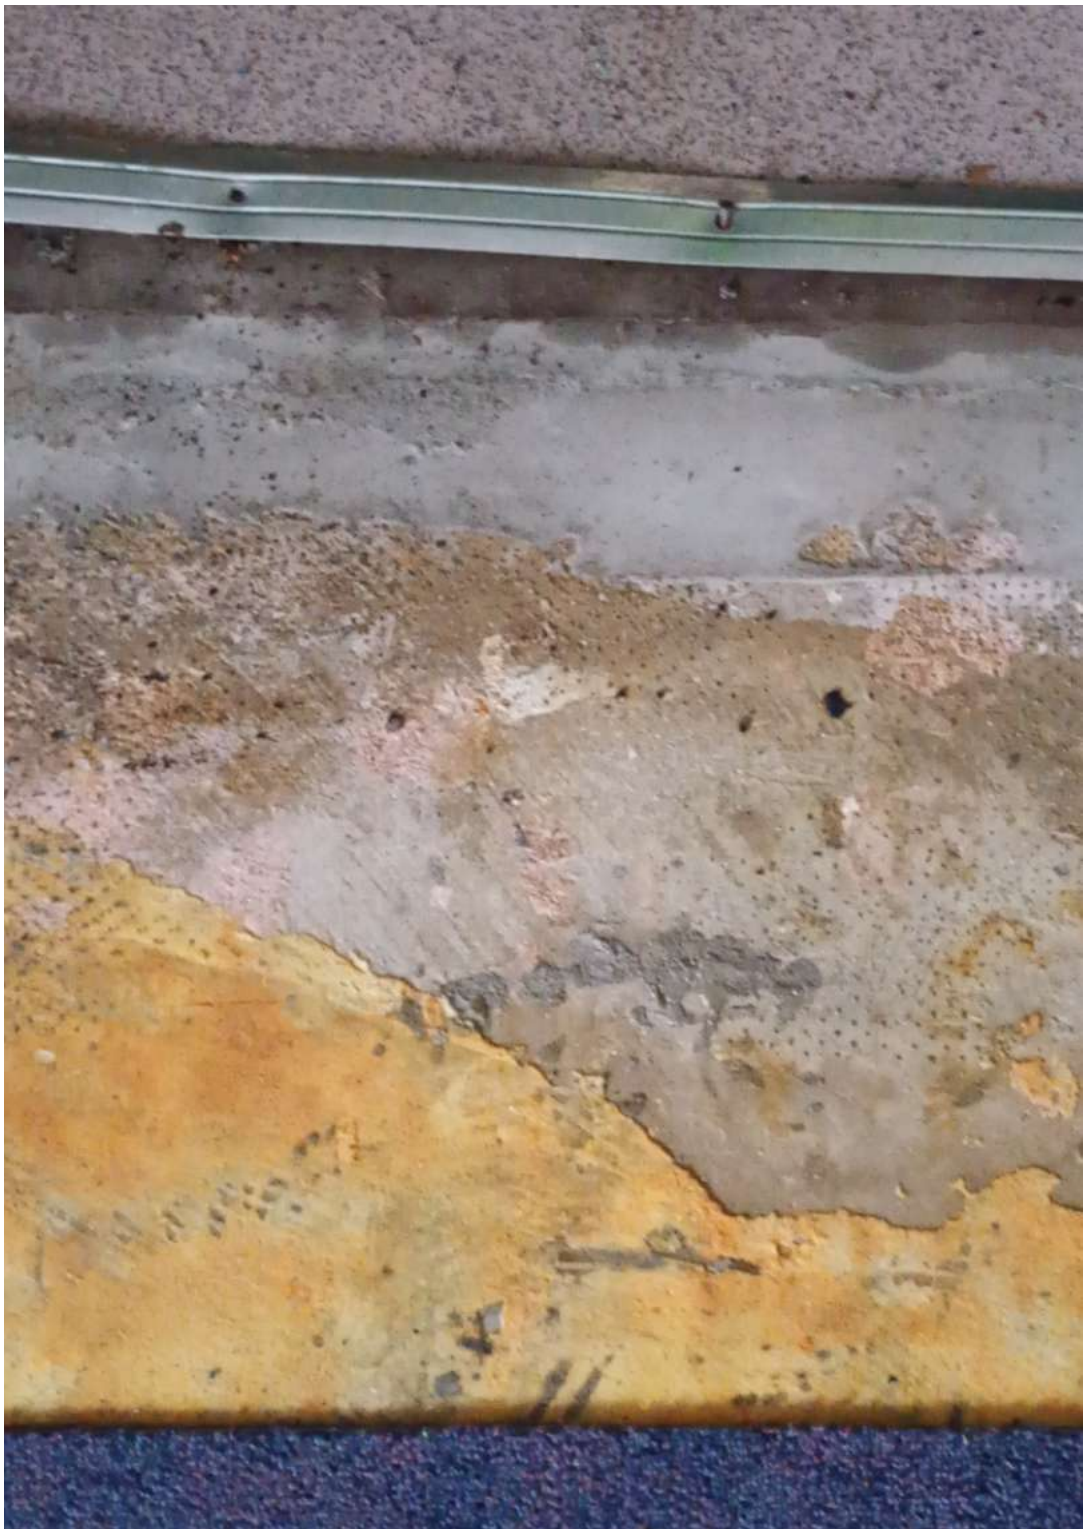
Plate 22

The modern partition in the reception area of the Births, Deaths and Marriages Services room has a glazed window. Inset: a detail of the solid flooring.

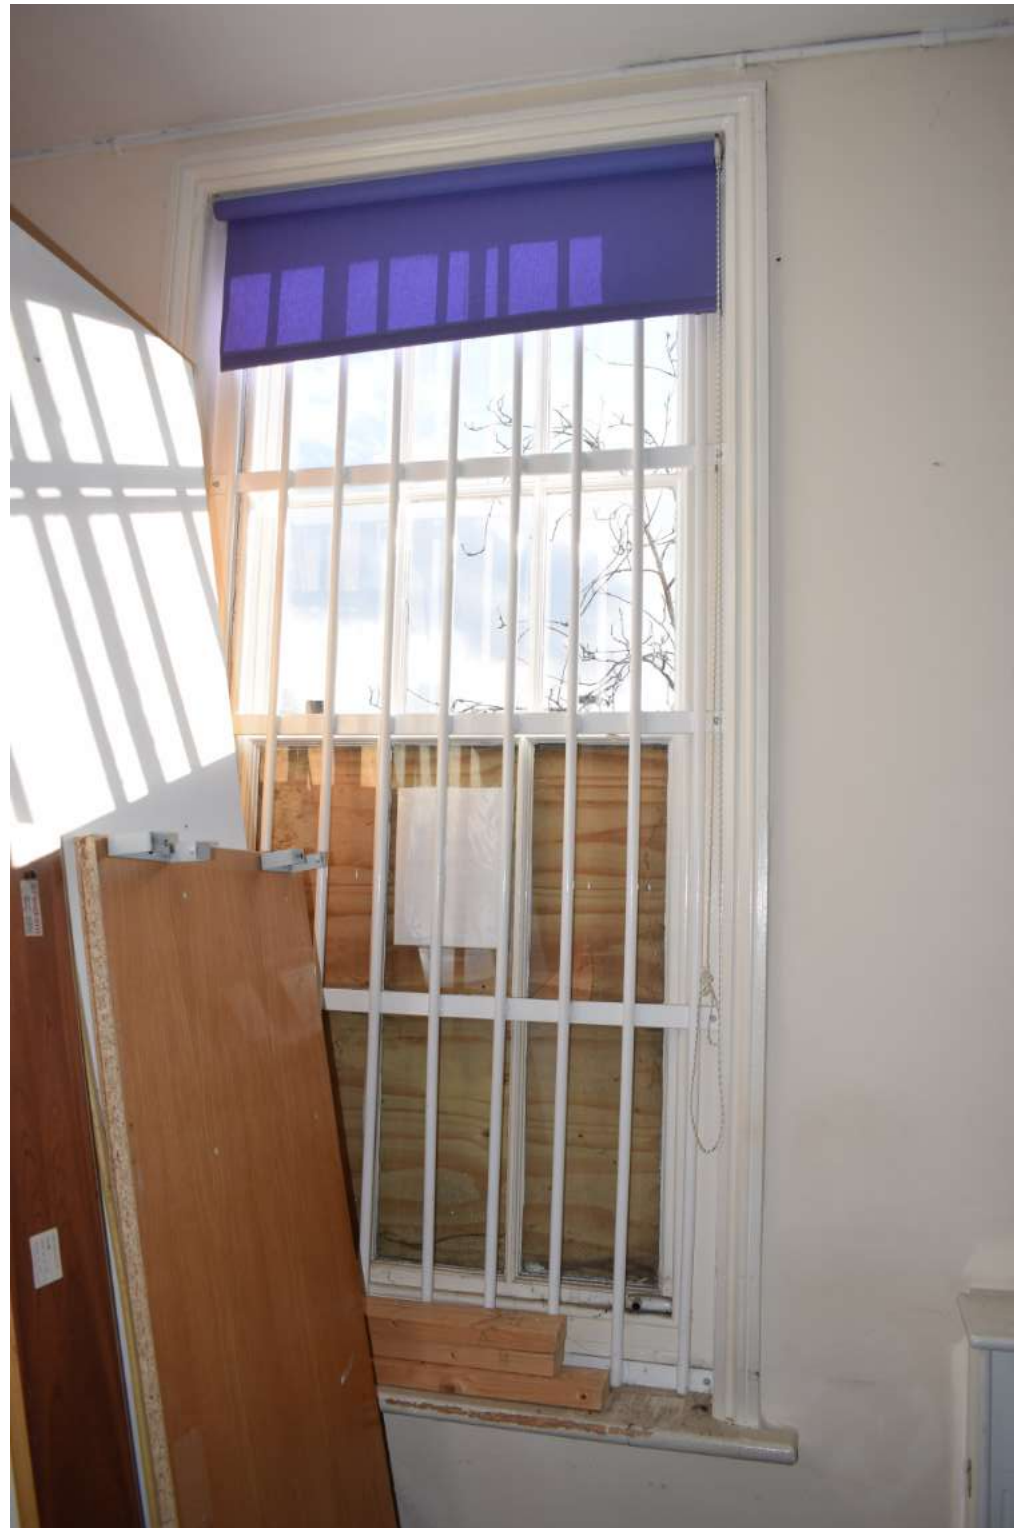
Plate 23

Opposite the modern partition is the sash window visible to the rear, the six over six panes are undamaged.

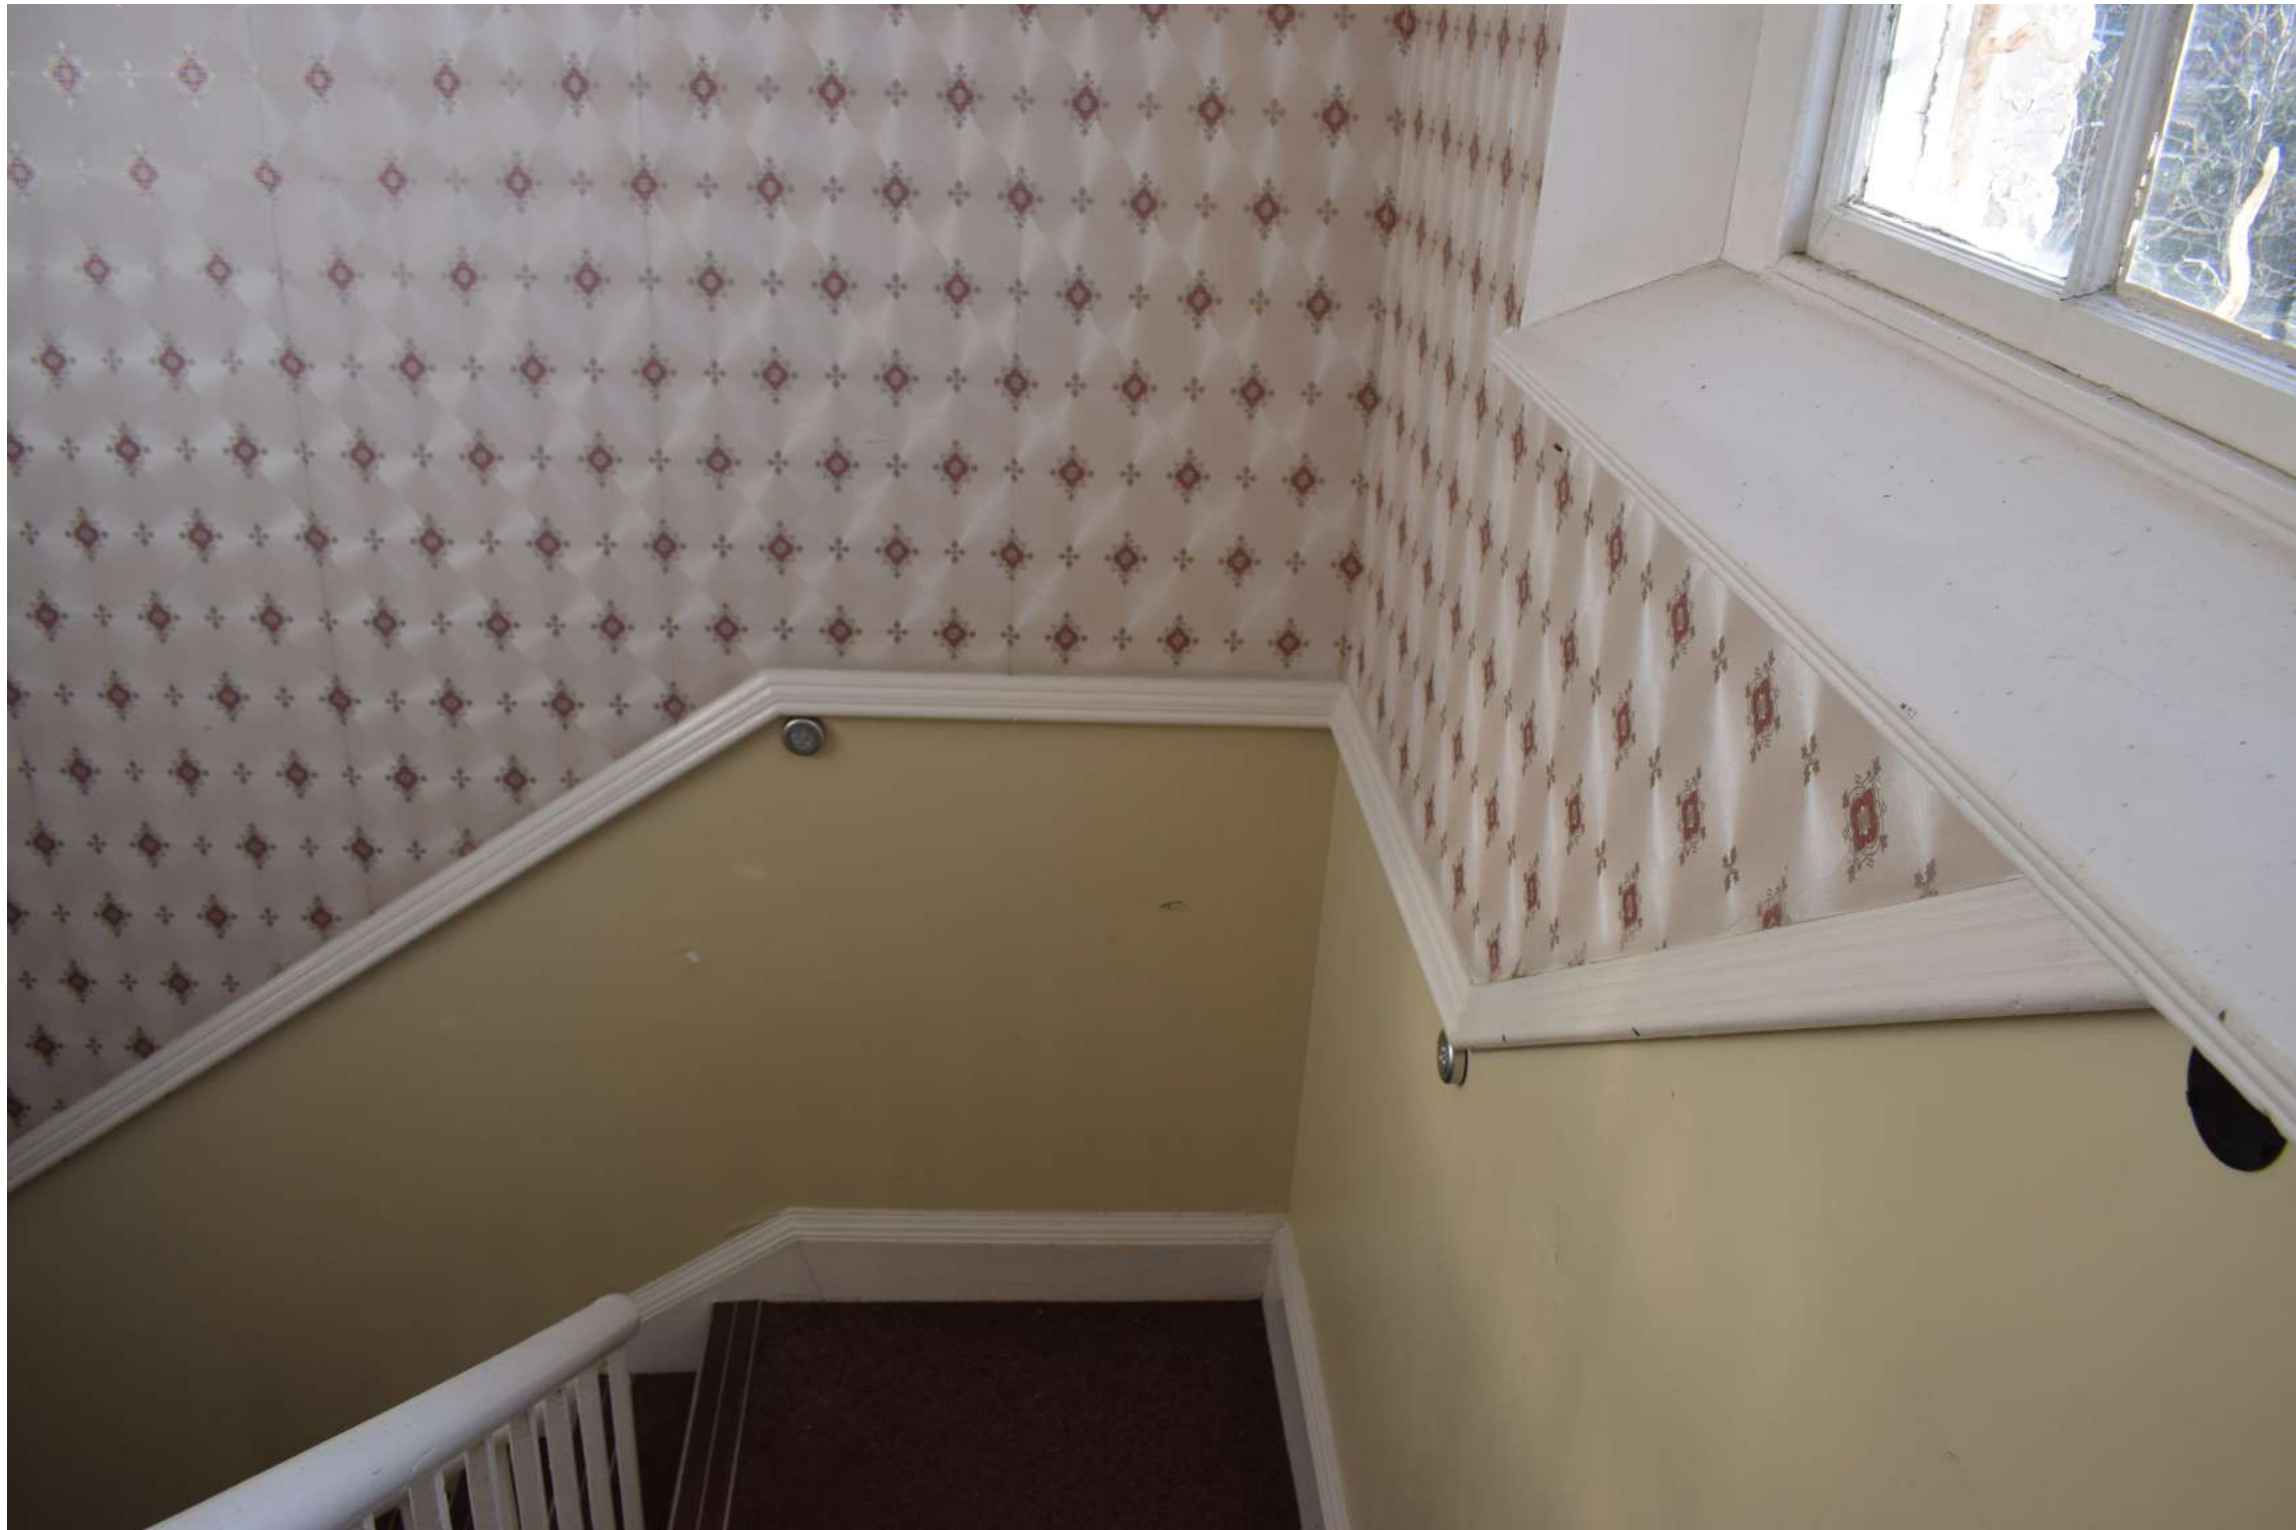
Plate 24

The existing dado rail profile is continued along the entire stairwell elevation to the first floor.
