Archway Heritage

# Appendix 11

## Yeomanry House

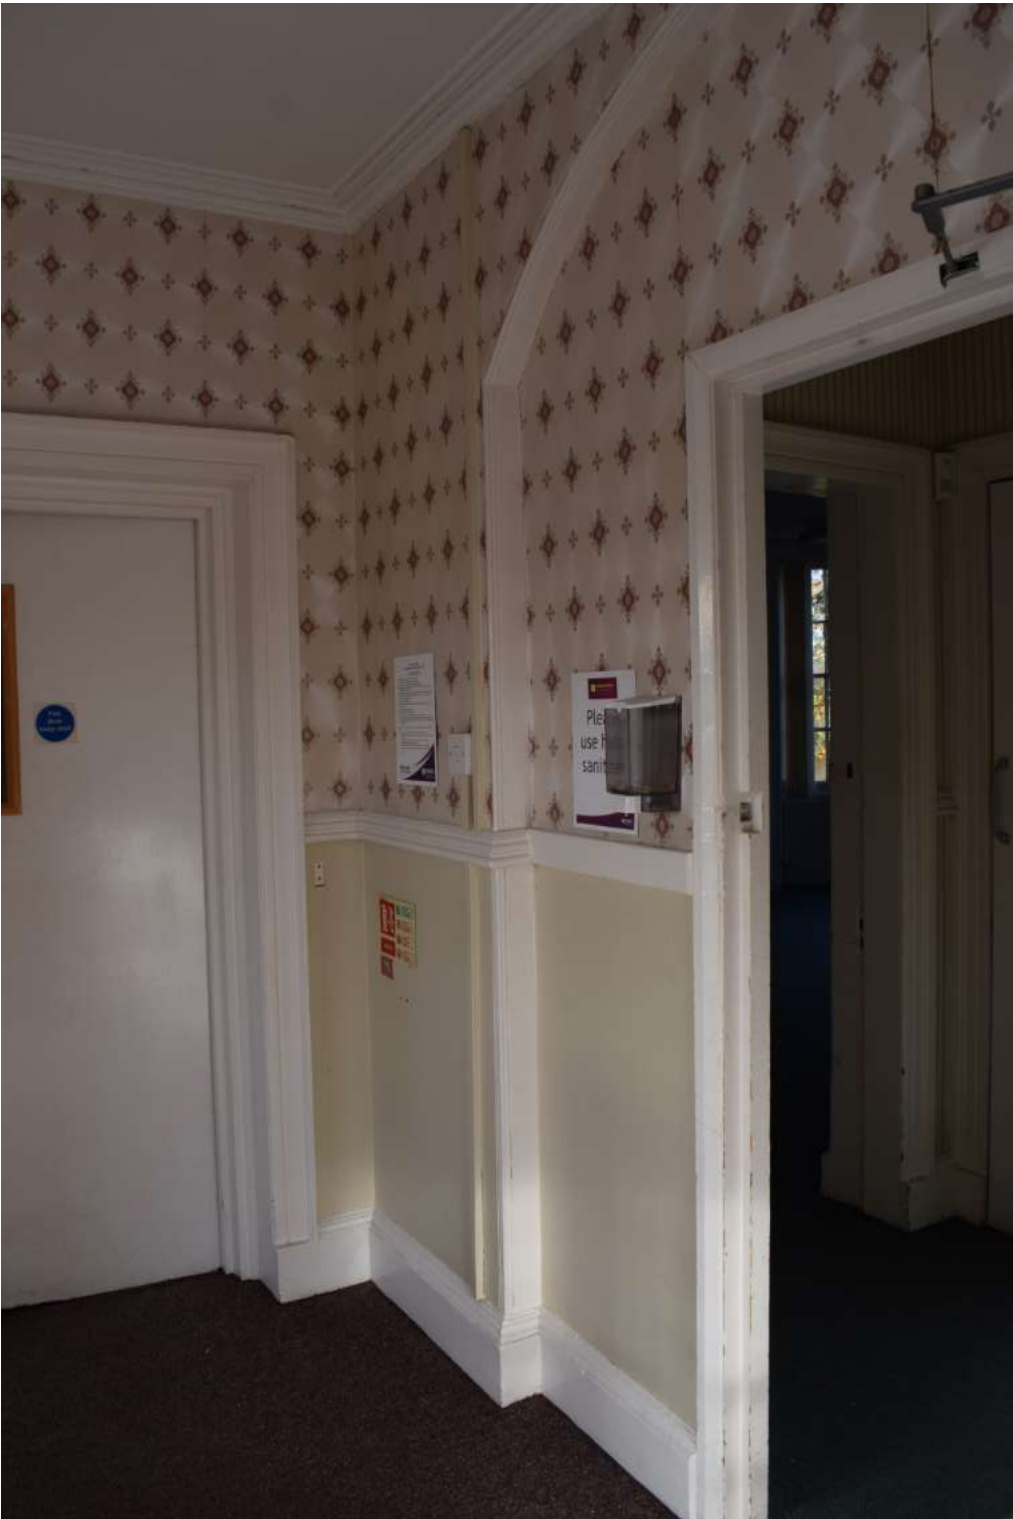
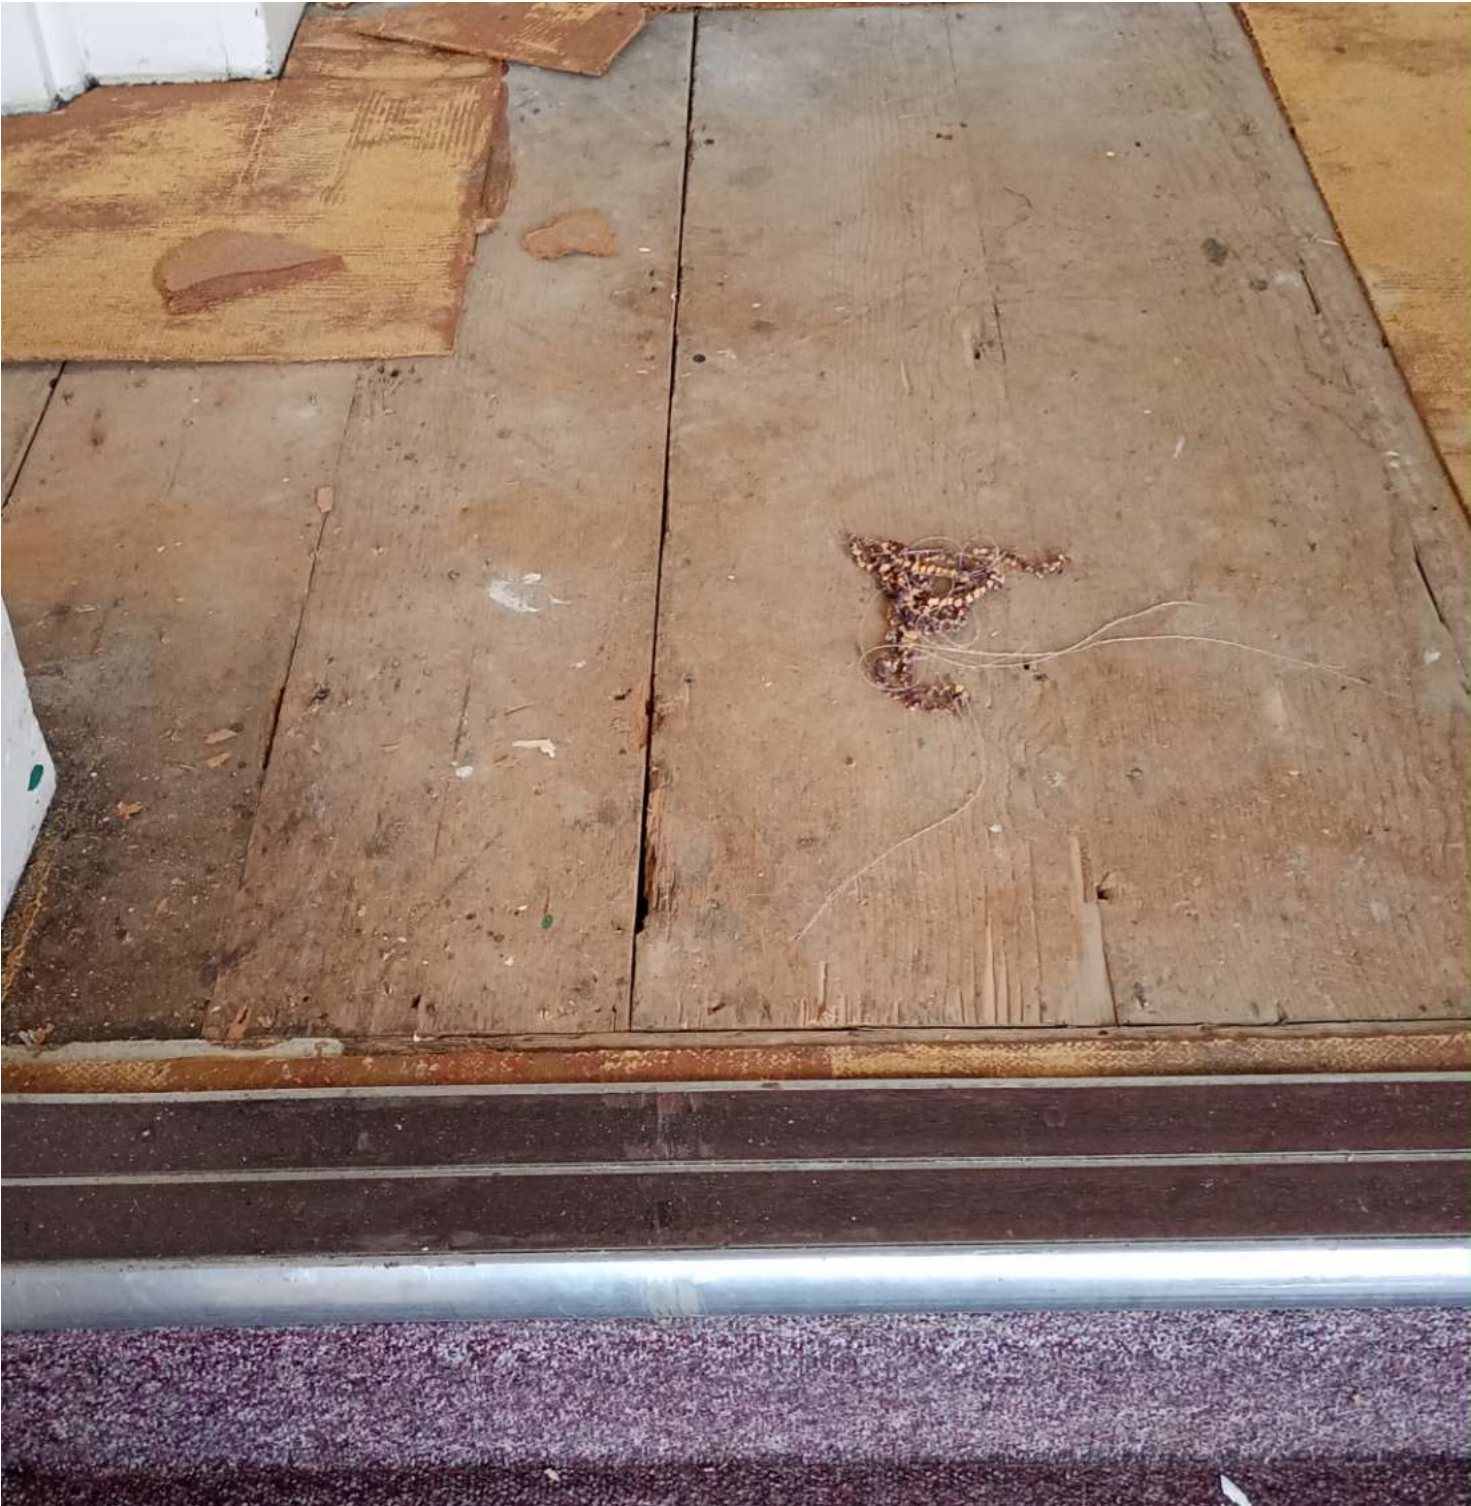
Plate 27

A general view showing the newly skirting boards matching the historic profile have been installed. Inset: a detail of the timber flooring.

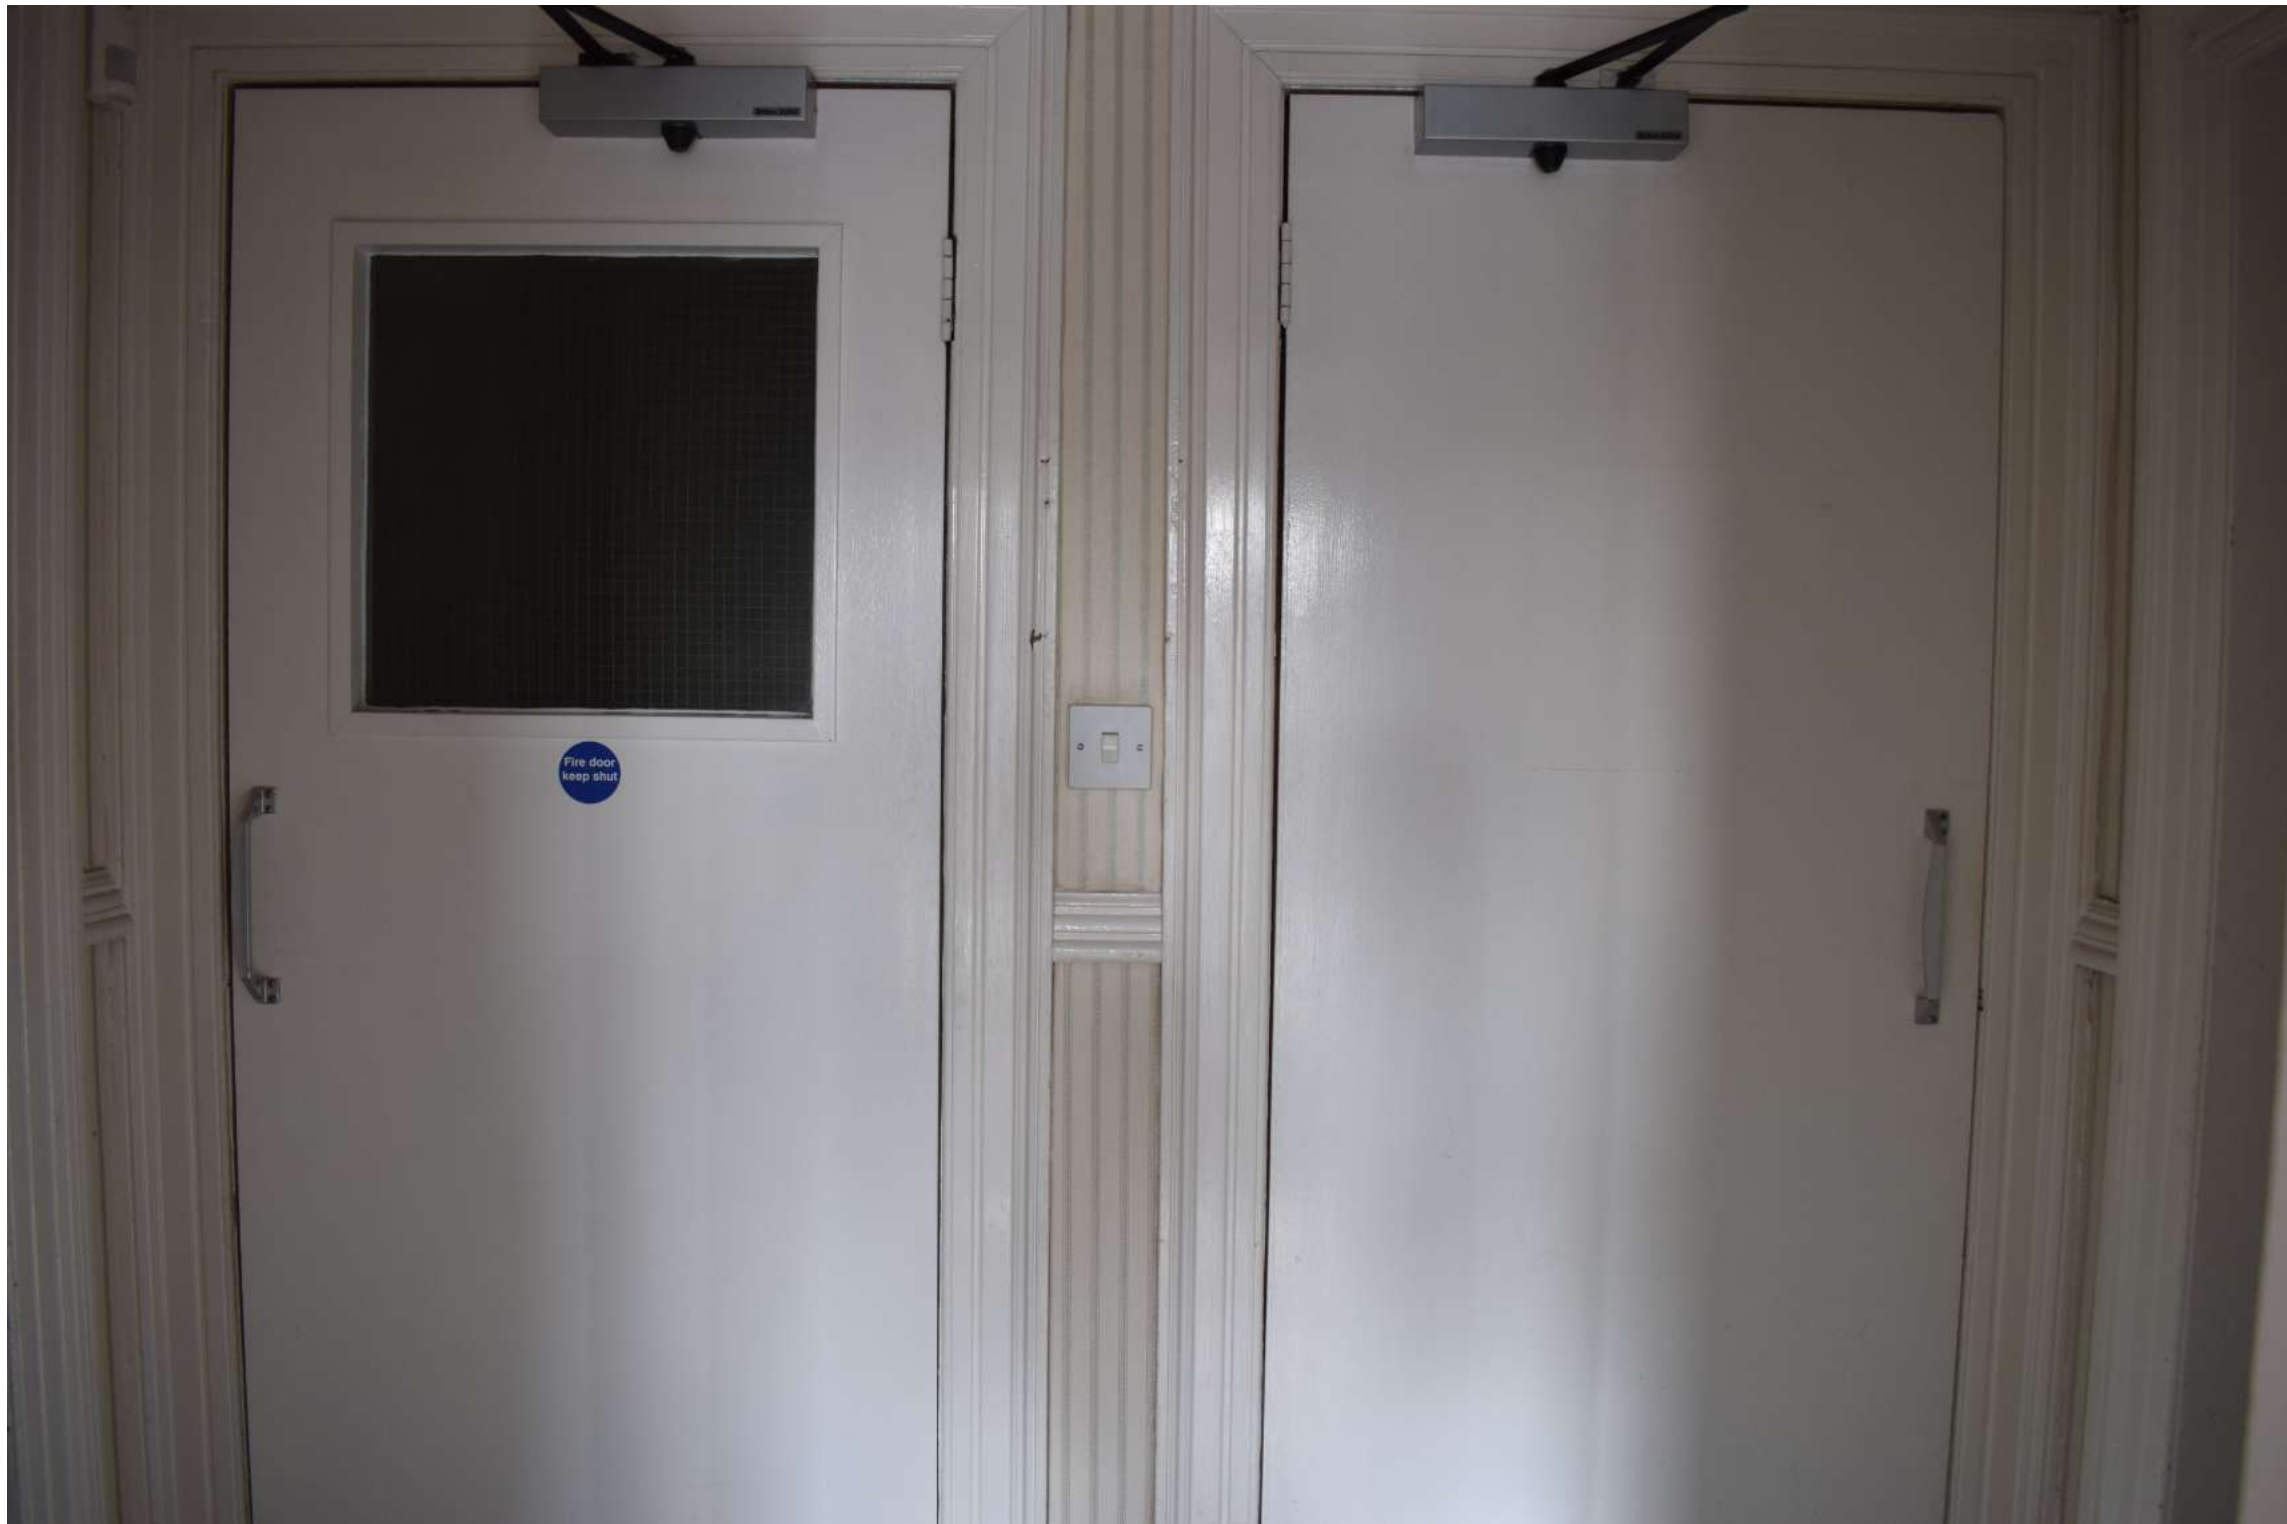
Plate 28

Two fire doors greet the visitor on this landing. The one on the right leads to a cupboard and on the left to the servants' stairs to the second floor.

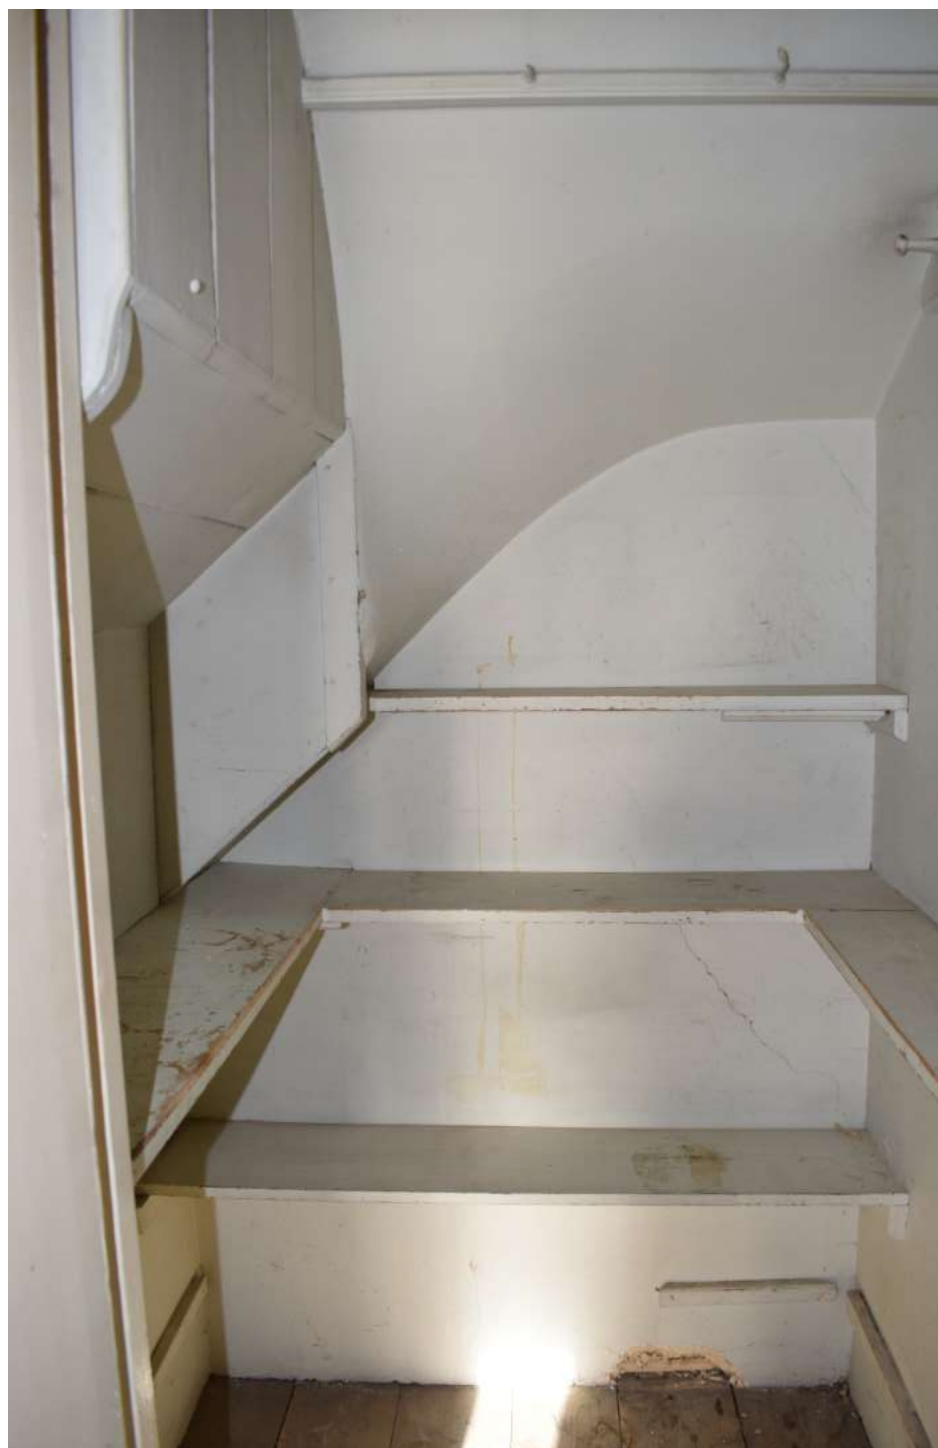
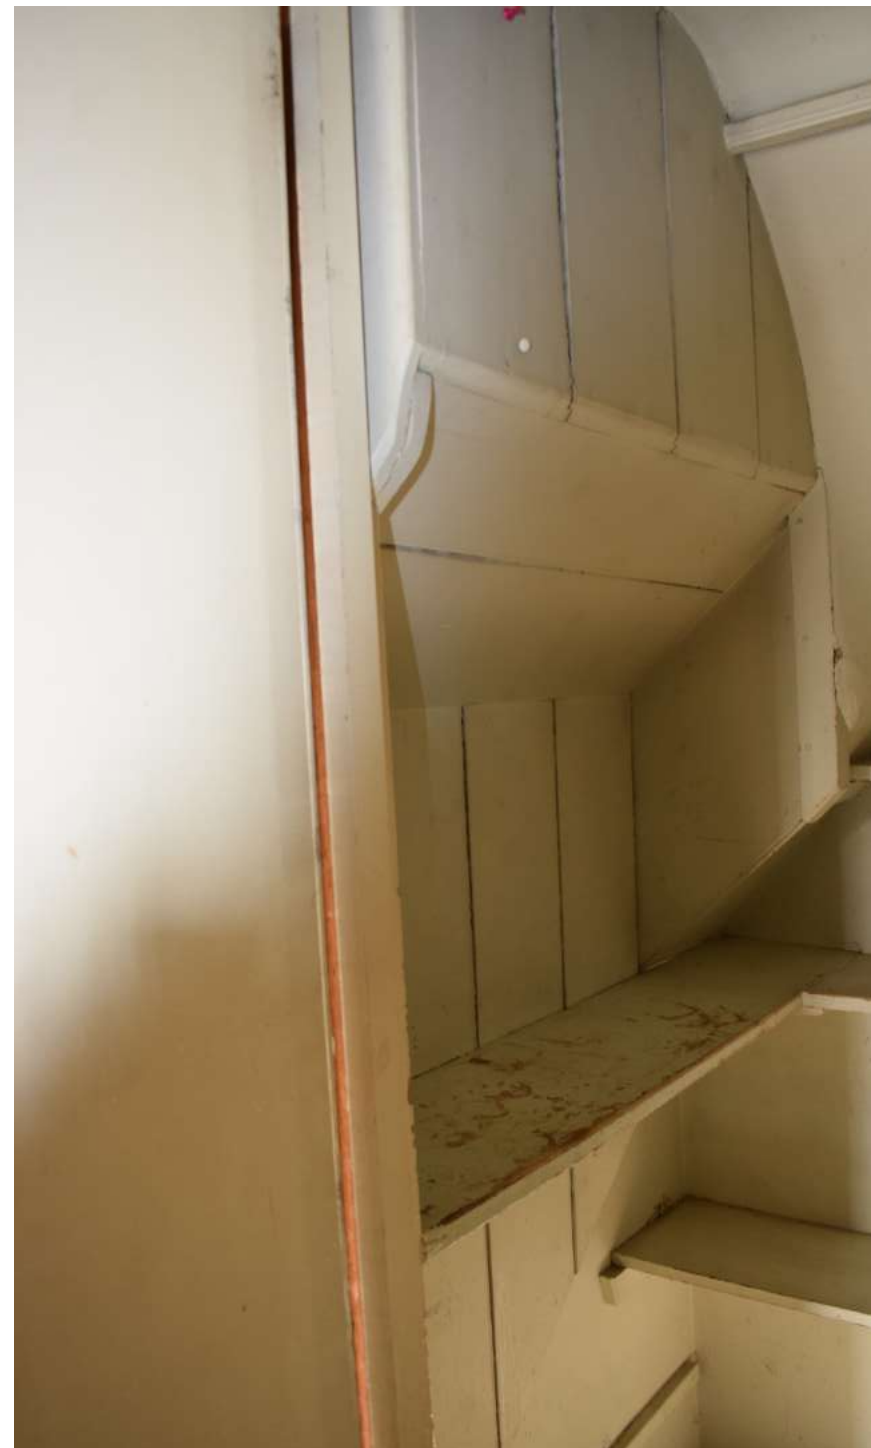
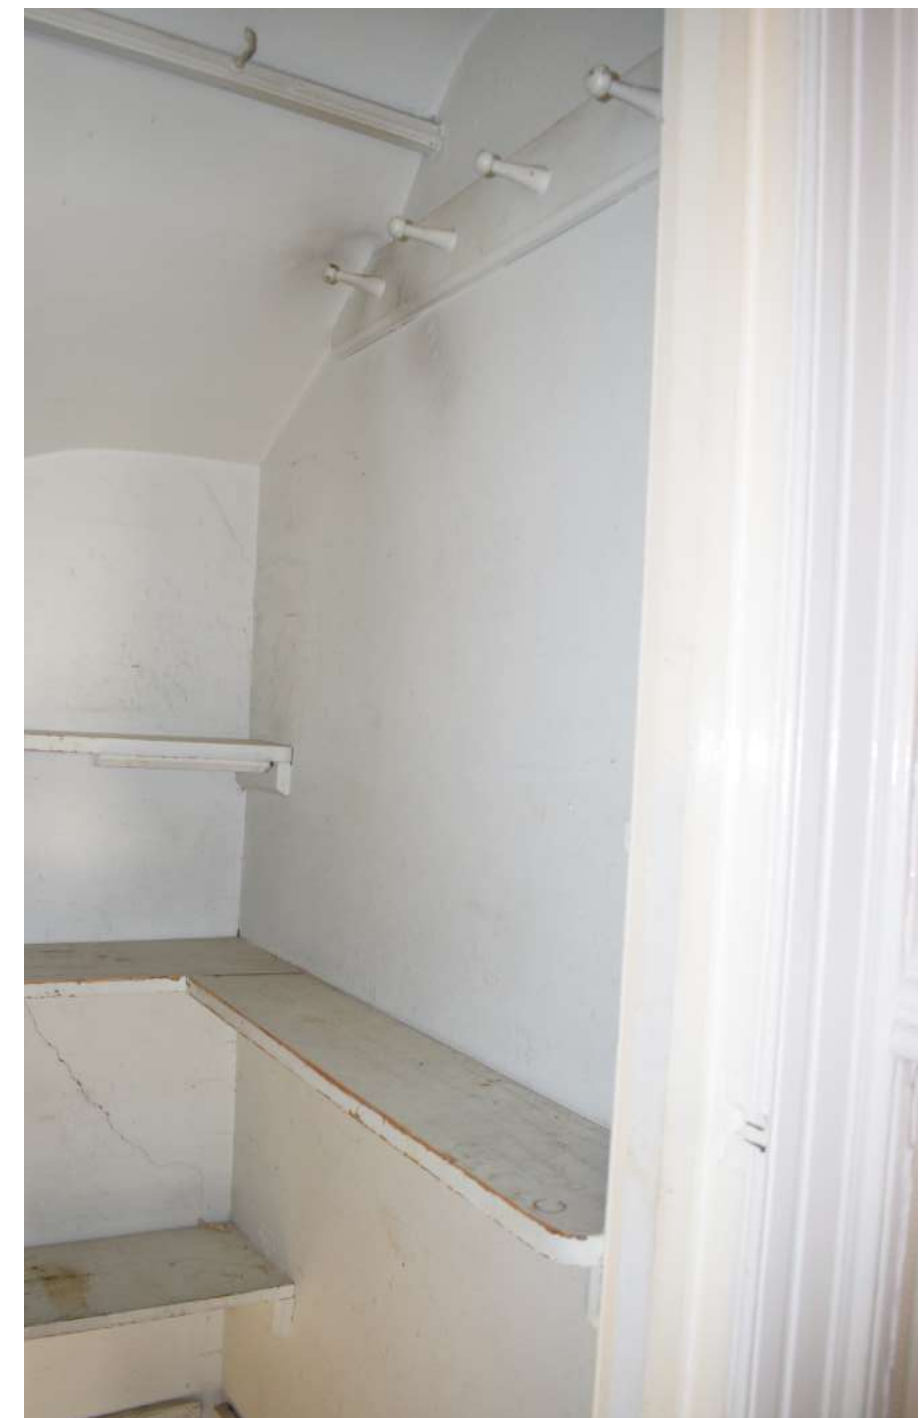
Plate 29

The storage space located beneath the servants' stairs.

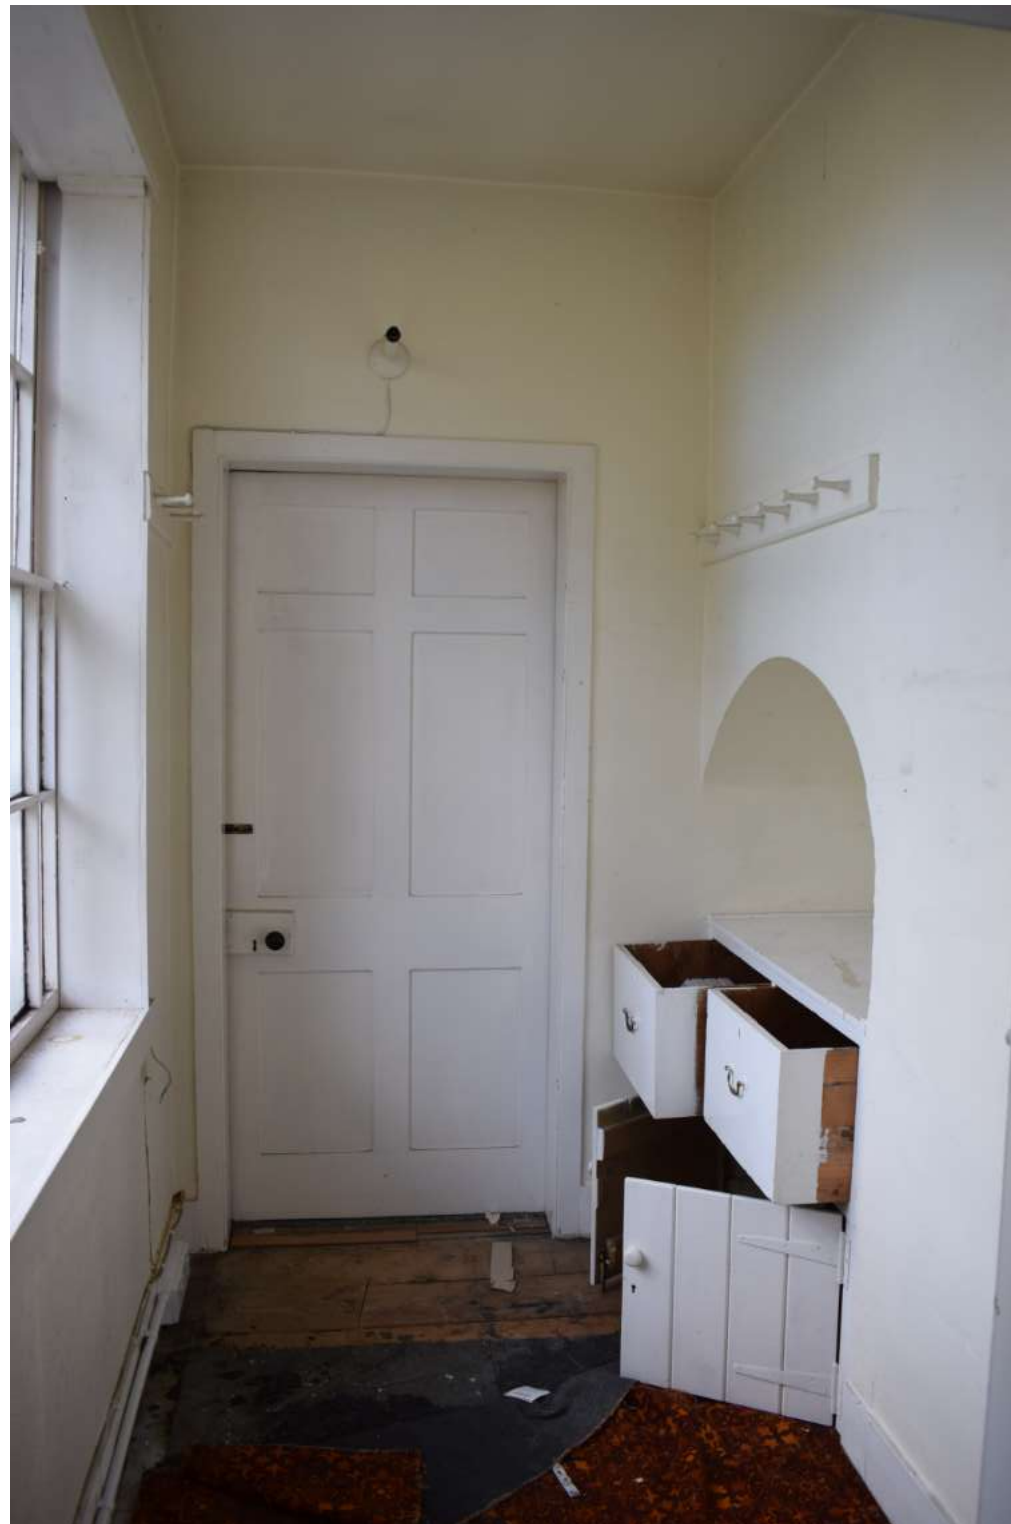
Plate 30

View of the small serving area (larder) has a timber floor, very low non-decorative skirting, and no decorative detailing.

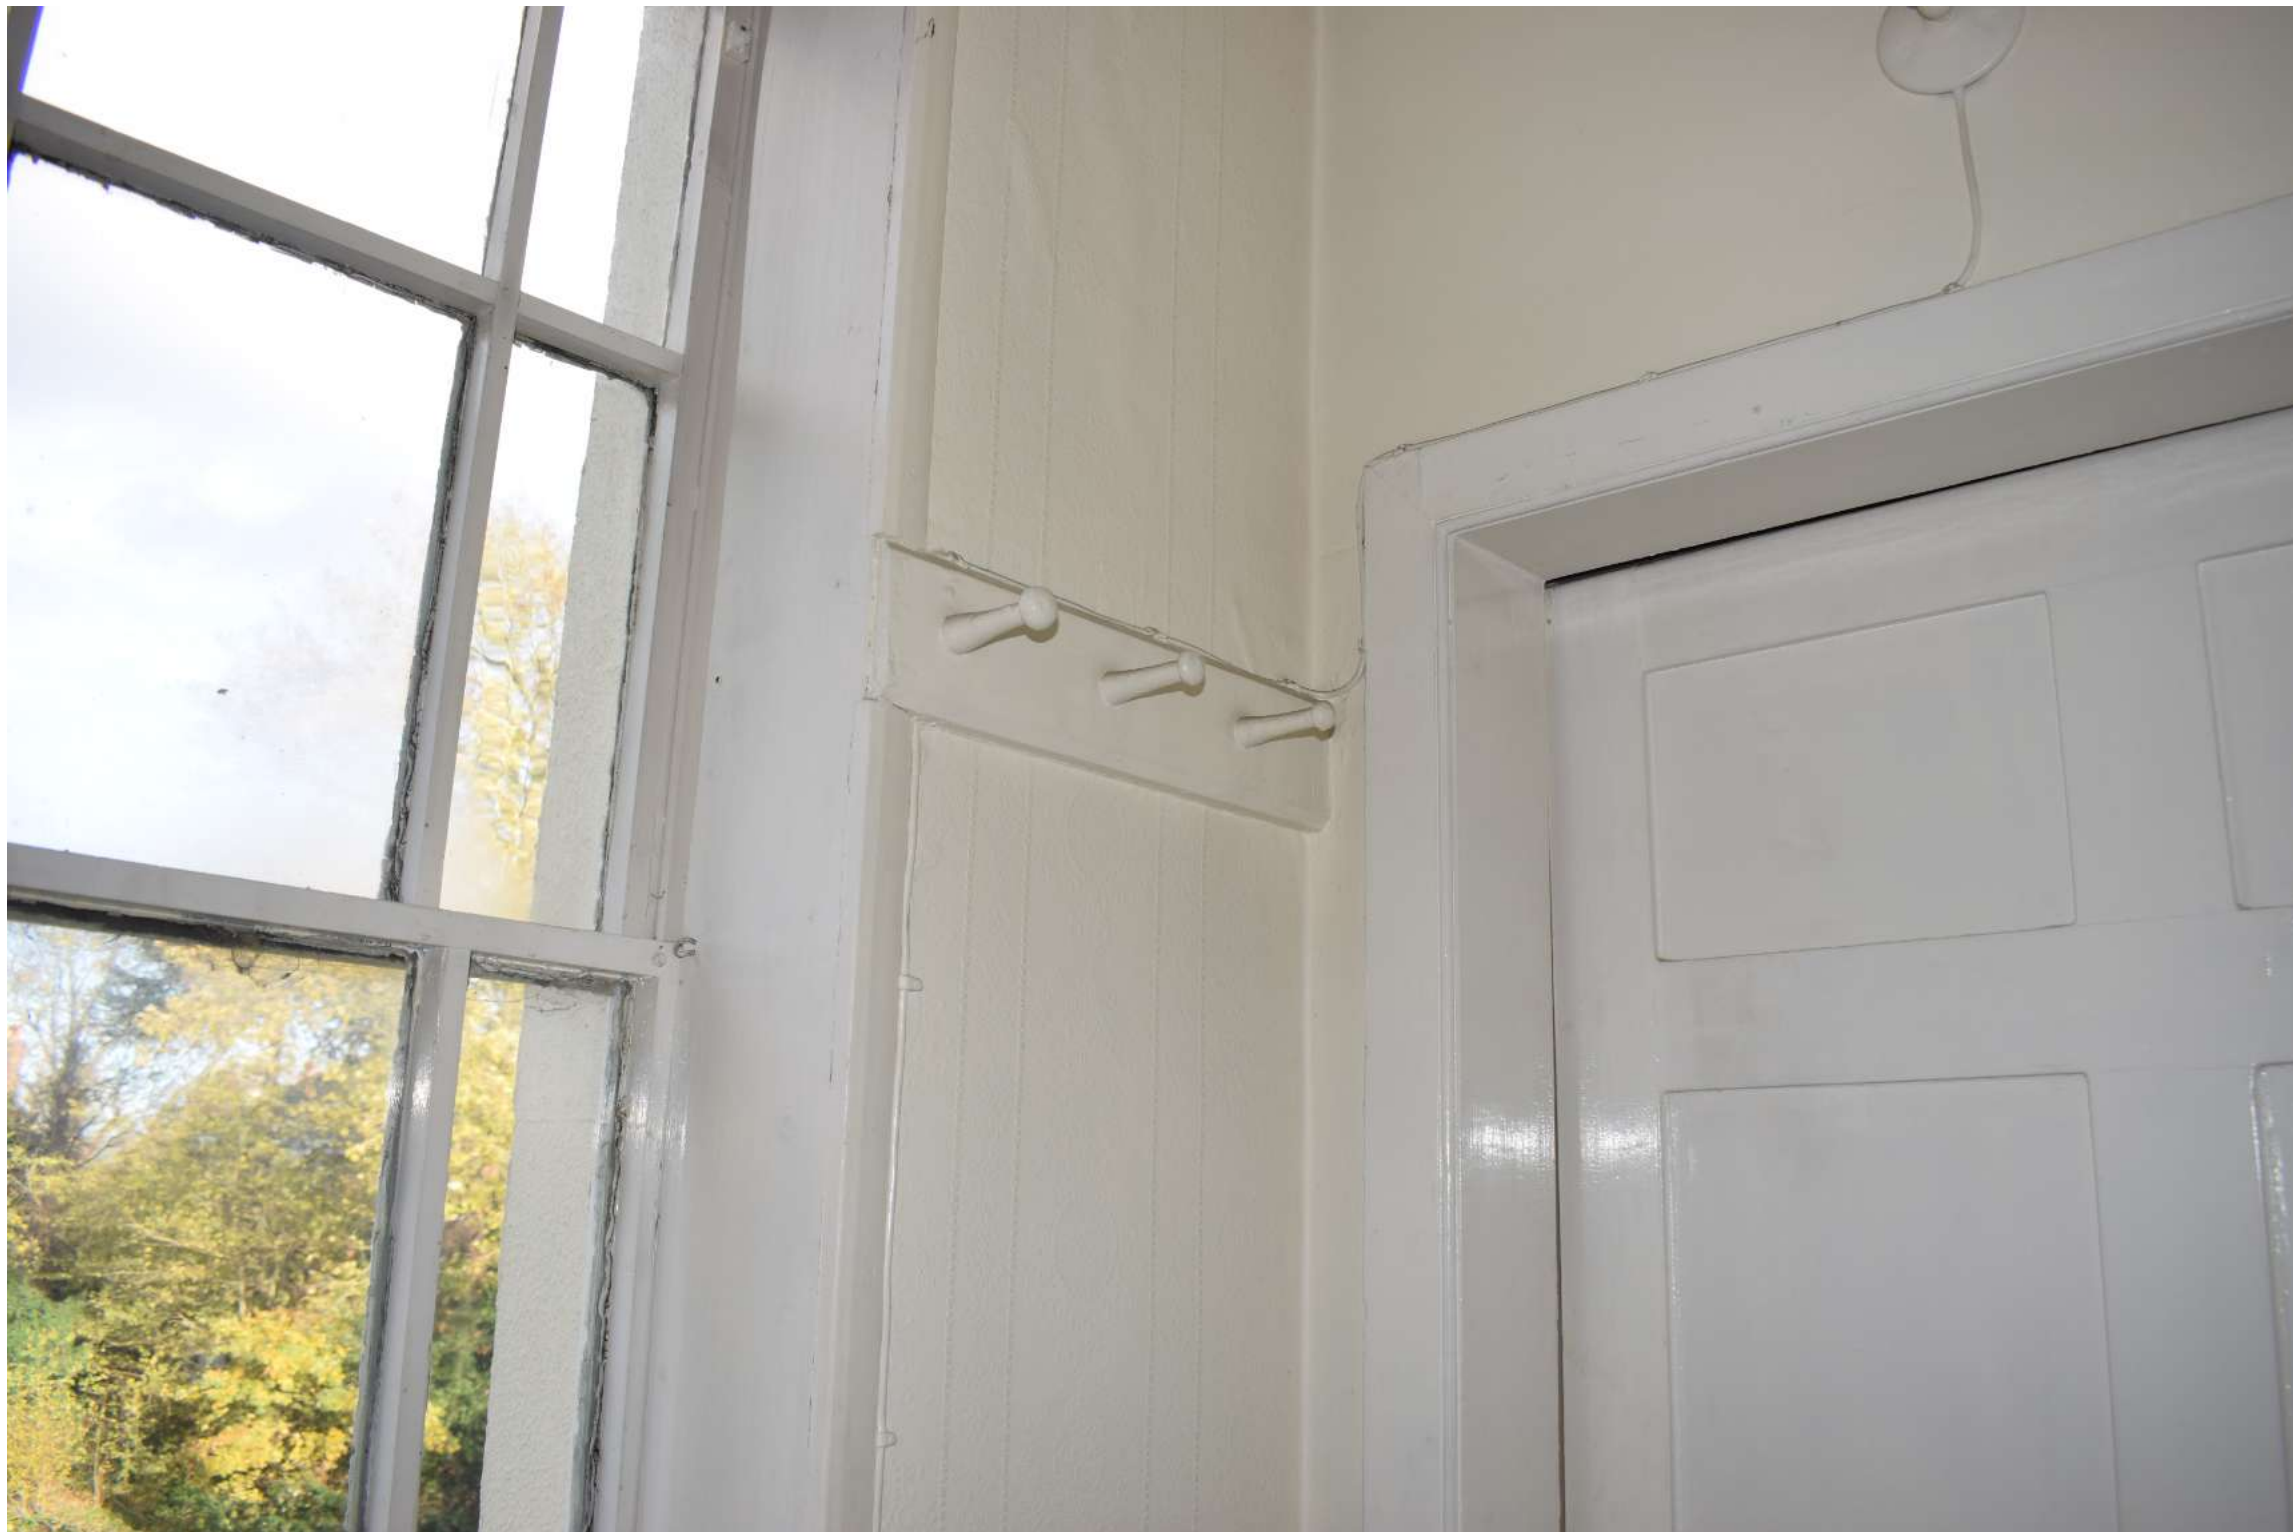
Plate 31a

View of the hooks either side of the eight over eight paned window.

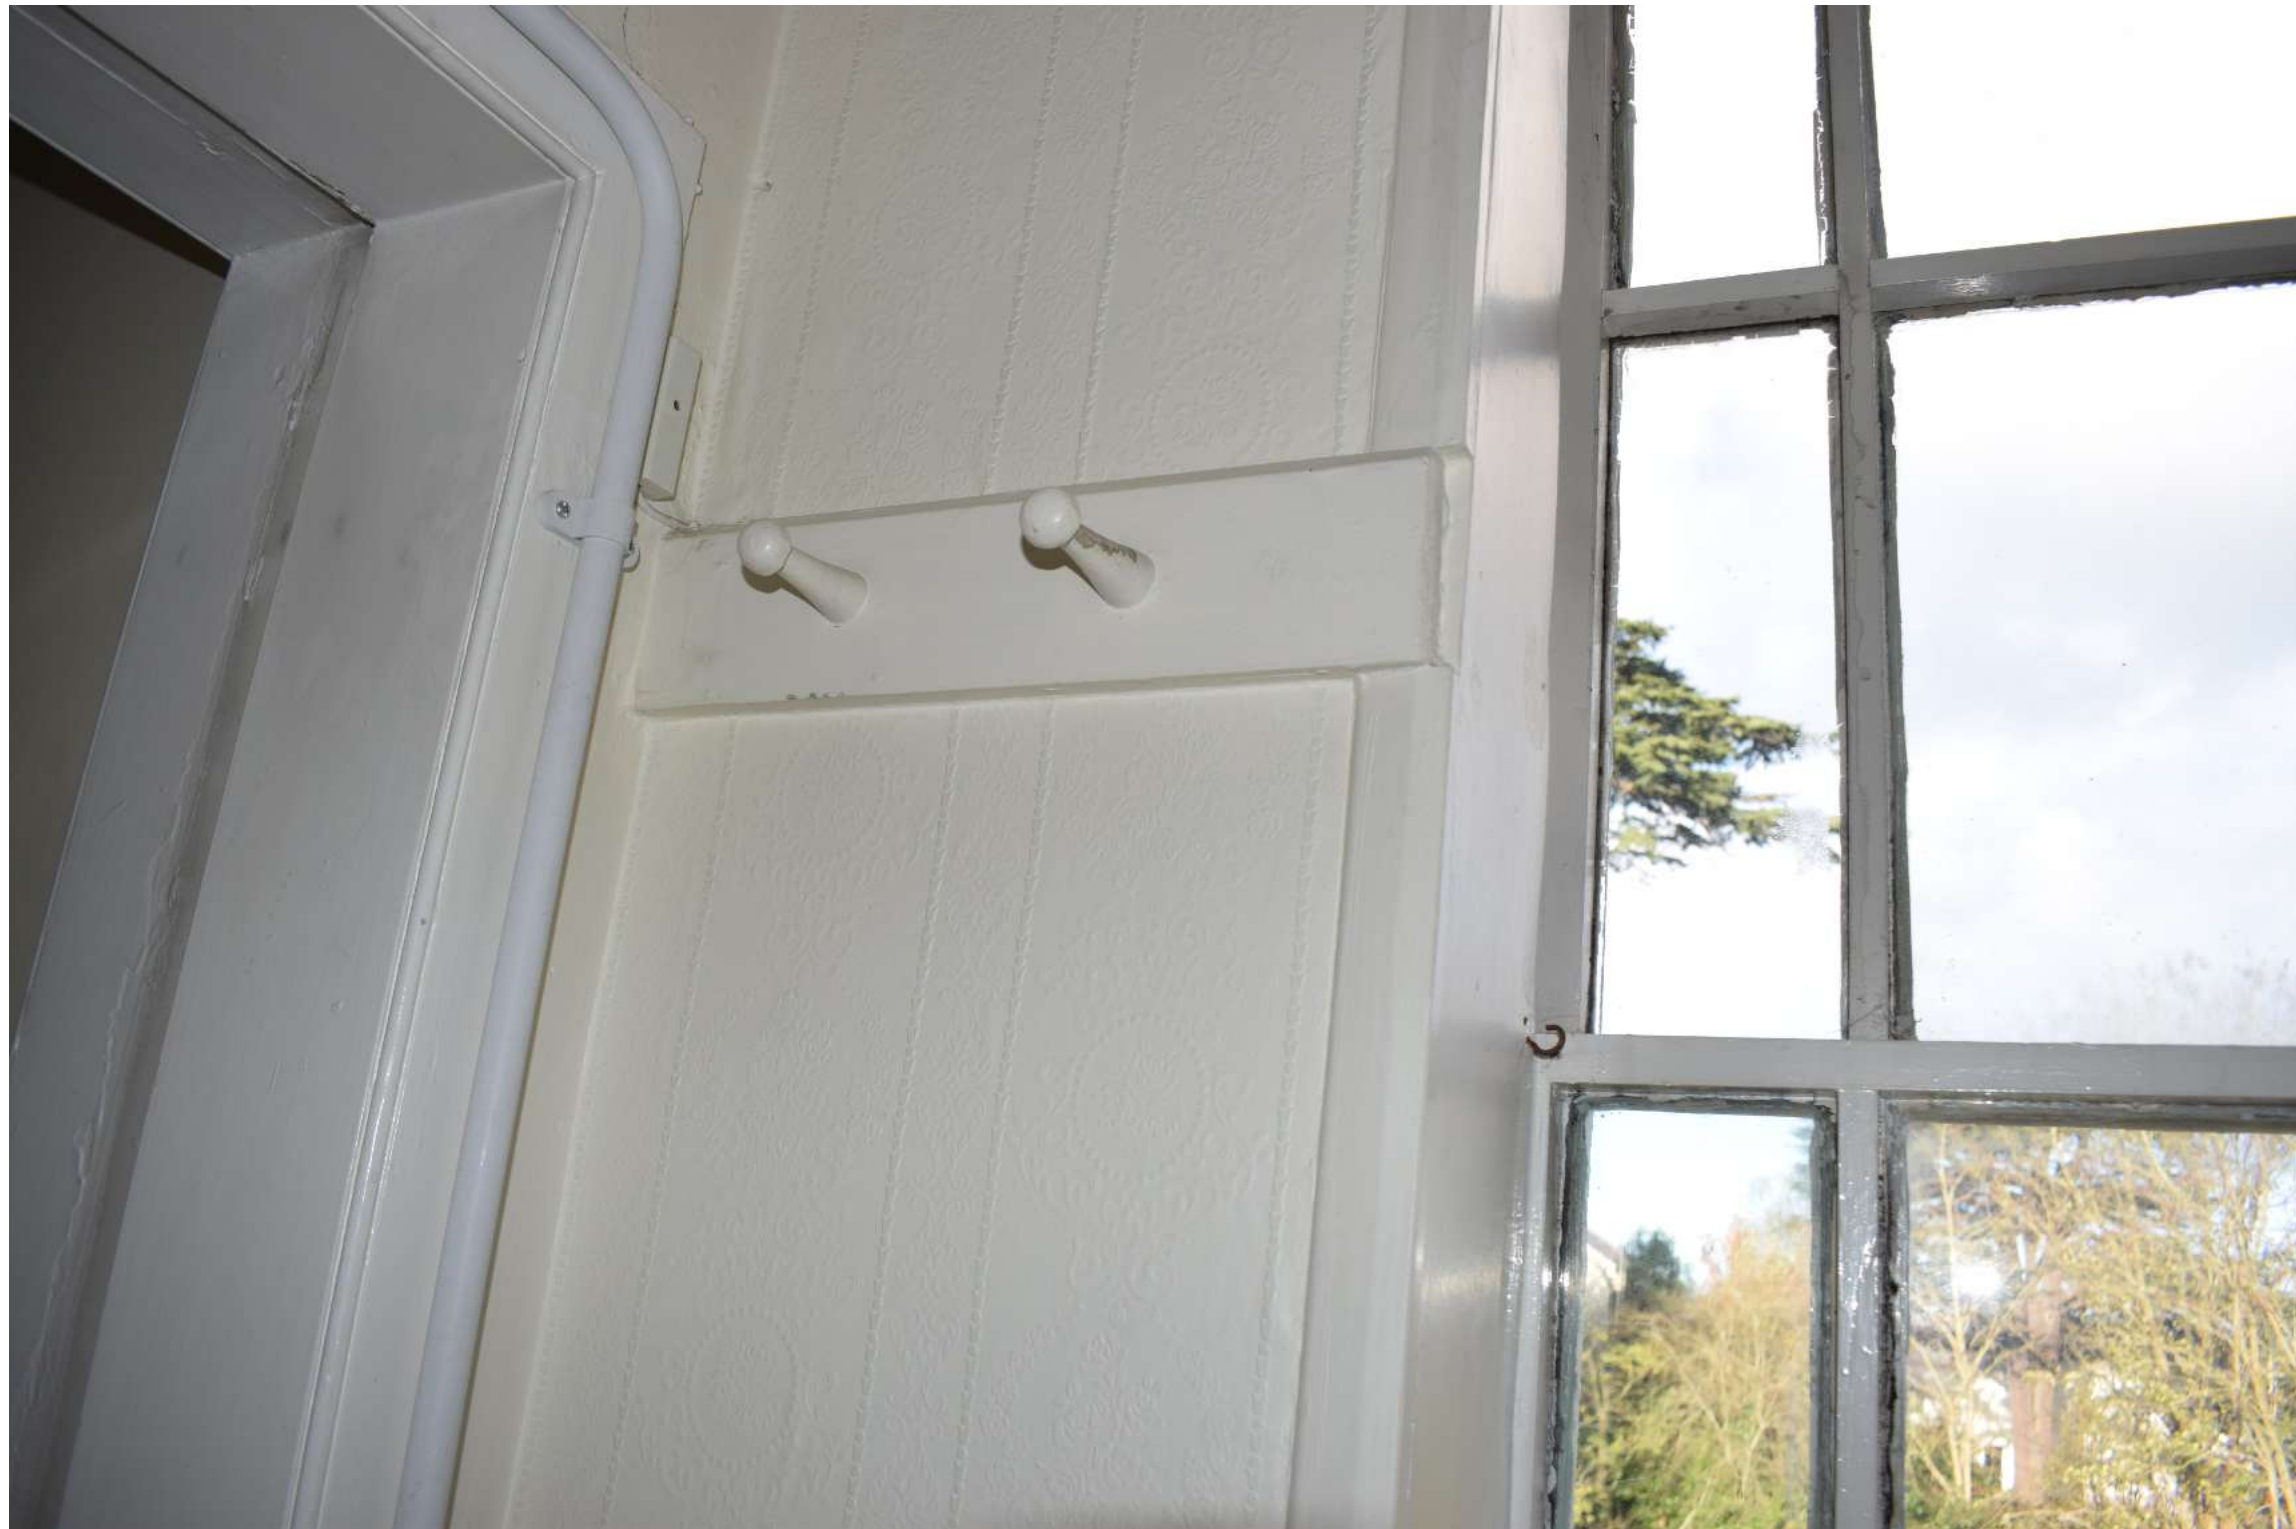
Plate 31b

View of the hooks either side of the eight over eight paned window.

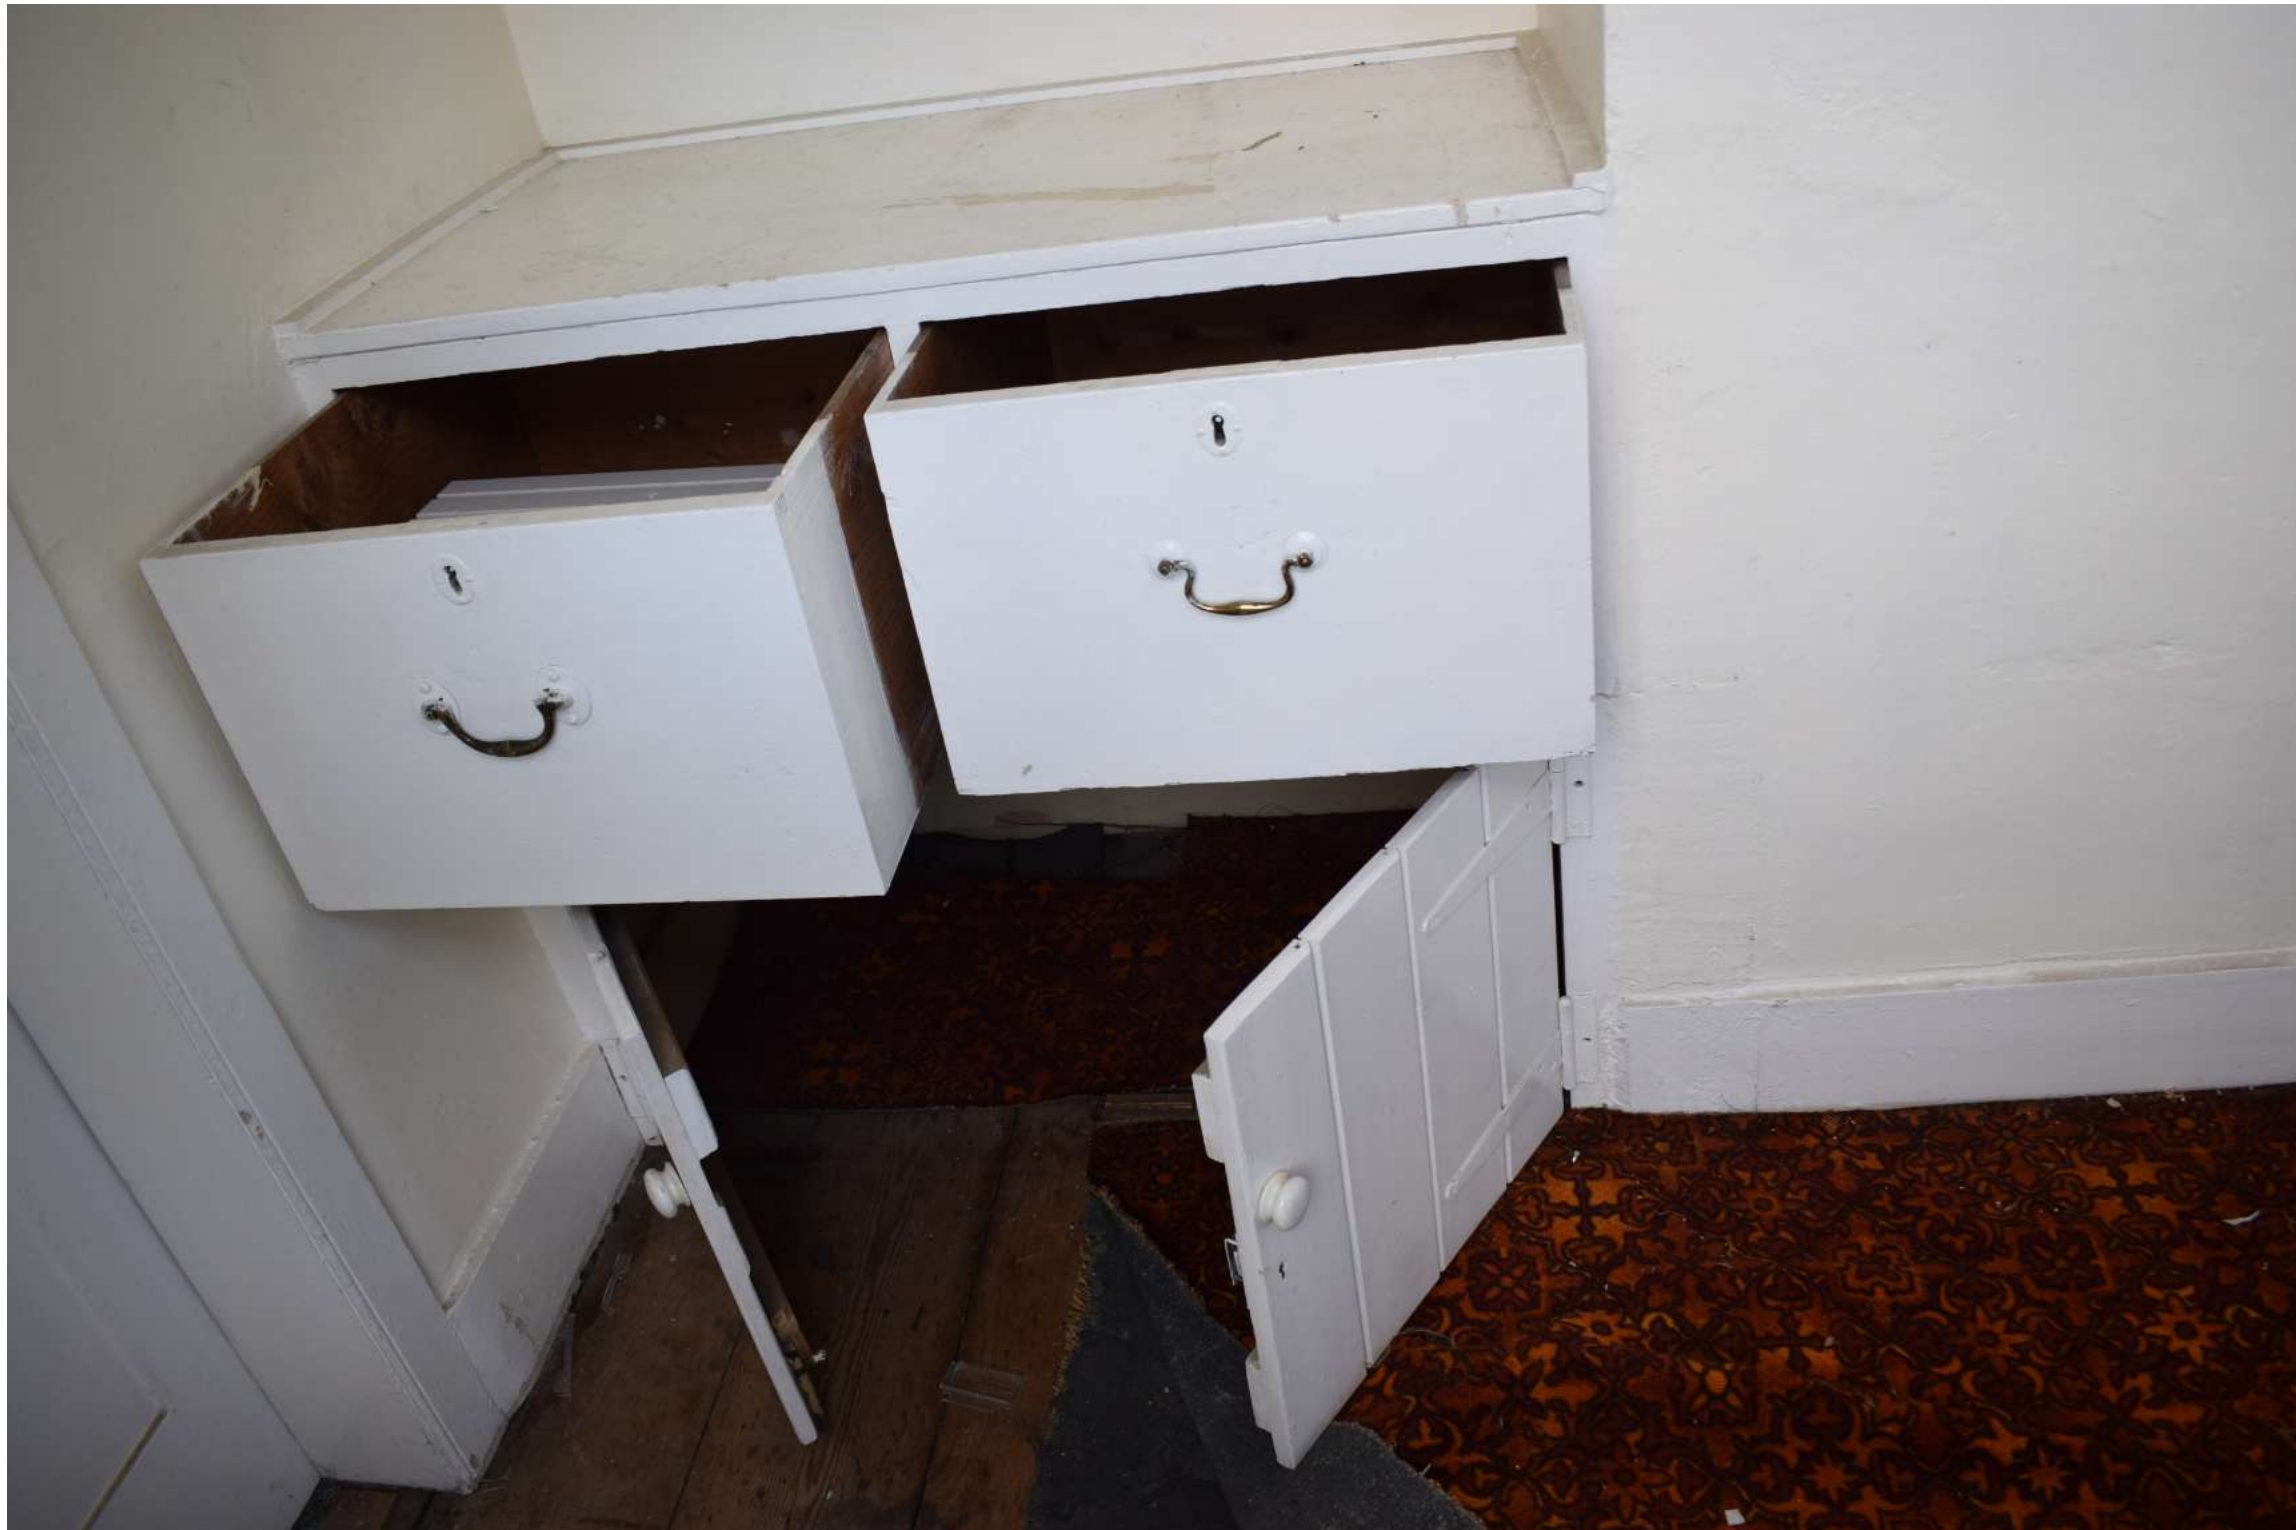
Plate 32

Image confirming the continuity of the timber floorboards from the larder through to the adjacent cupboard beneath the servants' stairs.
