Archway Heritage

# Appendix 11

## Yeomanry House

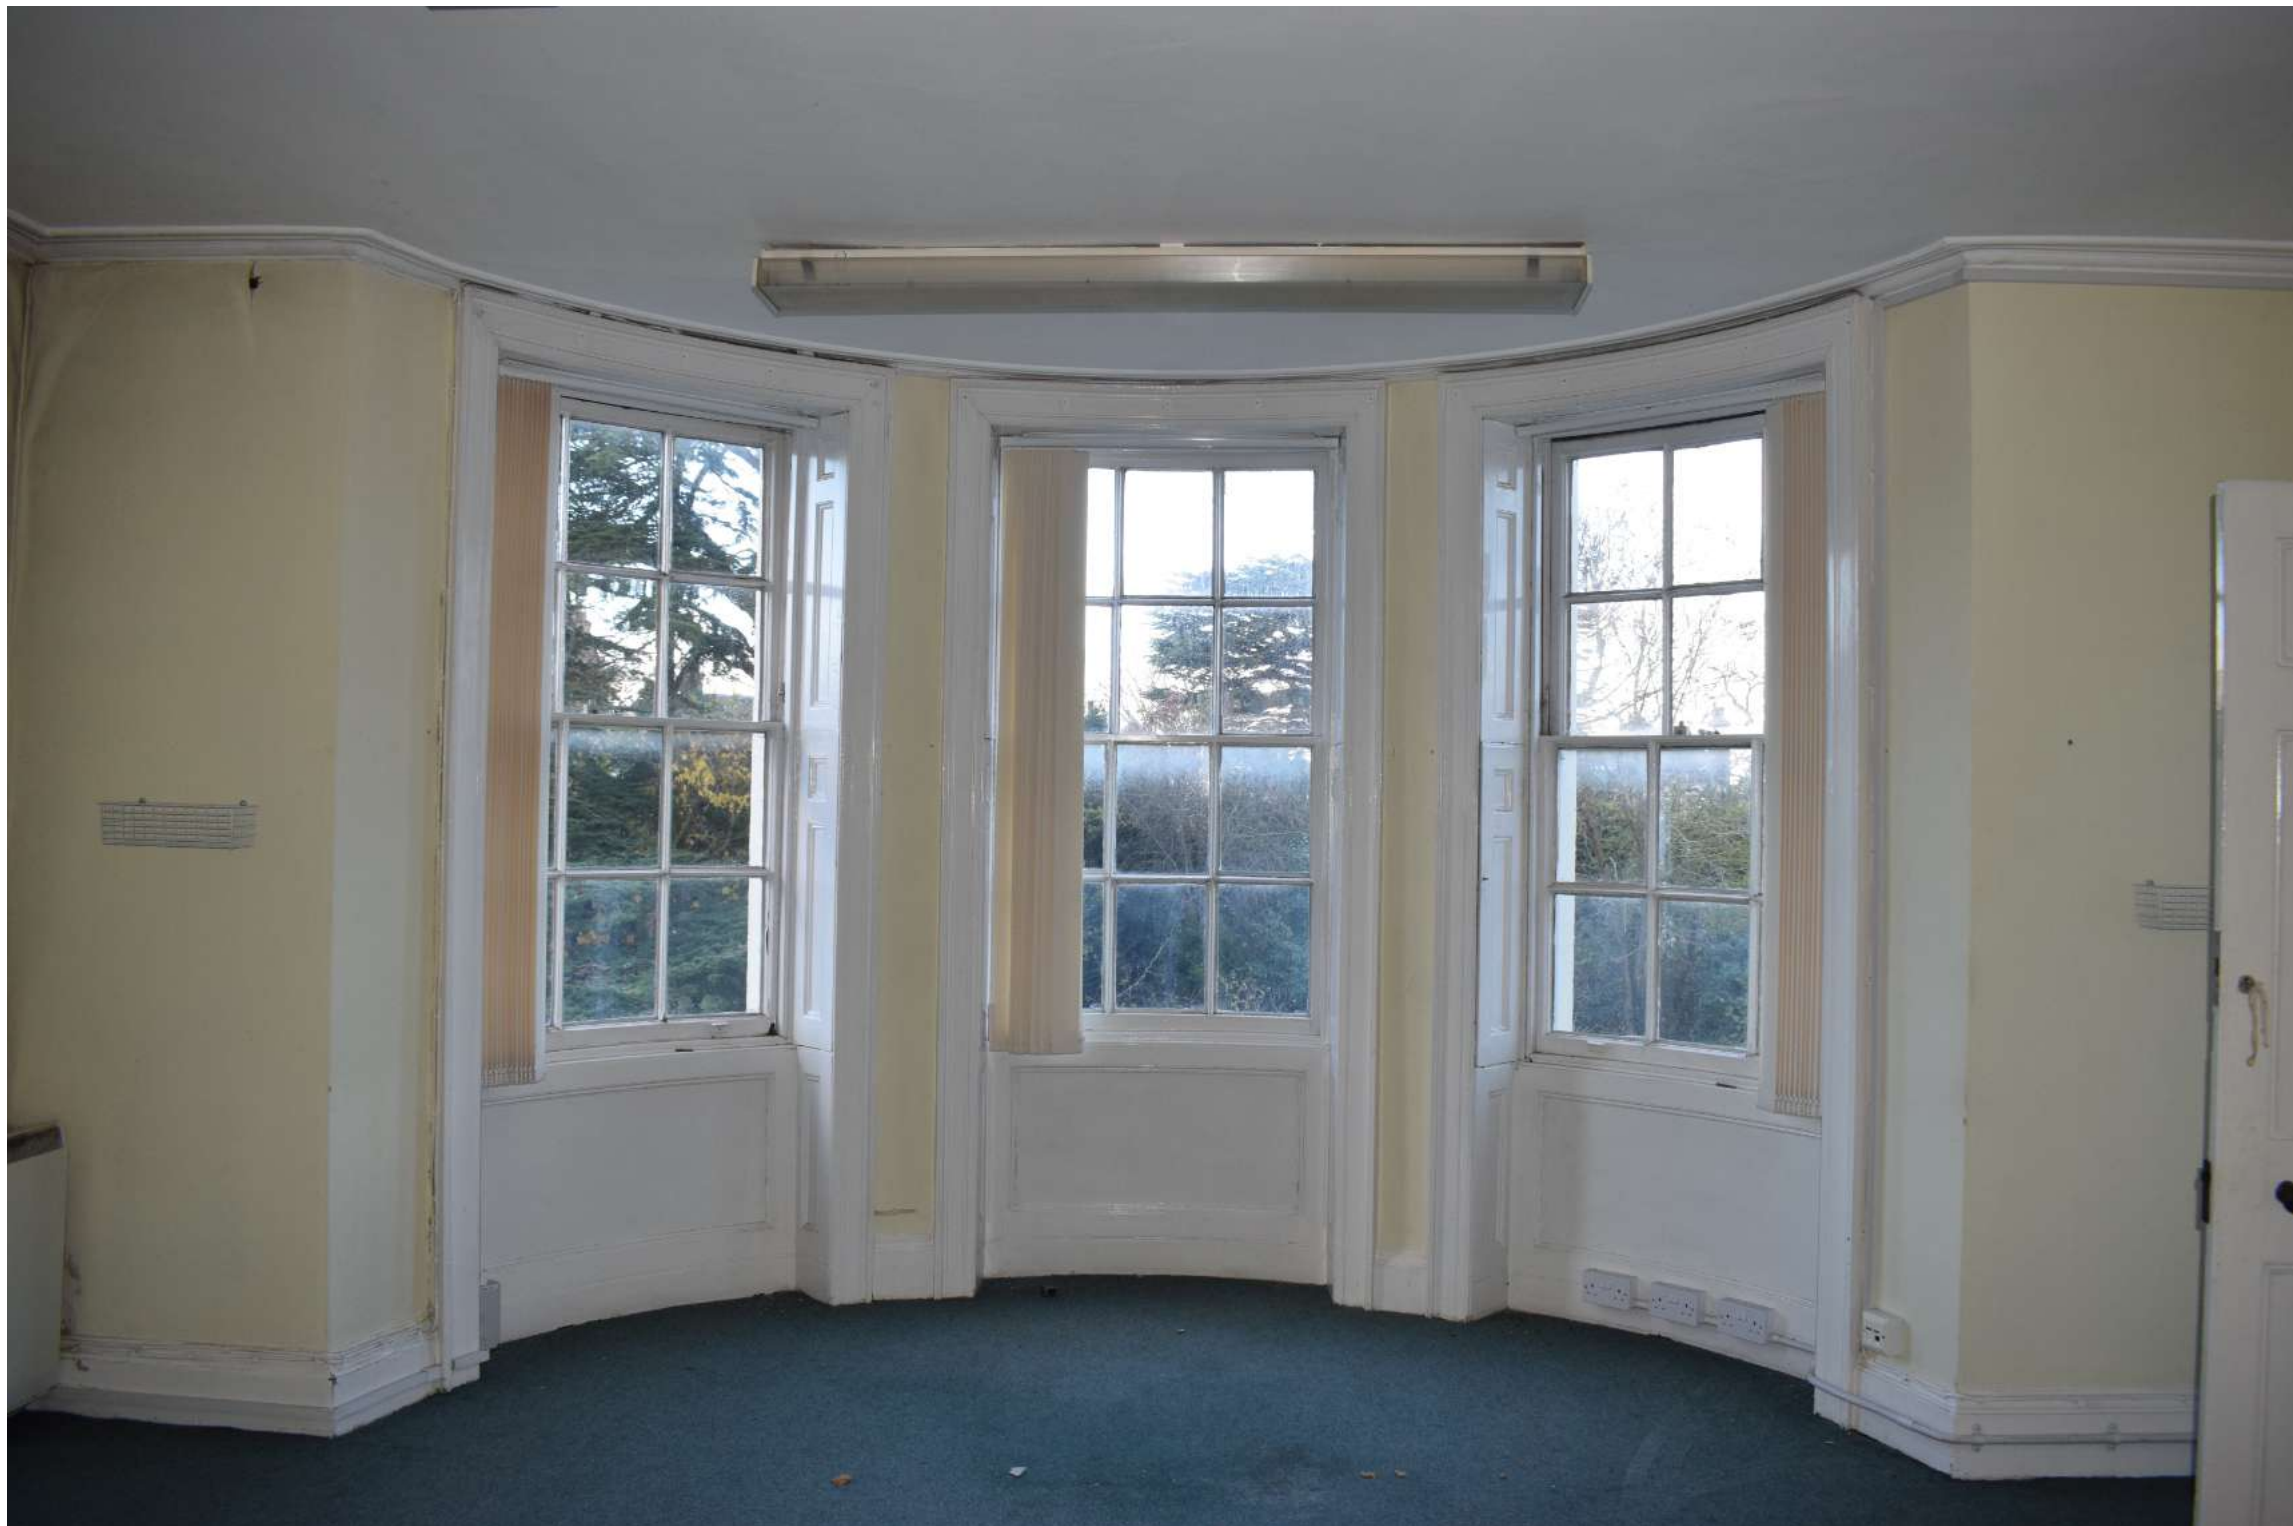
Plate 33

Fenestration detail of the office, situated on the west side, lit by bow windows featuring six-over-six sash units and tri-folding shutters.

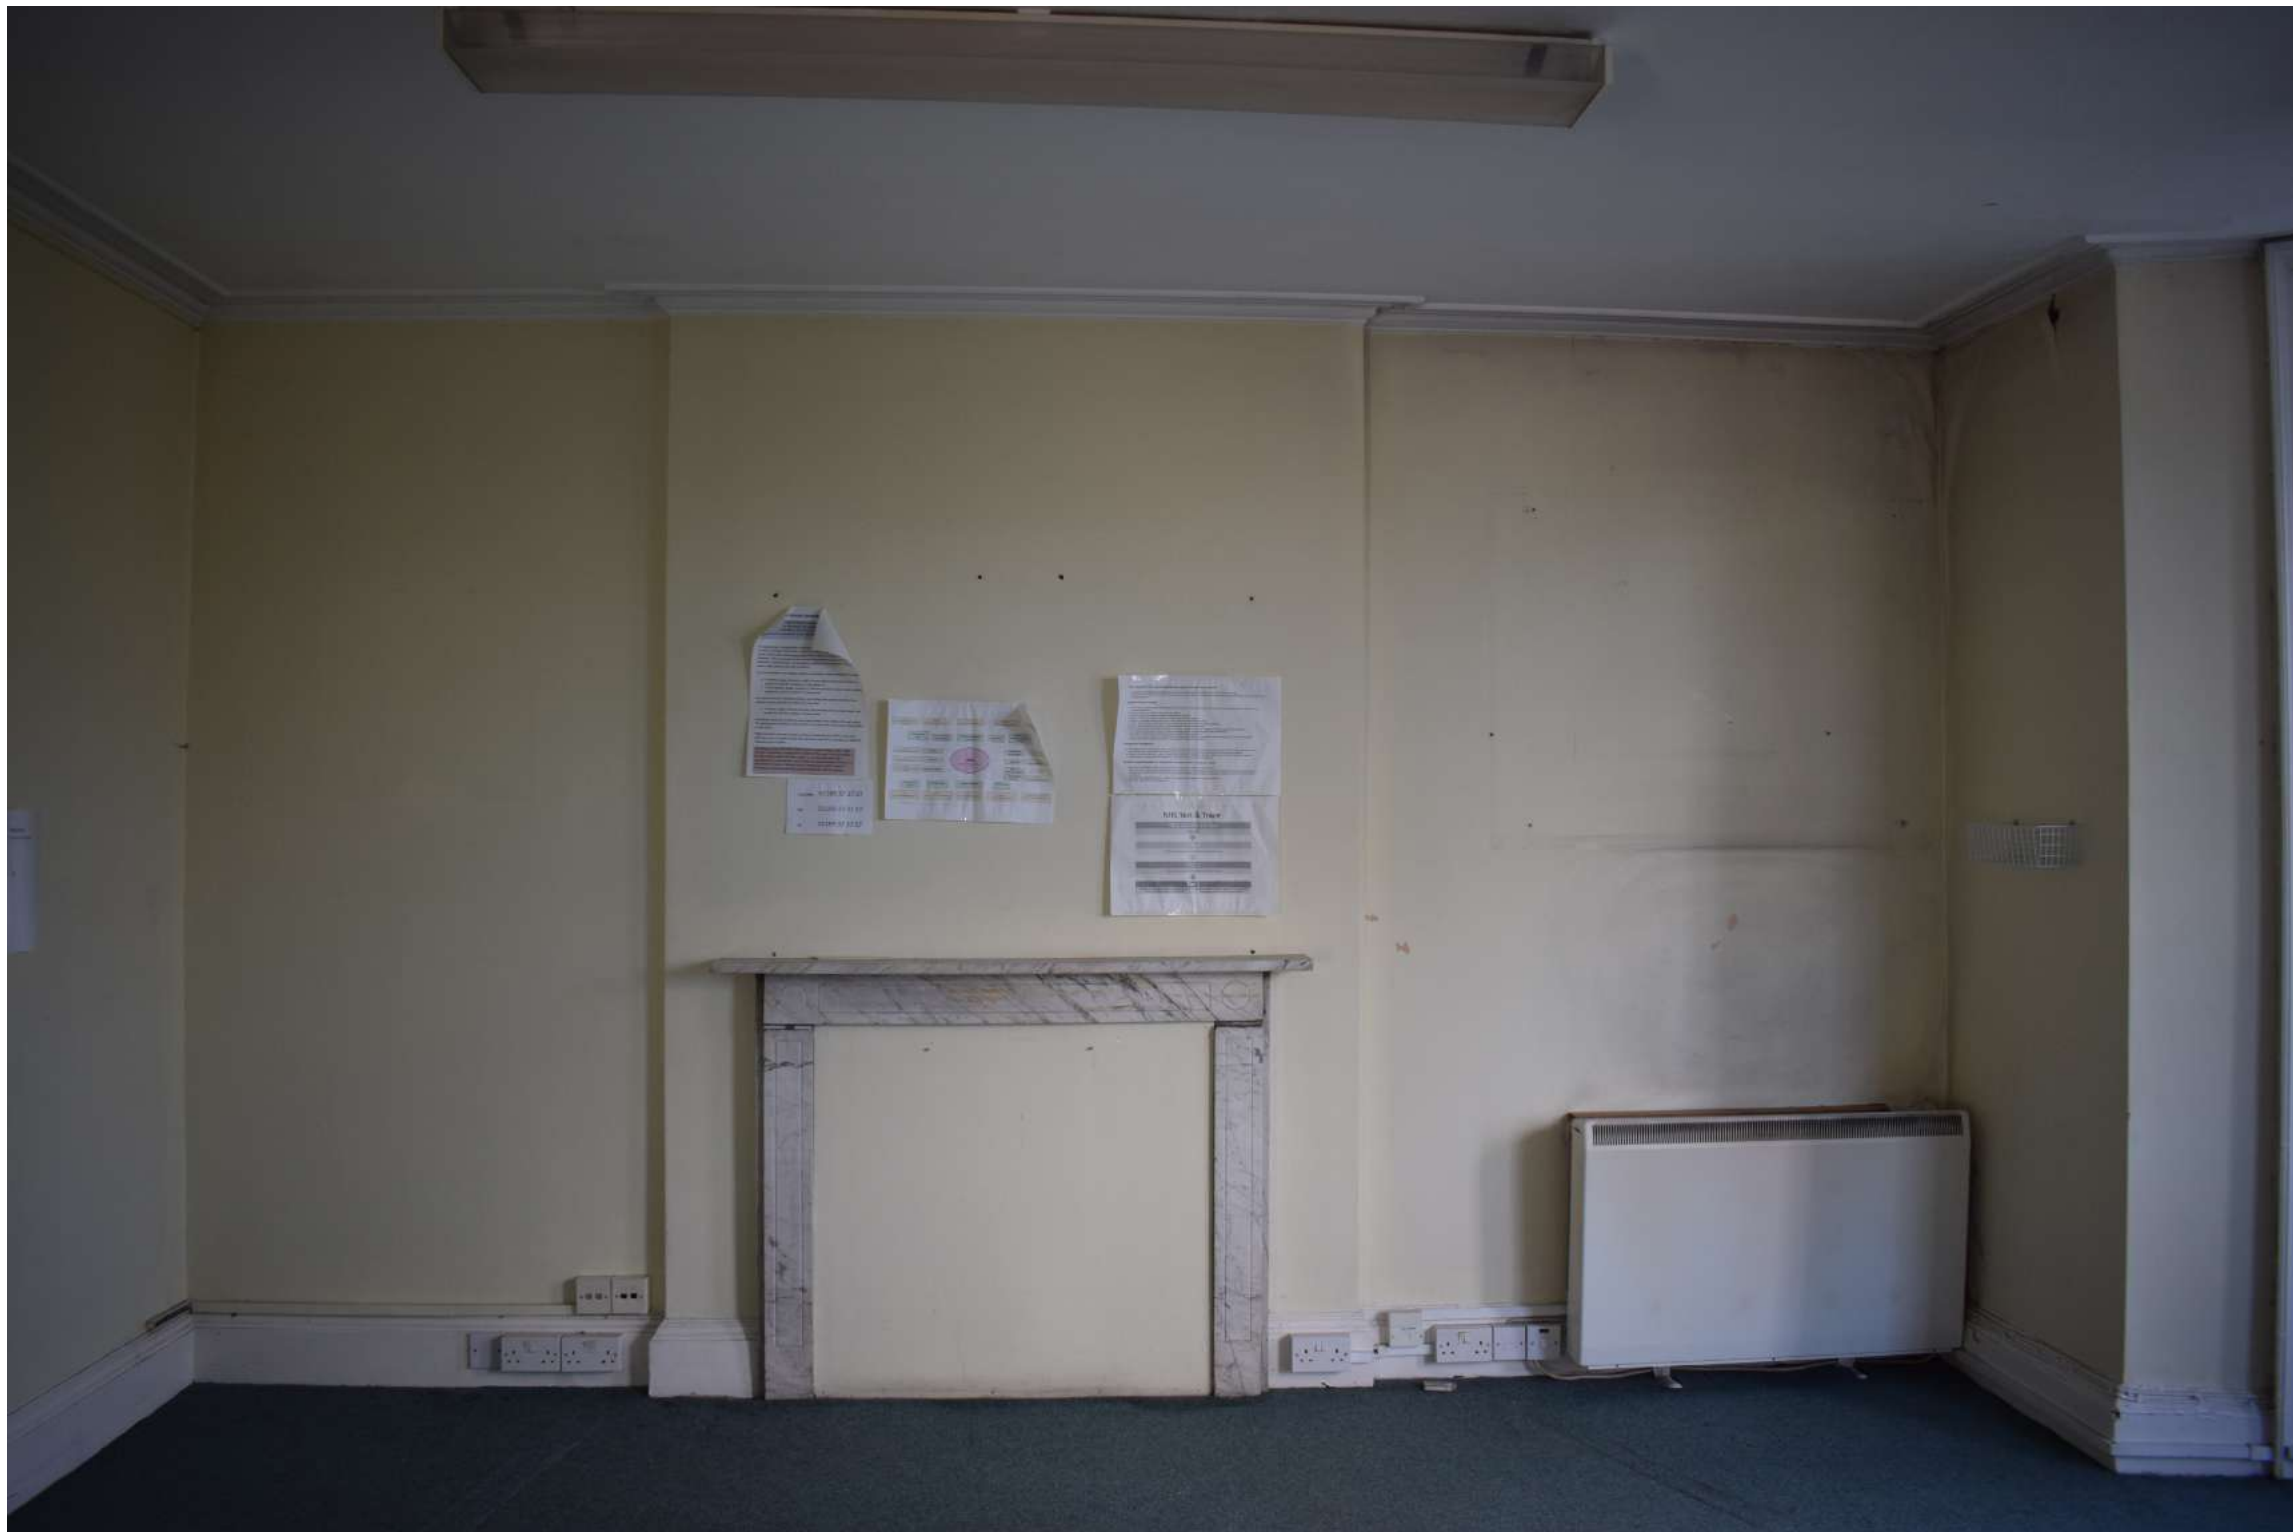
Plate 34

Architectural features noting the non-decorative coving, relatively high skirting, and lack of wall rails in this bow window room.

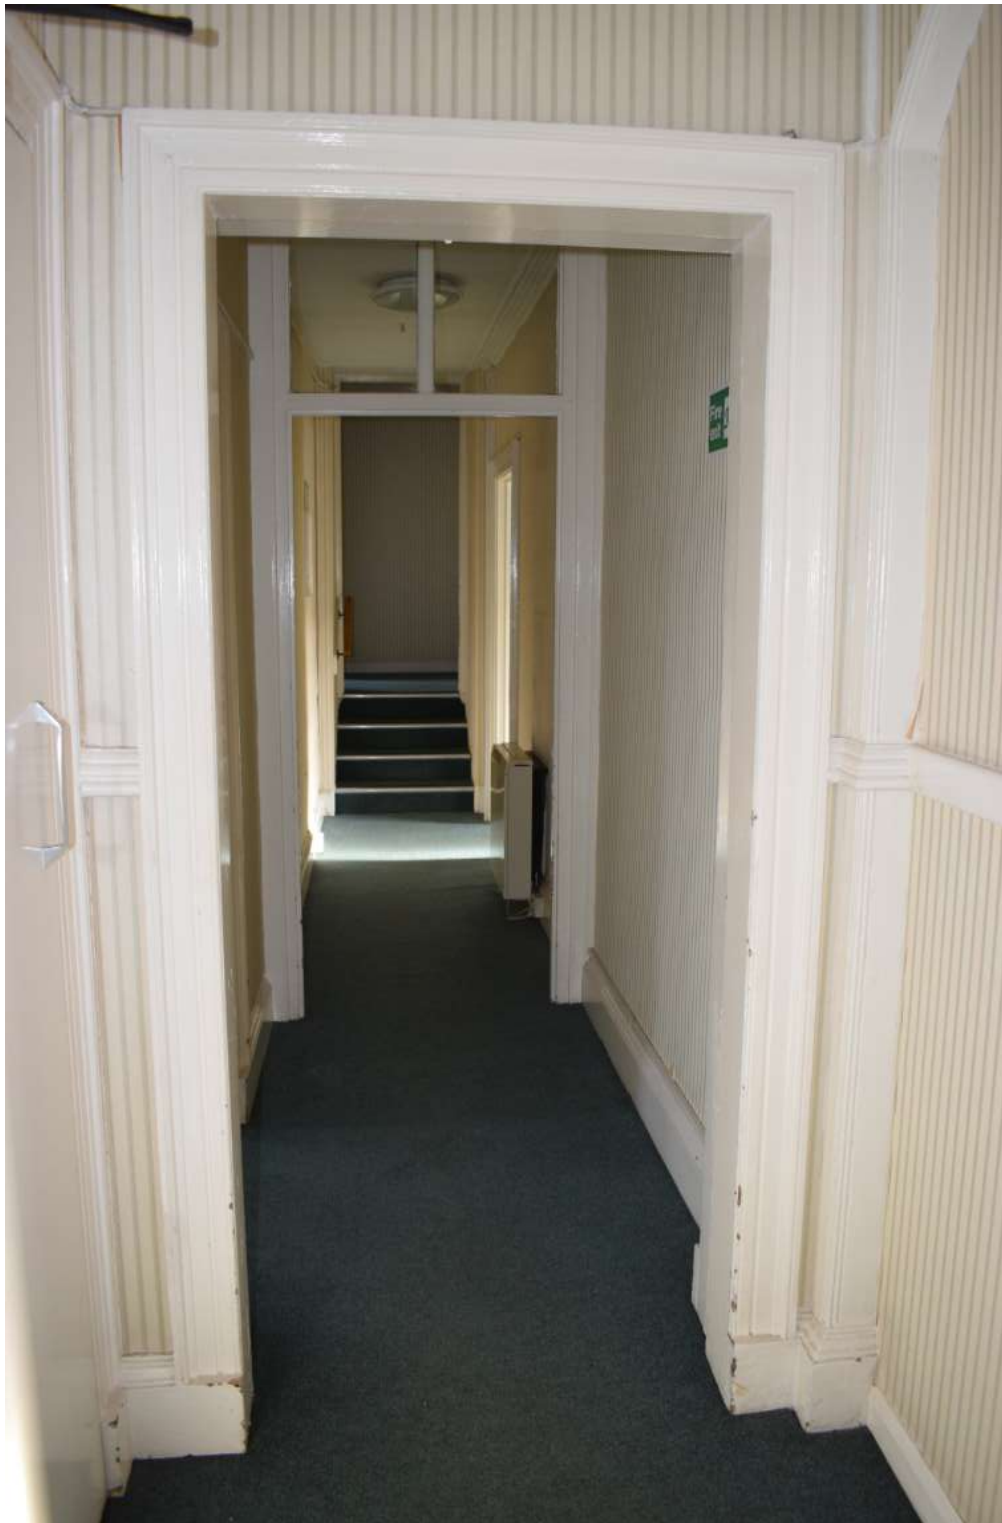
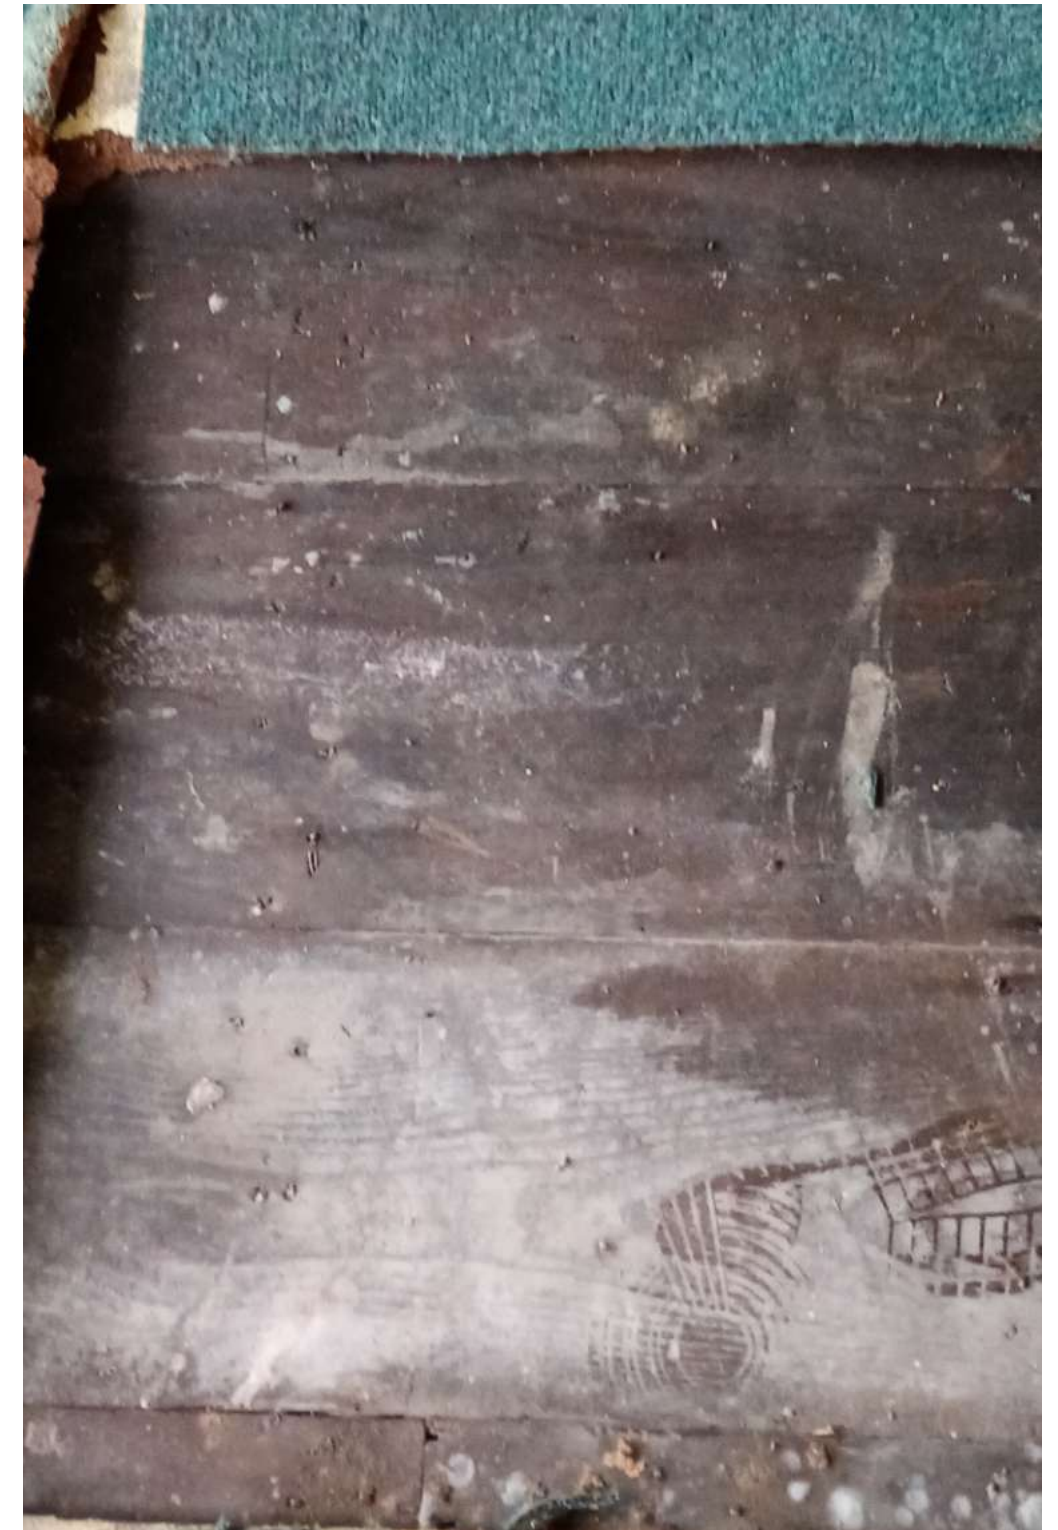
Plate 37

The modern corridor sub-divides the historic bedrooms. Inset: a detail of the timber flooring in Room 13.

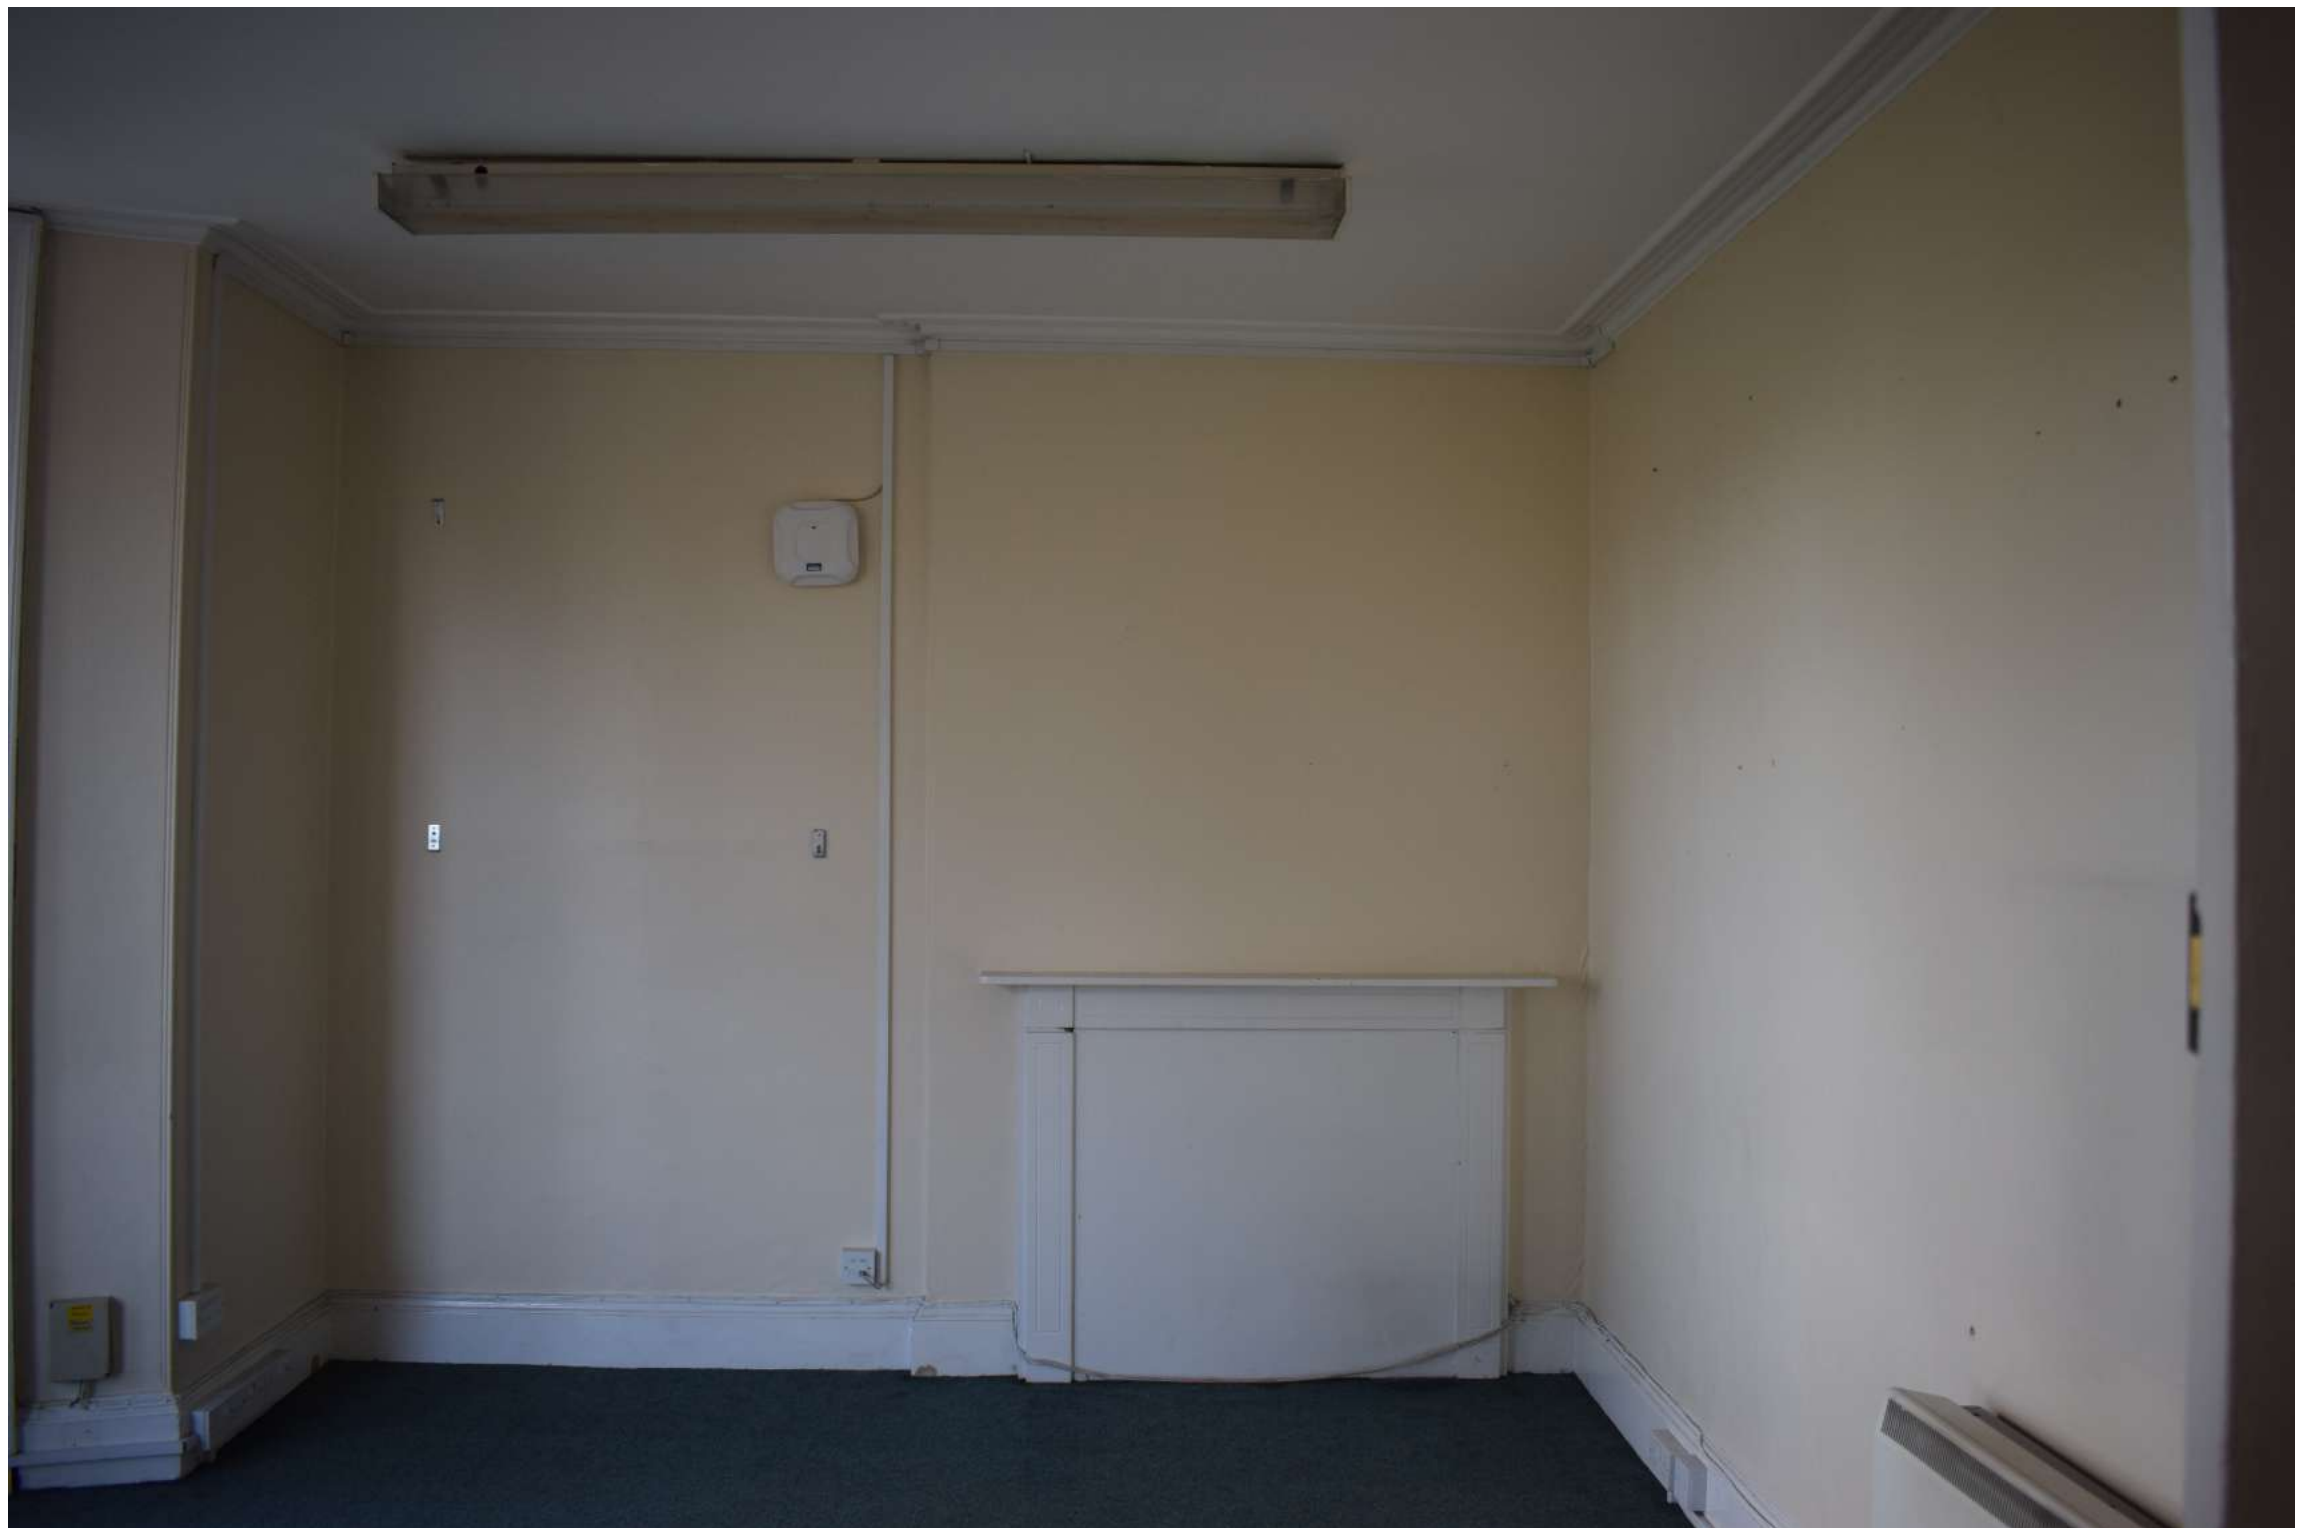
Plate 38

The coving is non-decorative, the skirtings are relatively high, and there are no rails. The fire place surround is modern.

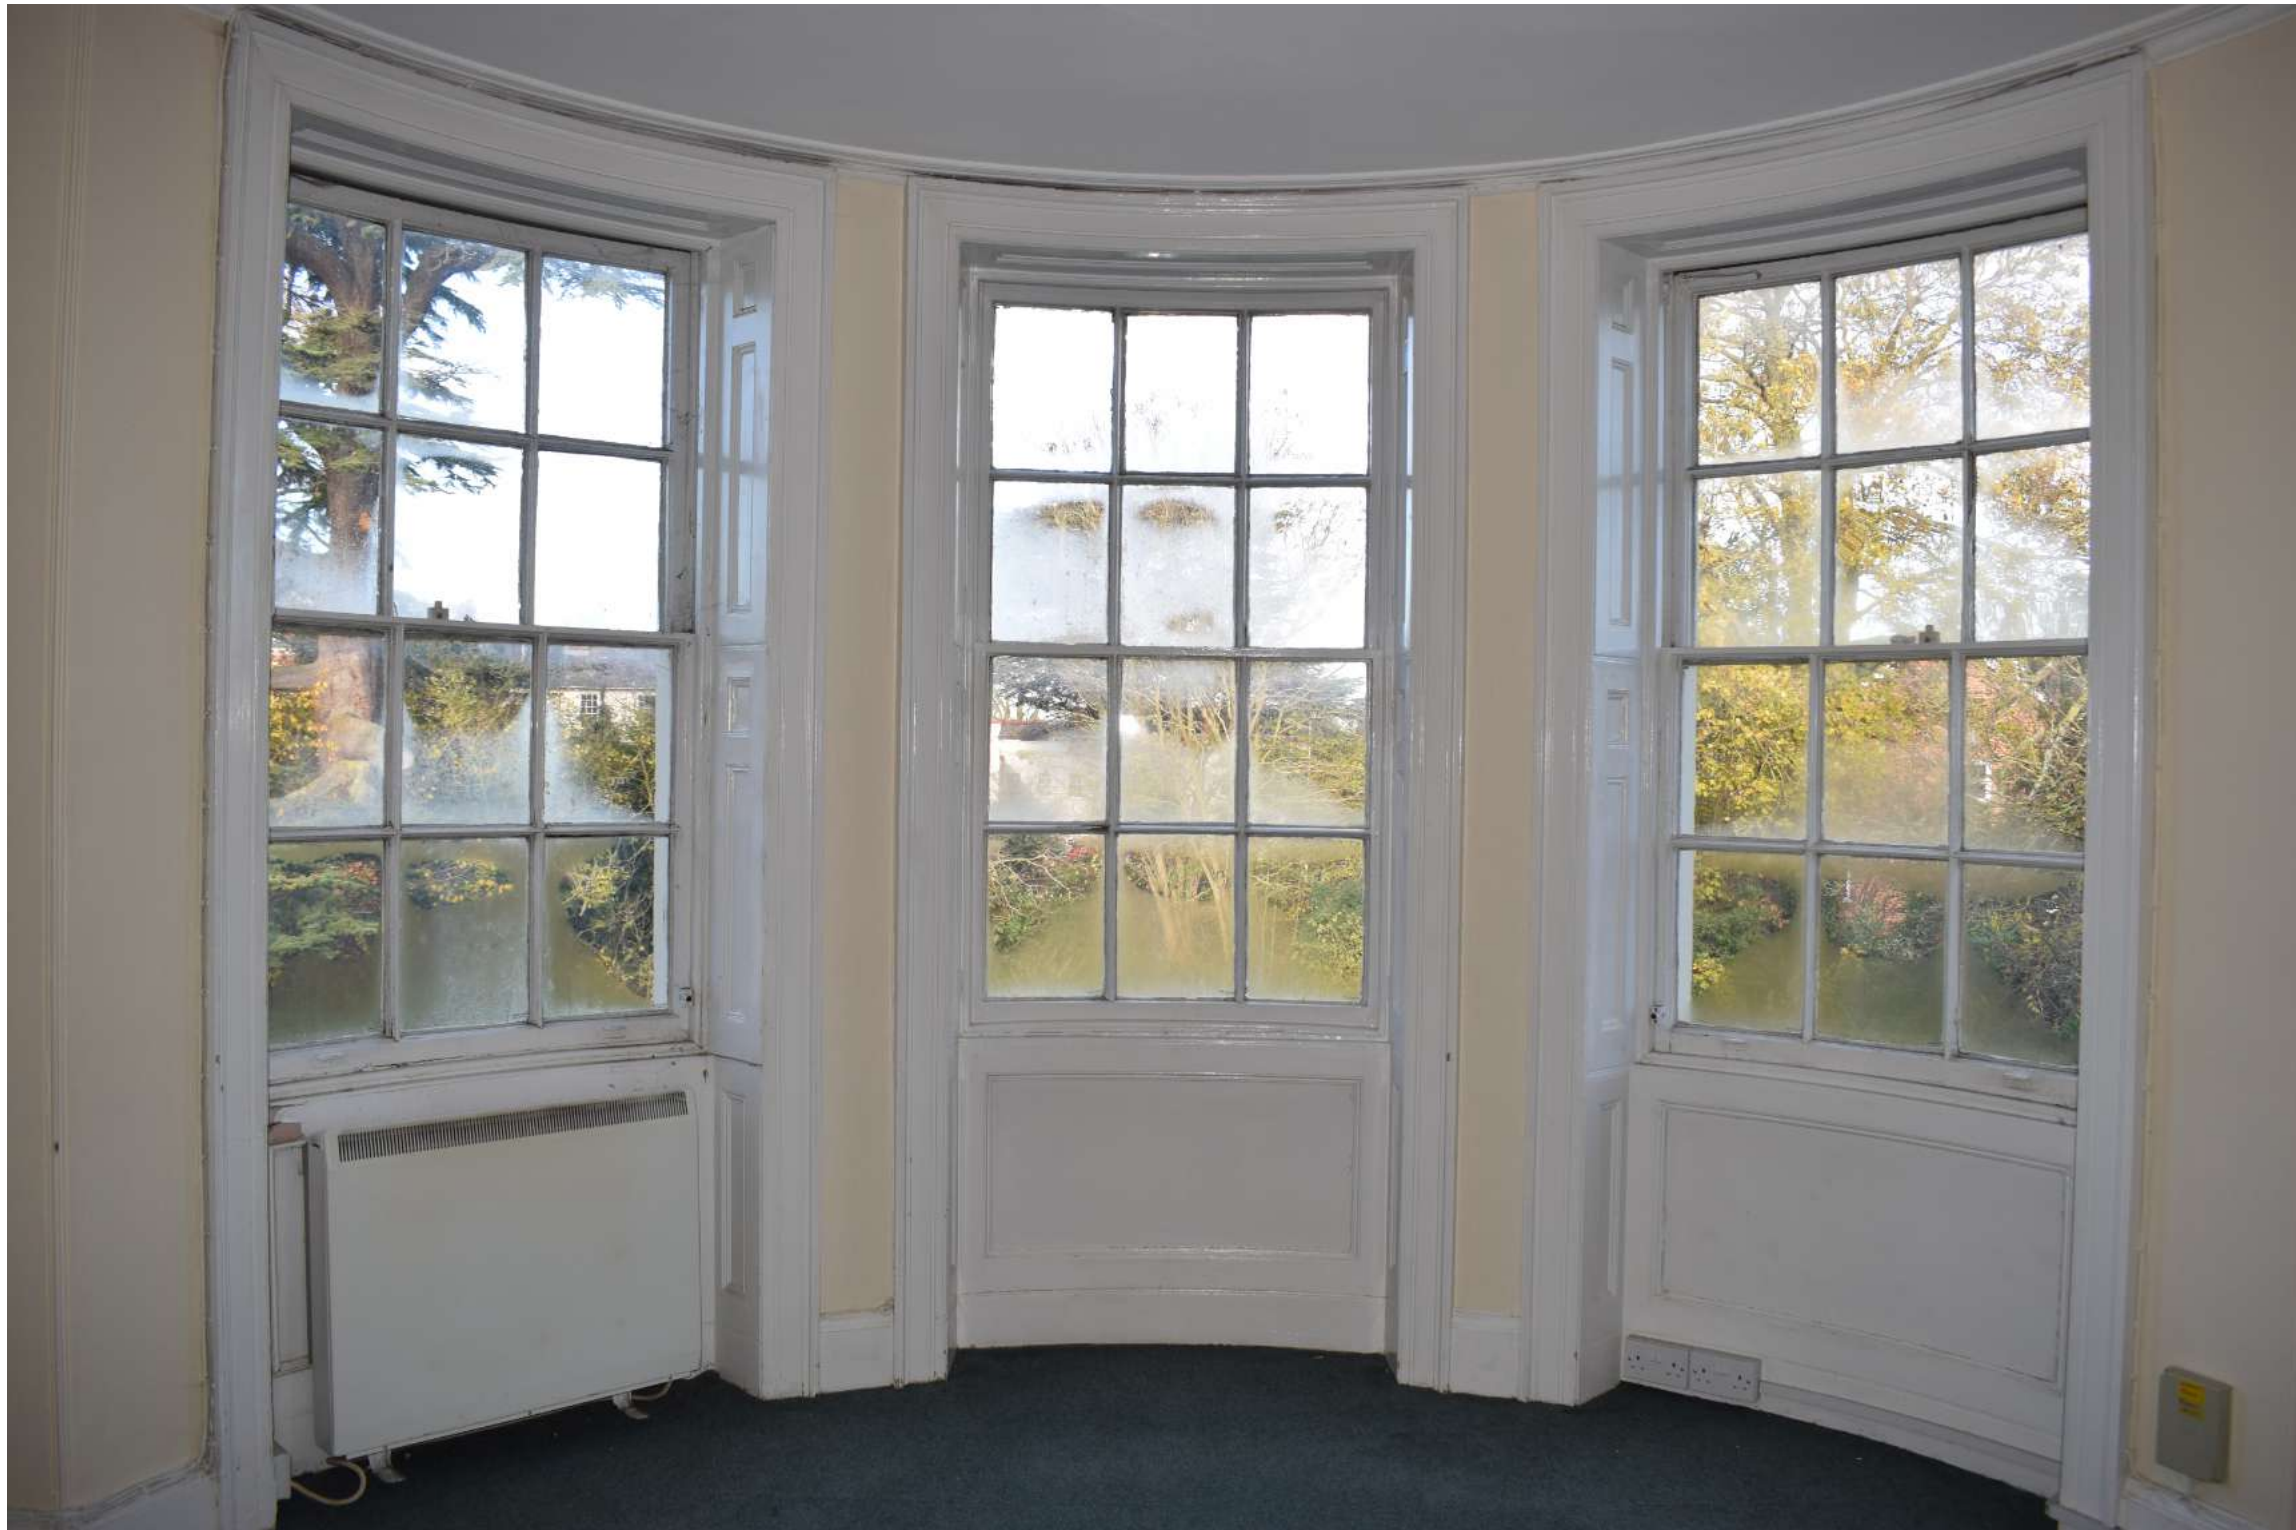
Plate 39

This room is on the west side lit by bow windows, which are over six sashes with tri-folding shutters.

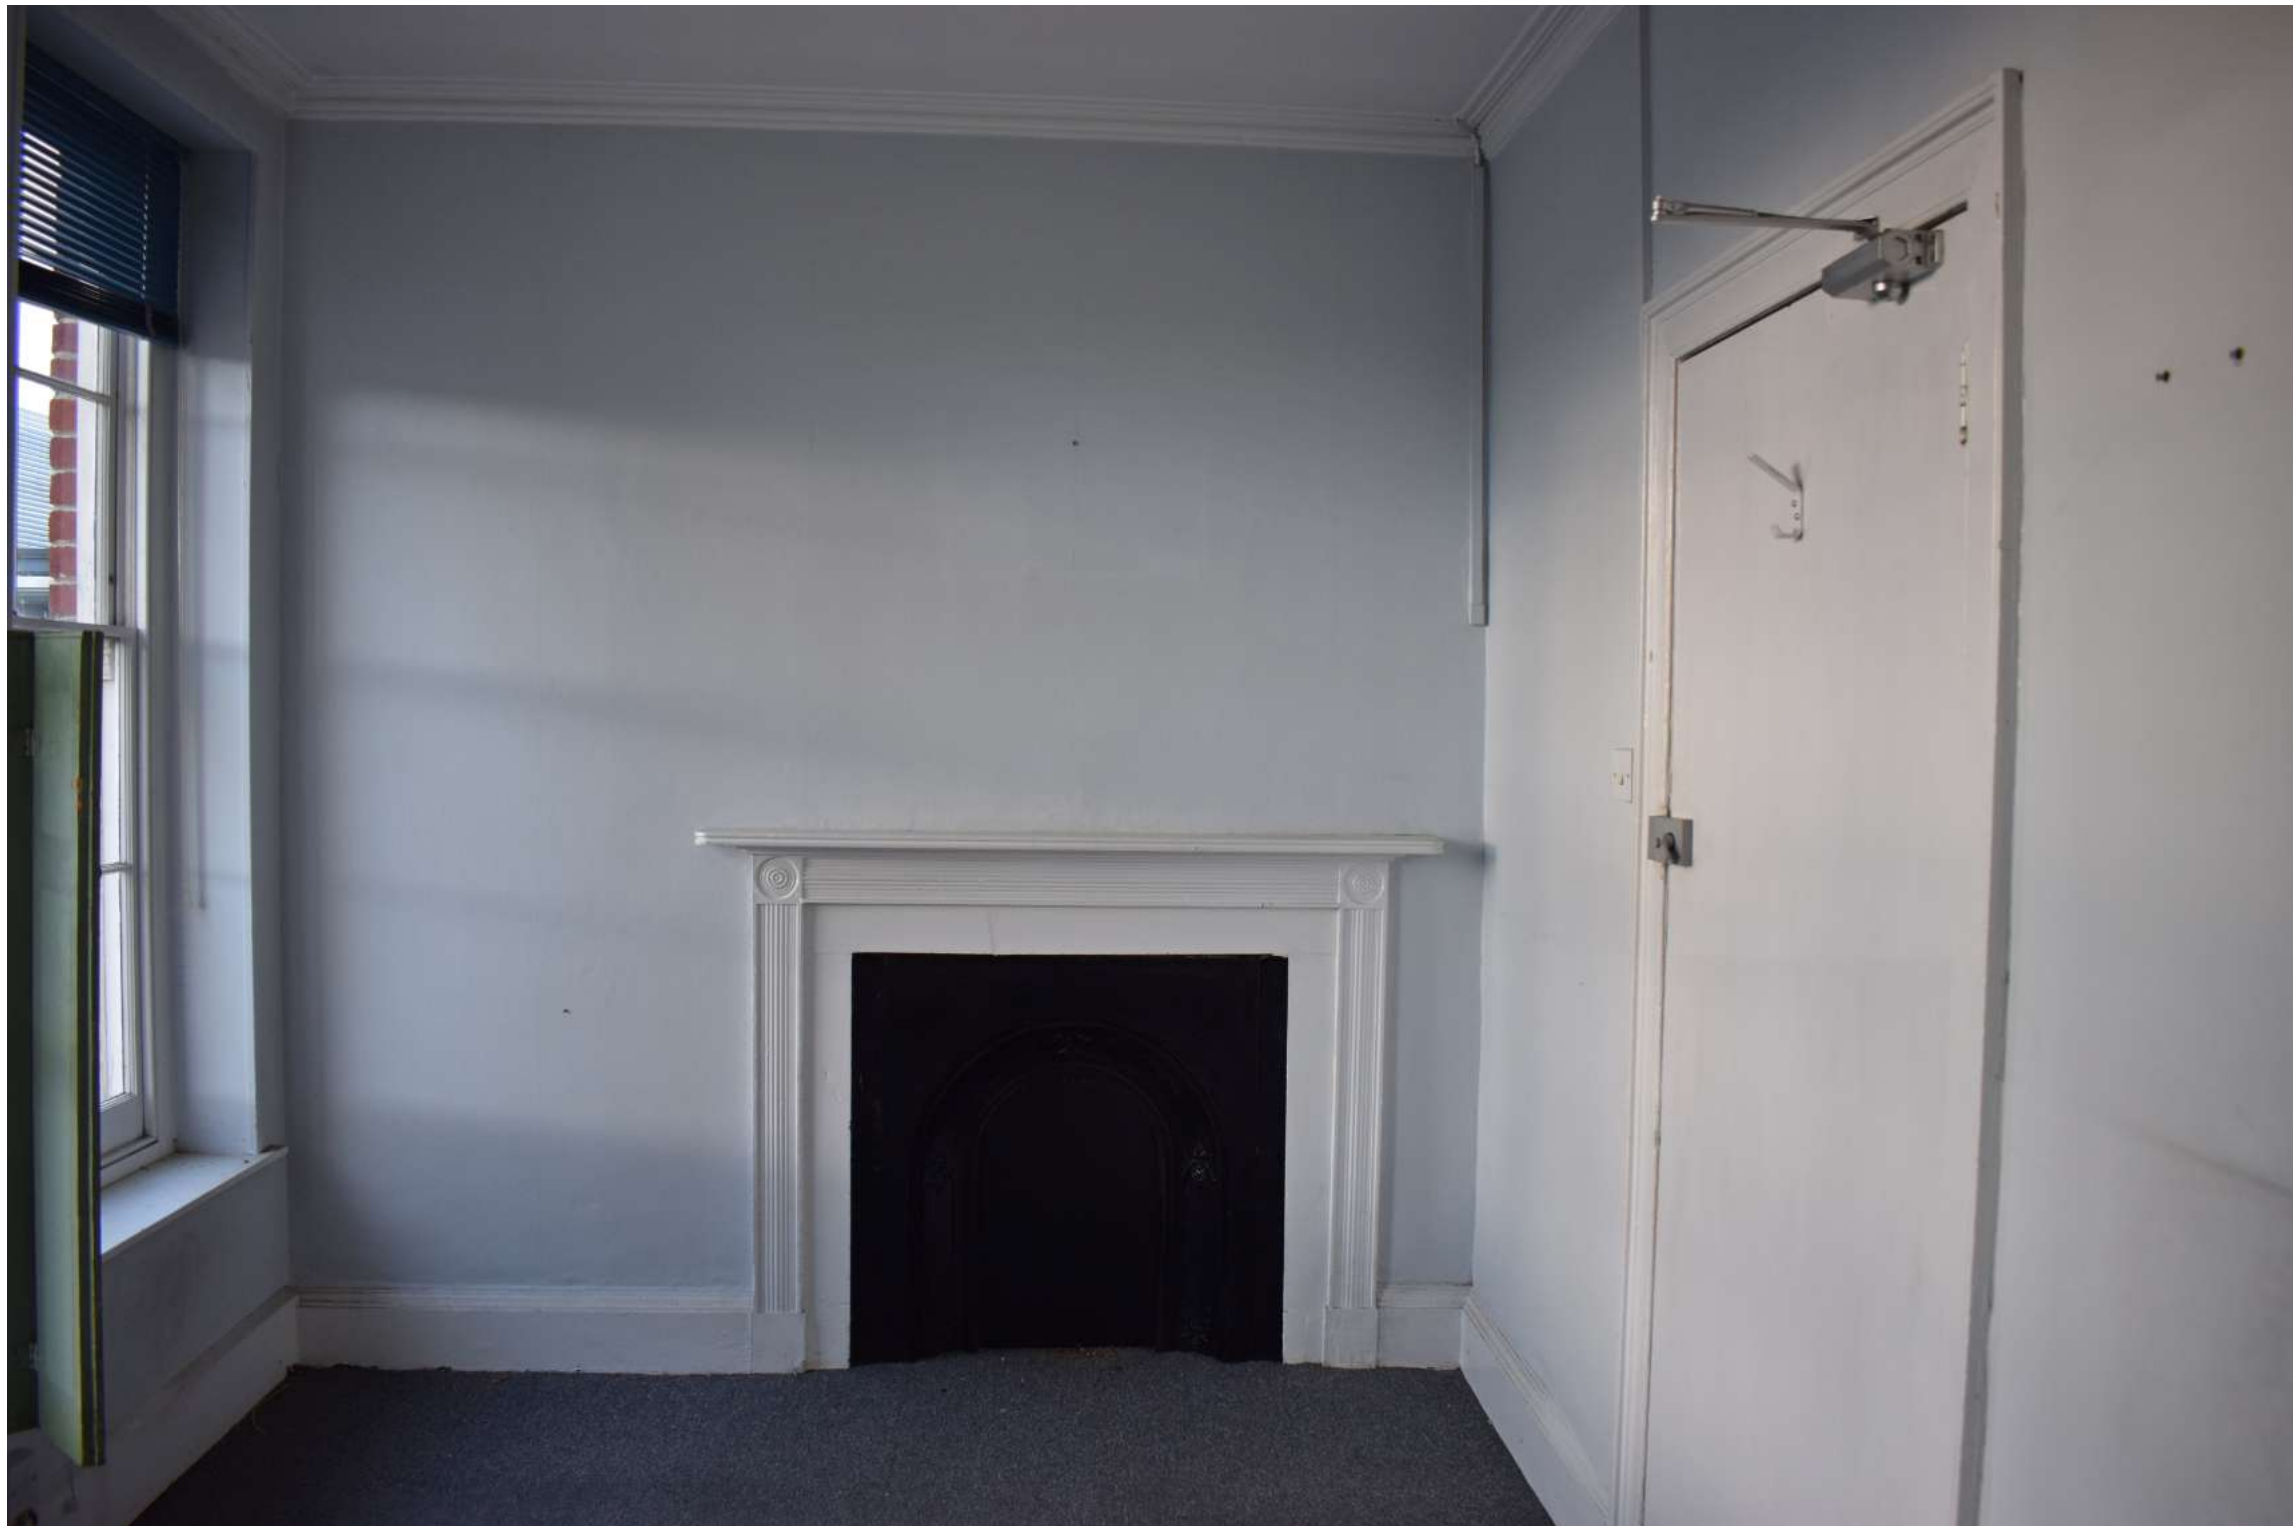
Plate 41

Rear room with non-decorative coving, and low-profile skirting,

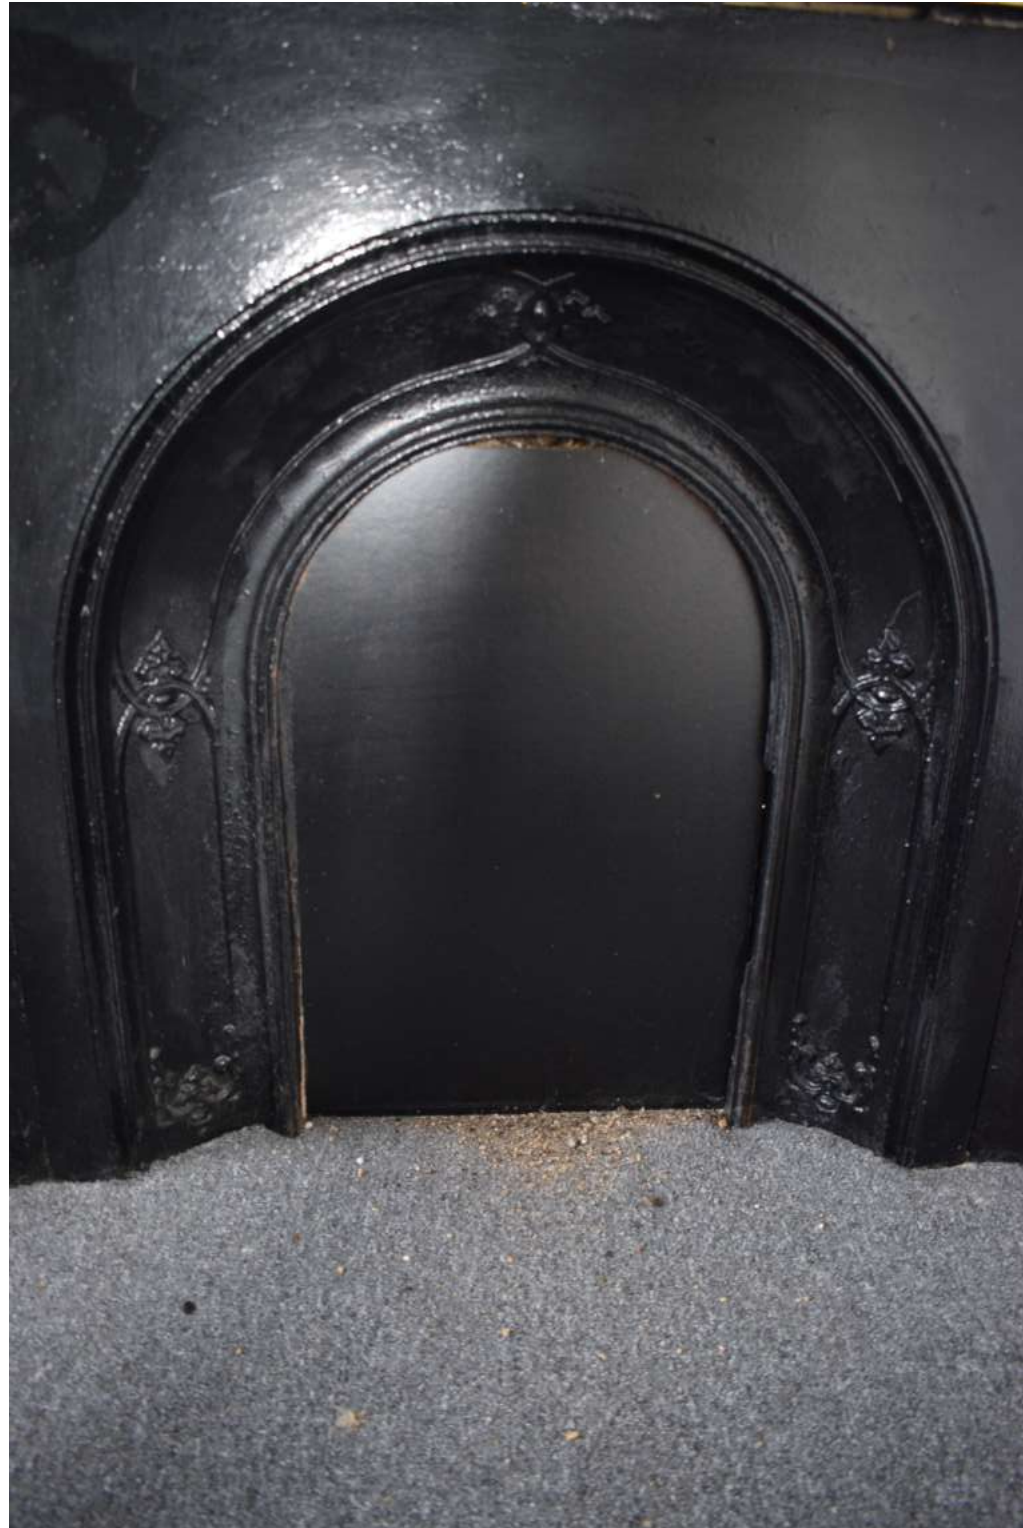
Plate 42

Detailed image of an iron fire place surround. Inset: a detail of the timber flooring.
