Archway Heritage

# Appendix 11

## Yeomanry House

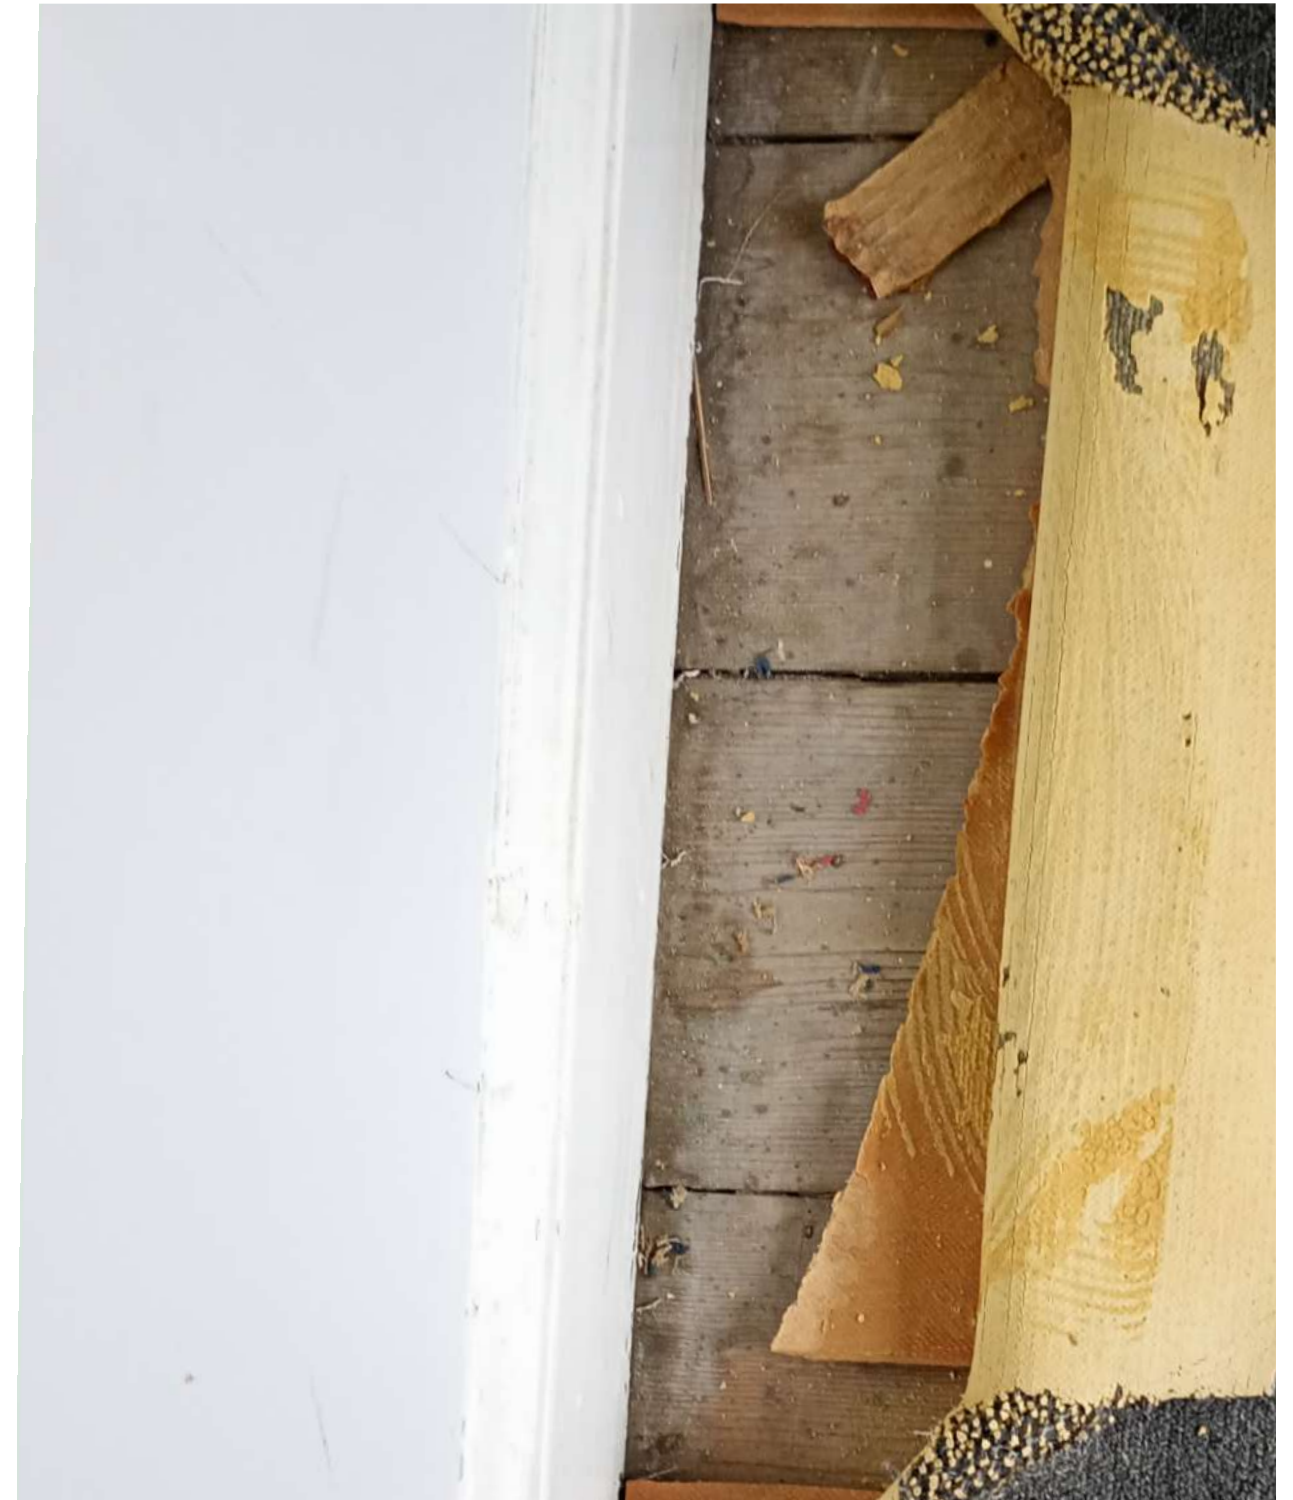
Plate 42

Detailed image of an iron fire place surround. Inset: a detail of the timber flooring.

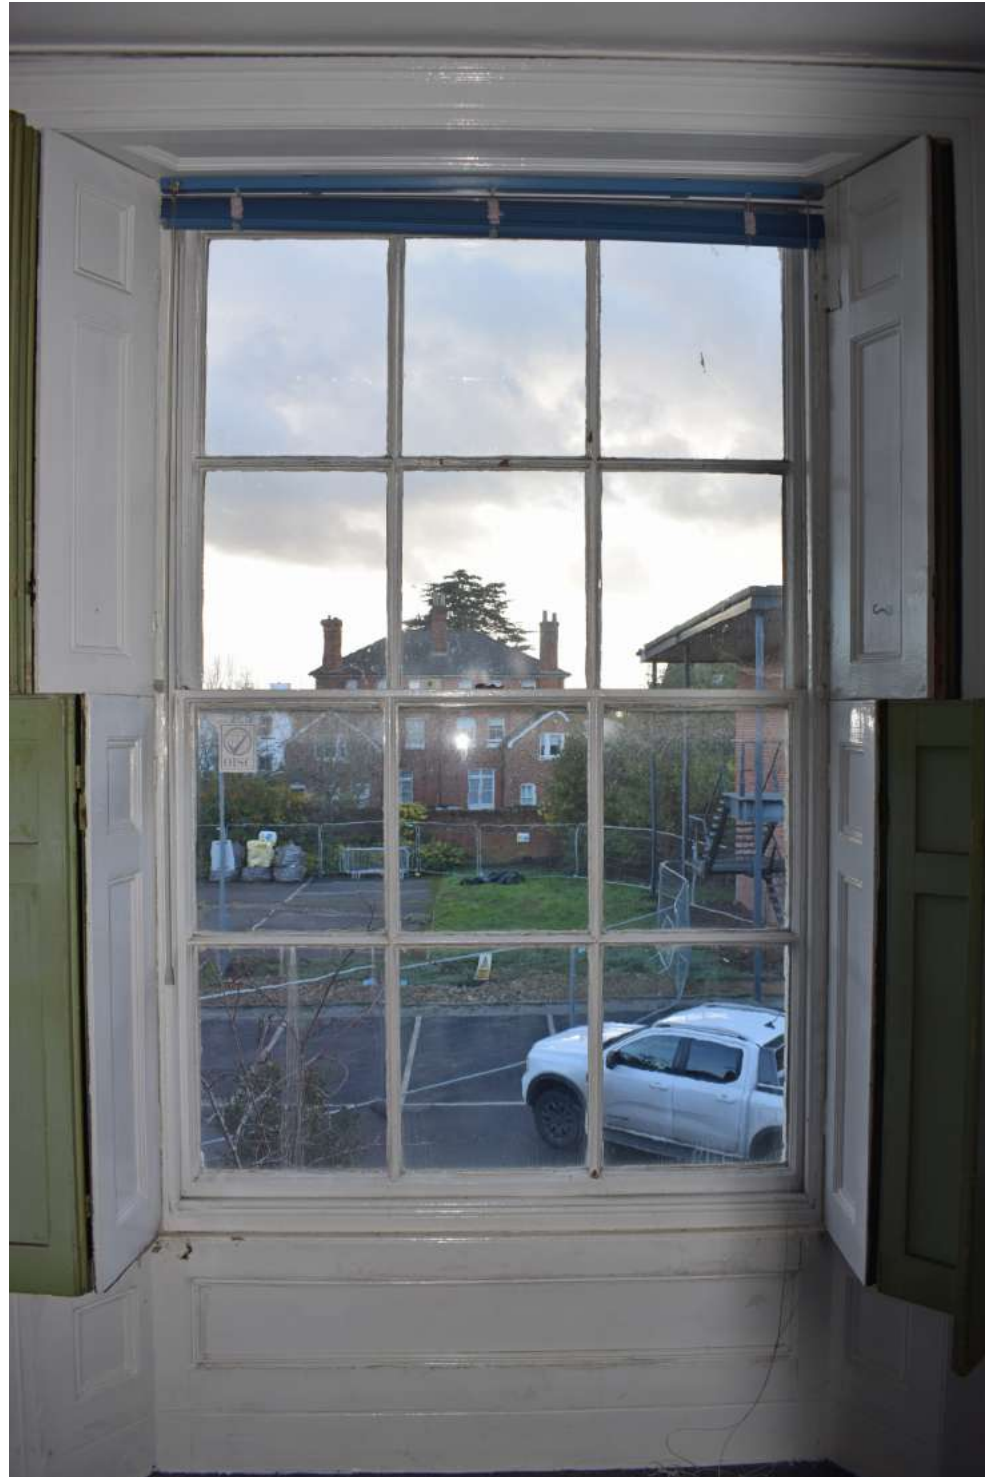
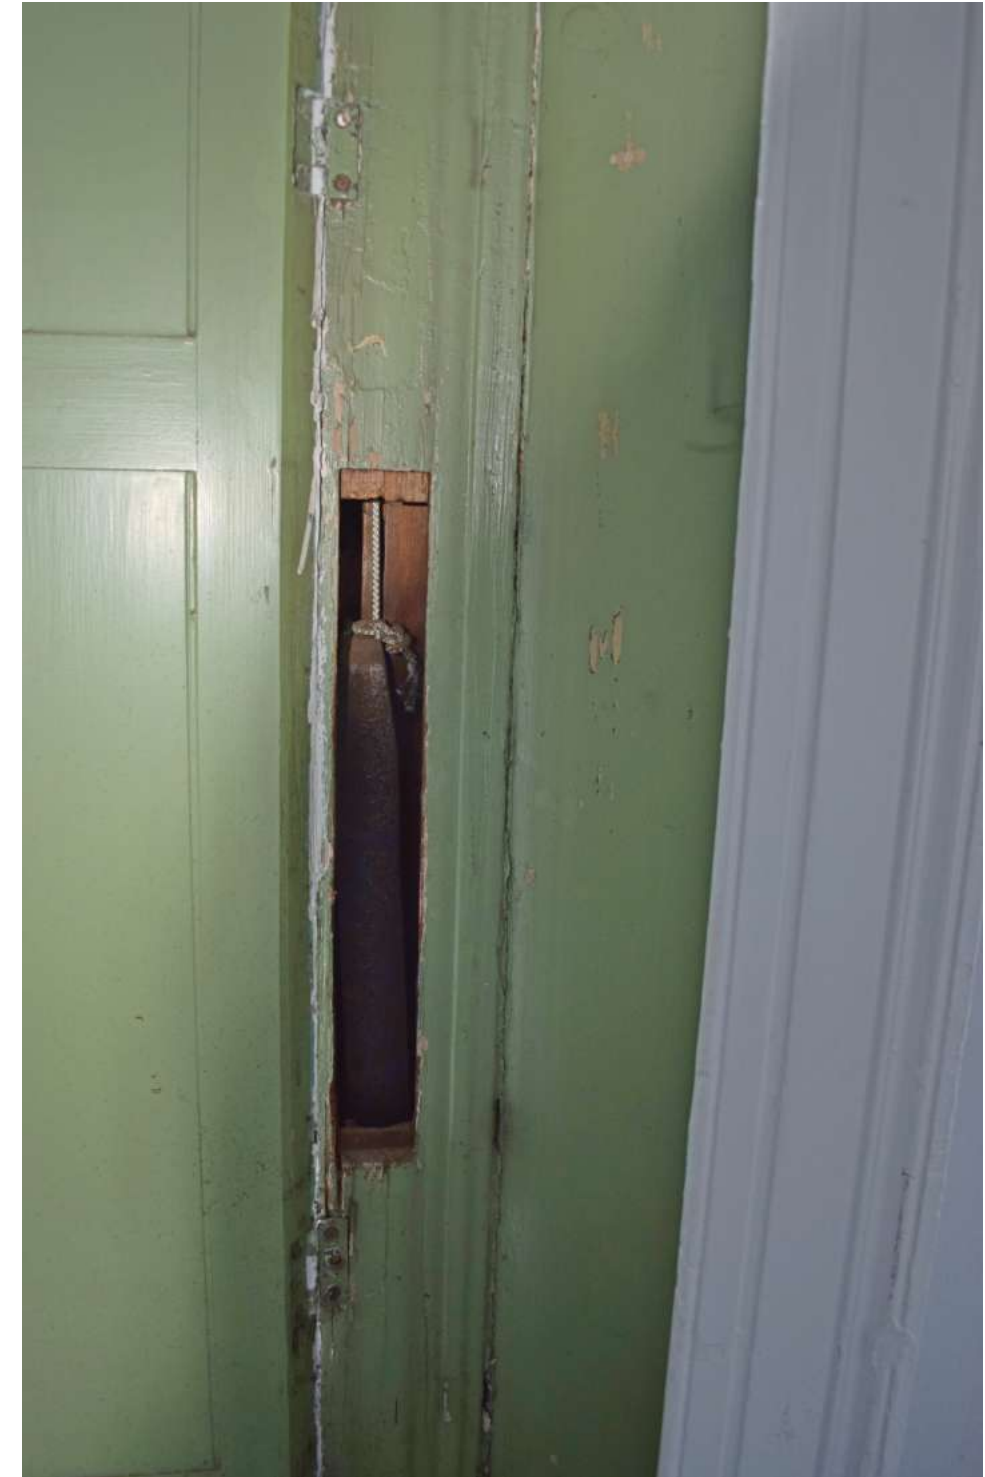
Plate 43

Images showing details of the tri-folding shutters and the weighting system installed, accessible for maintenance.

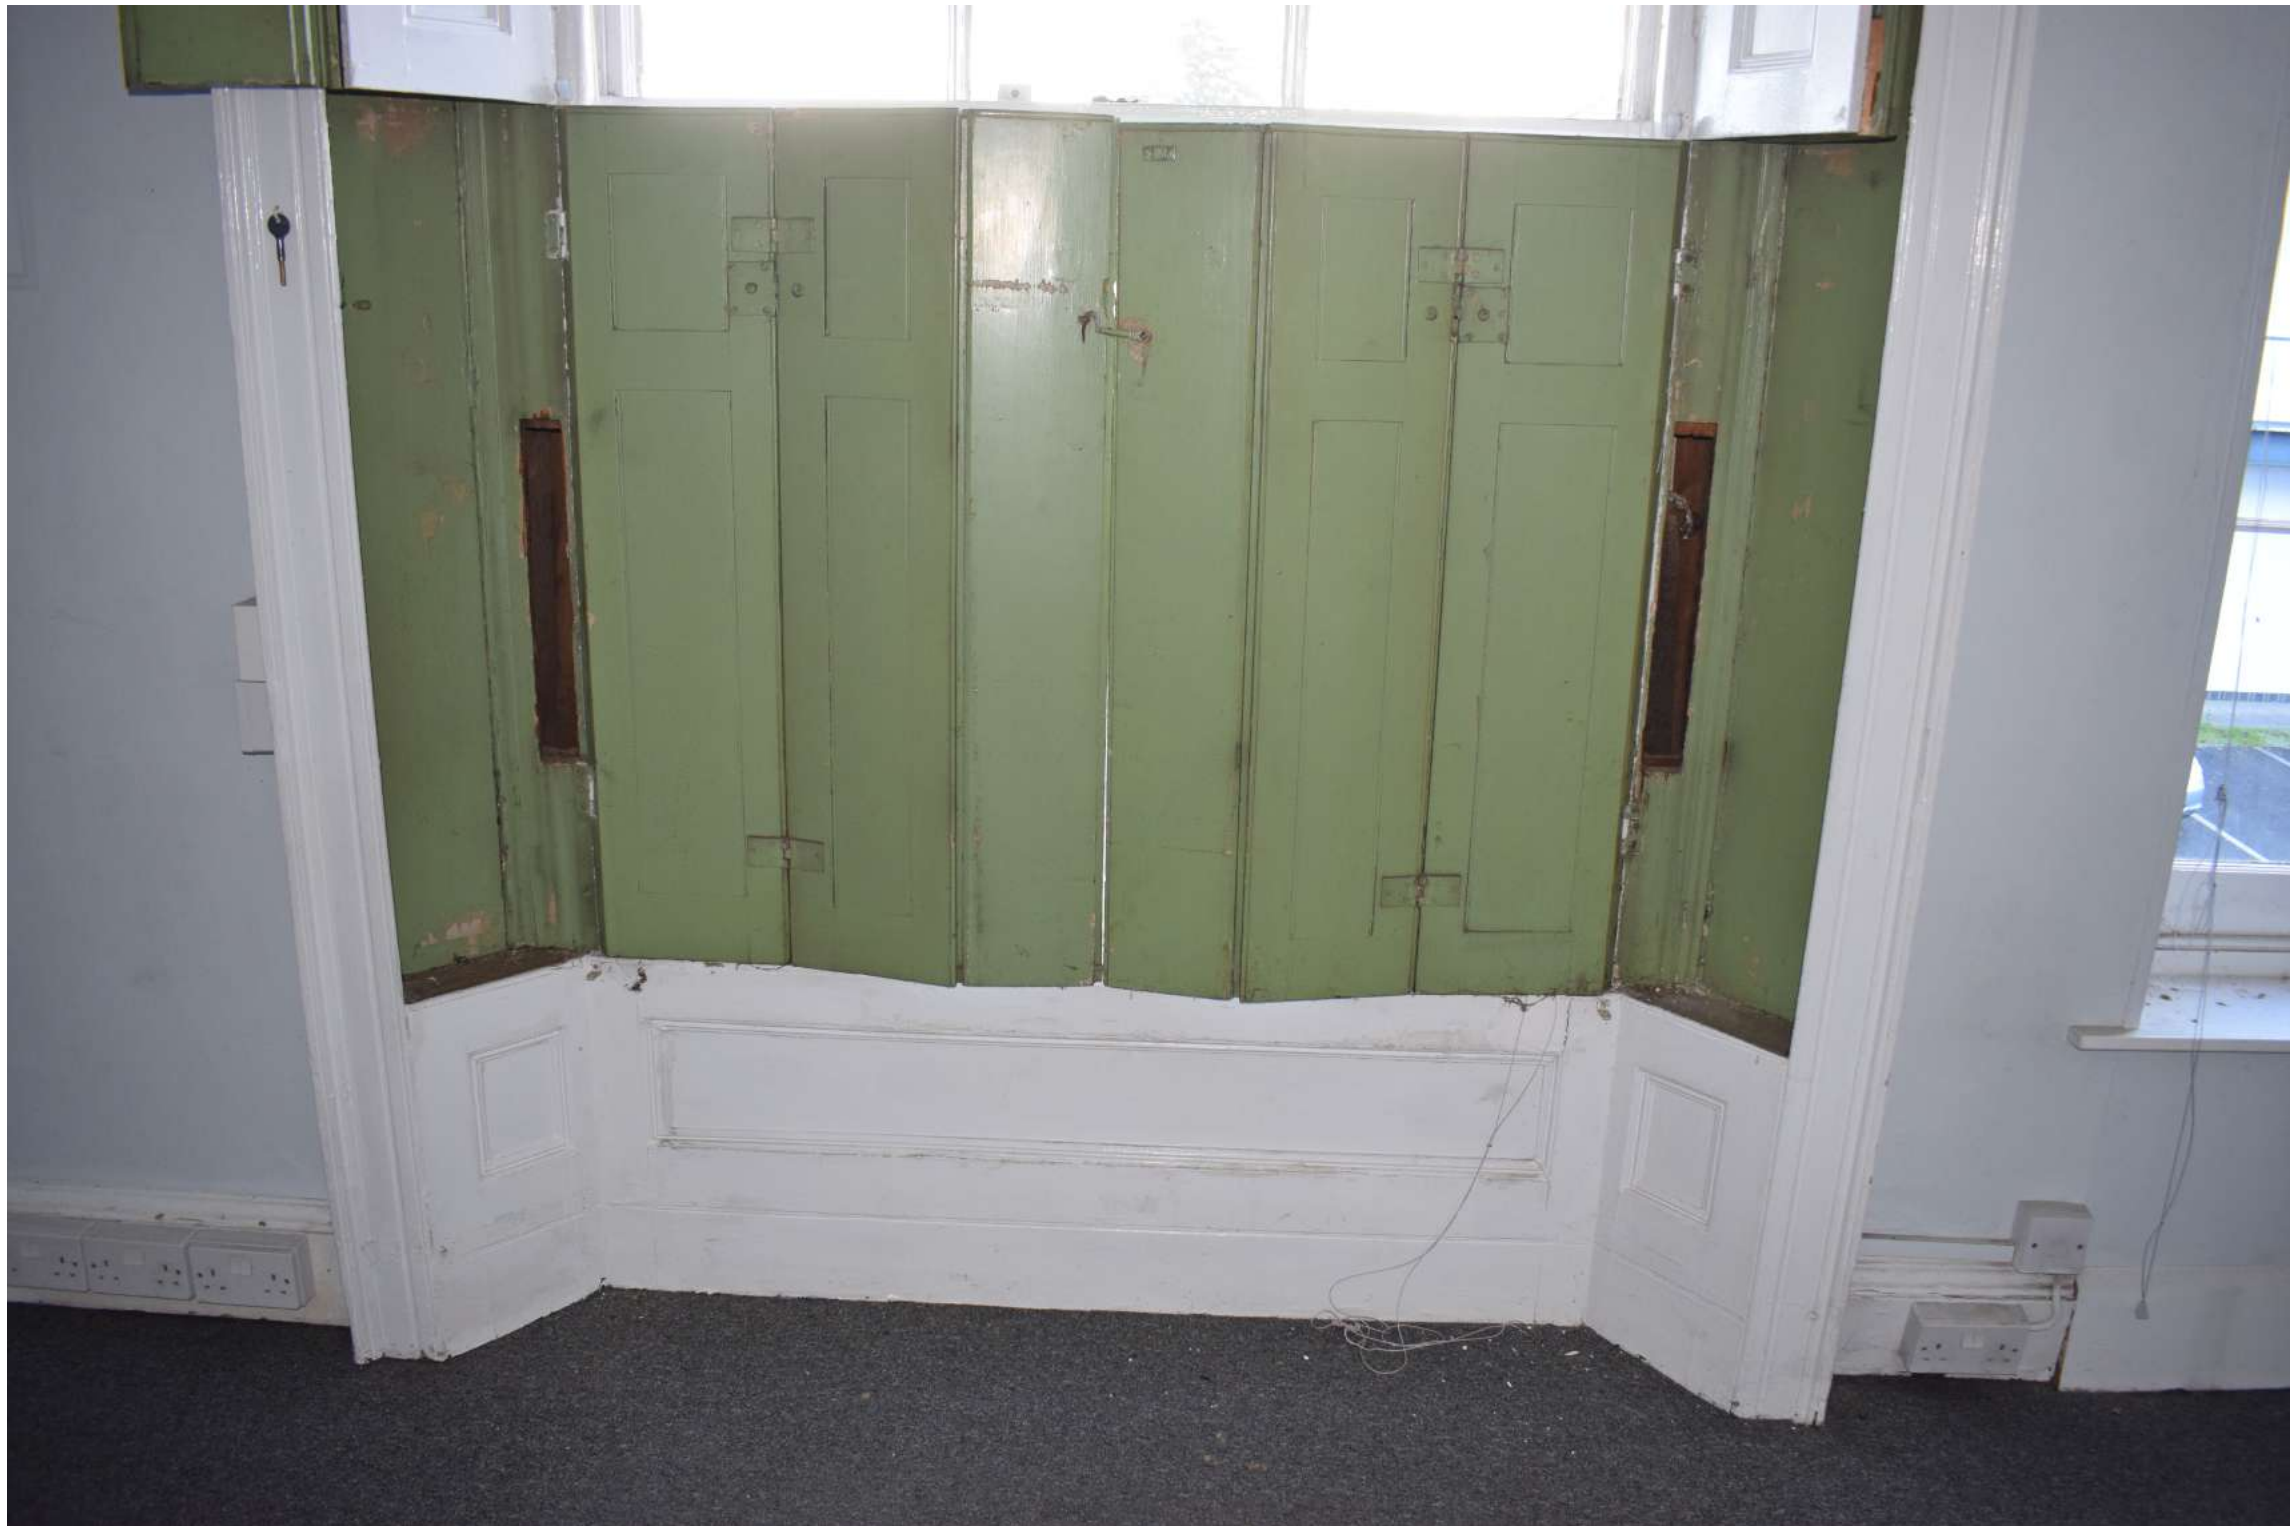
Plate 44

Image of the lower half of the tri-folding shutters.

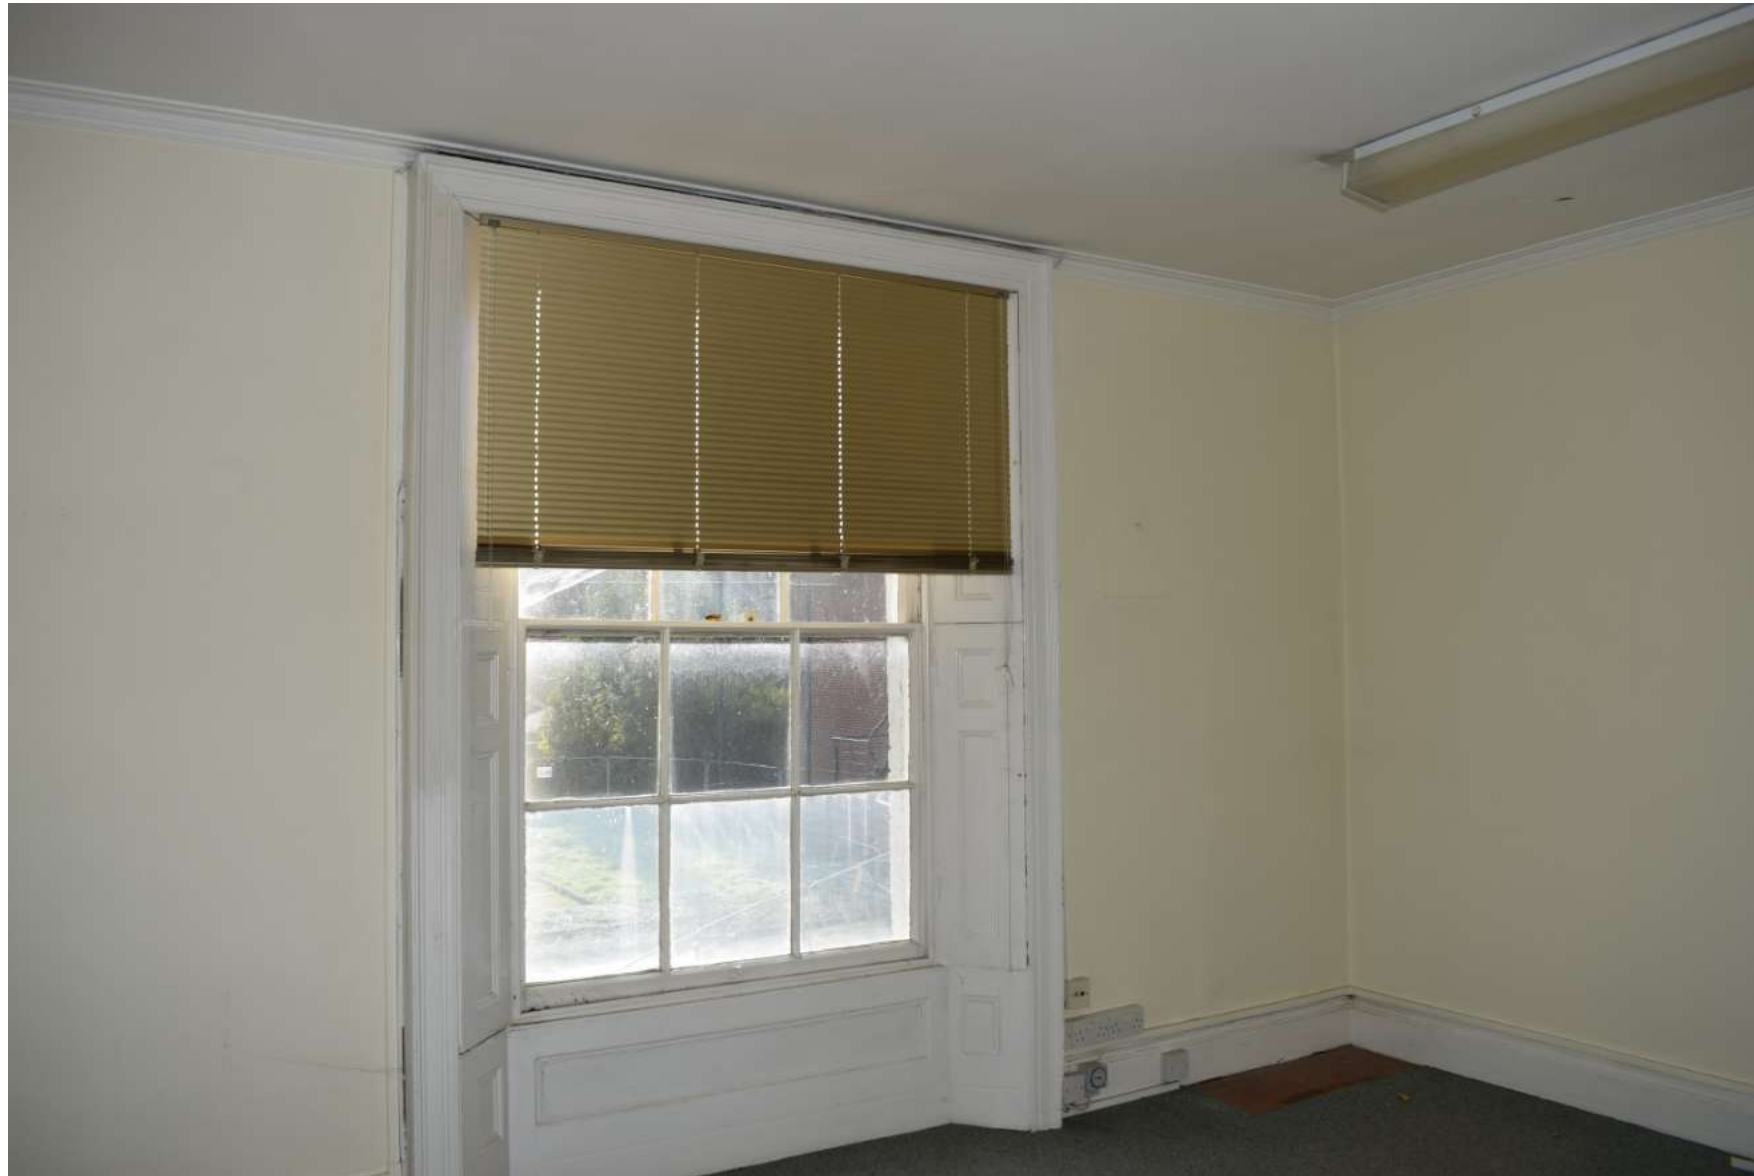
Plate 46

The rear-facing window lighting this room is a much larger, wider single window with different proportions.

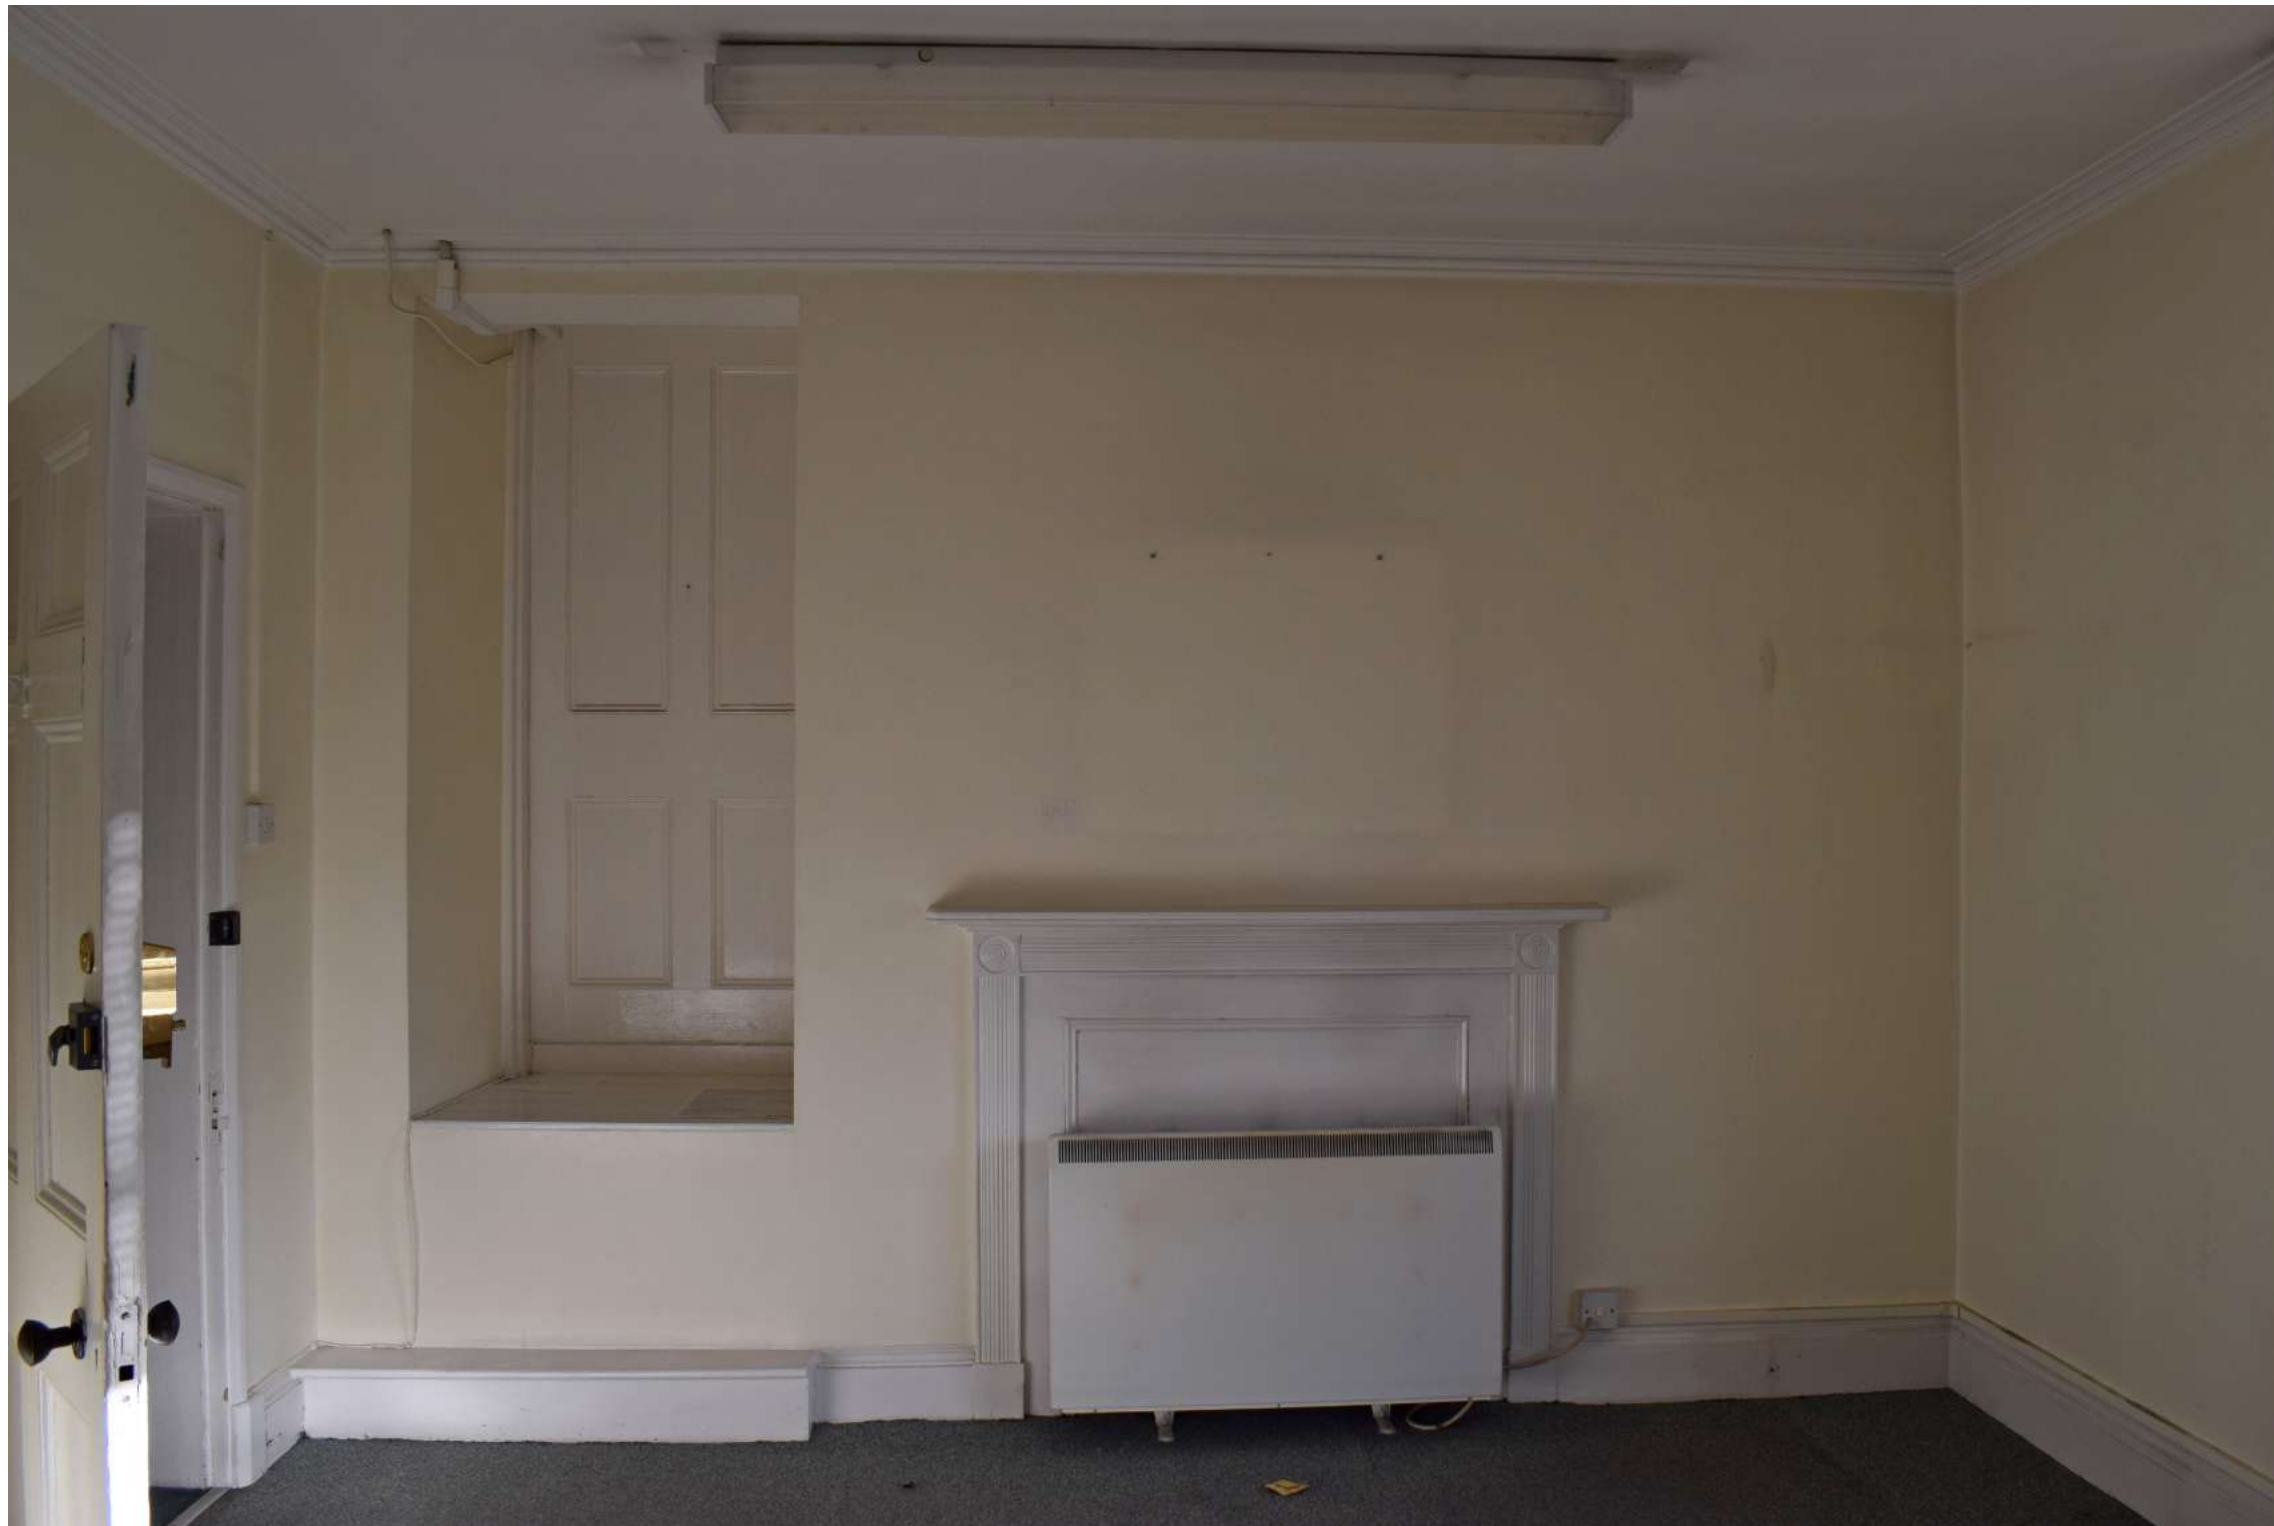
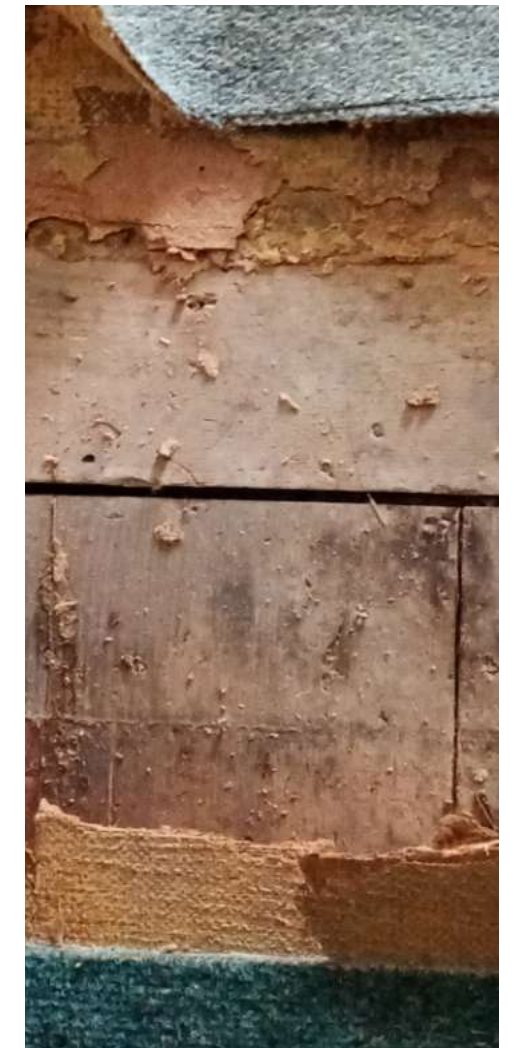
Plate 47

The room overlooking the rear (Office C) has a fireplace and a doorway to give access to the adjacent wing. This connects to the Phase 3 extension that is on a higher level and indicates this space was once a cupboard. Inset: a detail of the timber flooring.

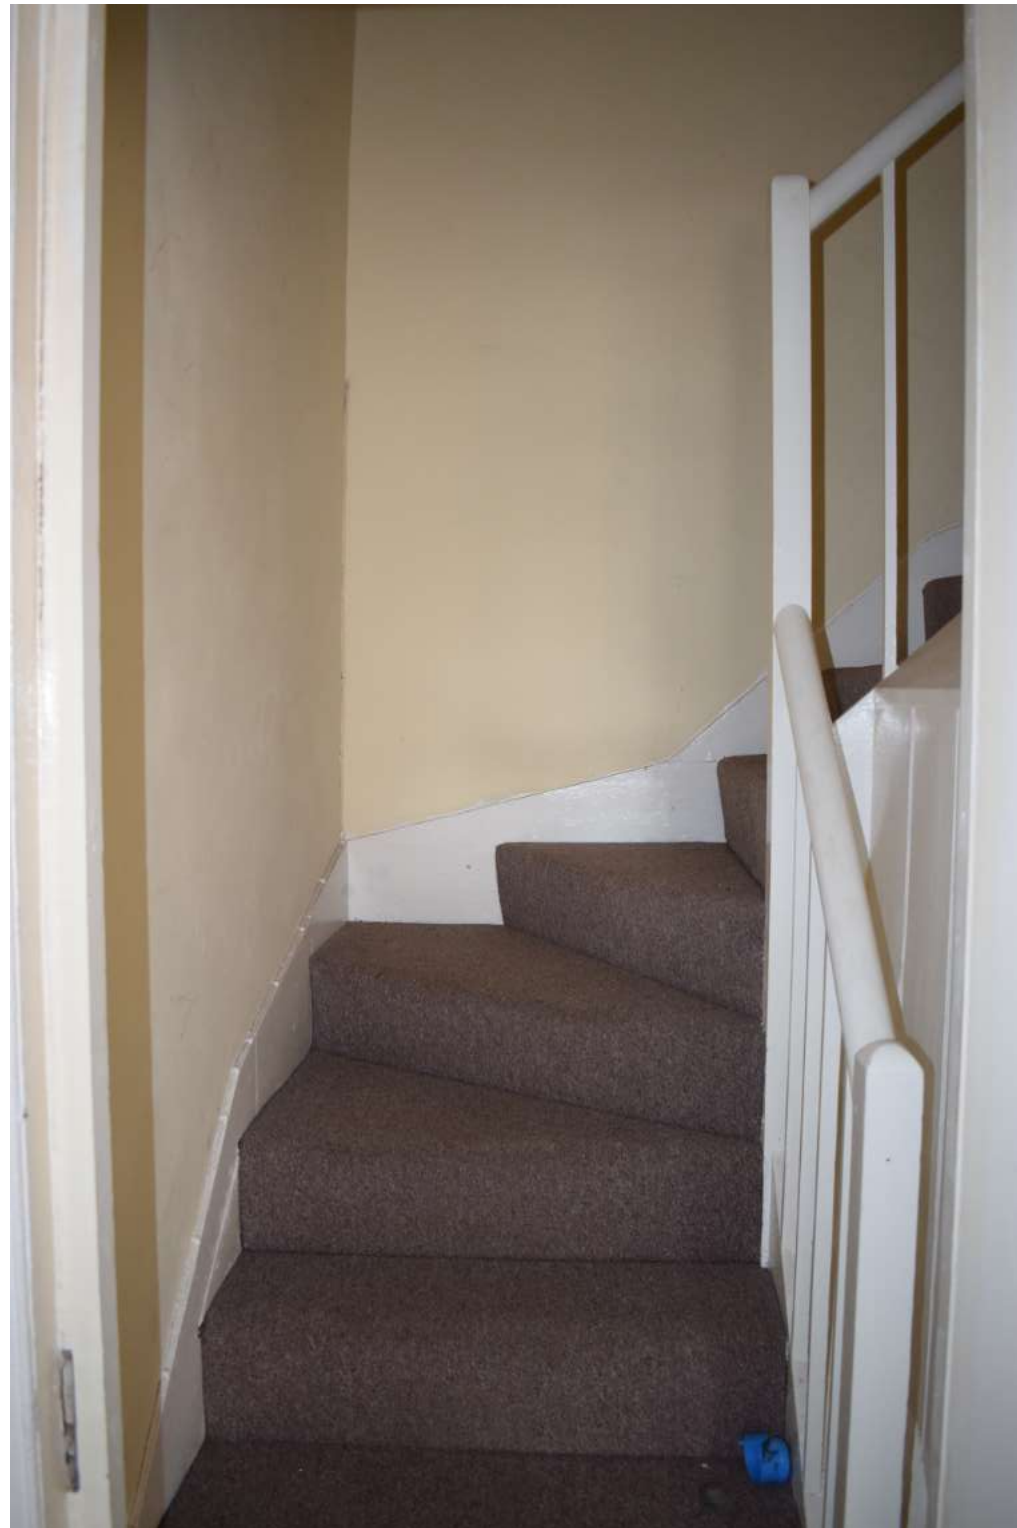
Plate 48

The servant stair to the second floor of the 1810 phase has a high, non-decorated skirting. The servant stair lacks dado, coving, or decorative features, consistent with a secondary stair used by servants to reach the attic floor.

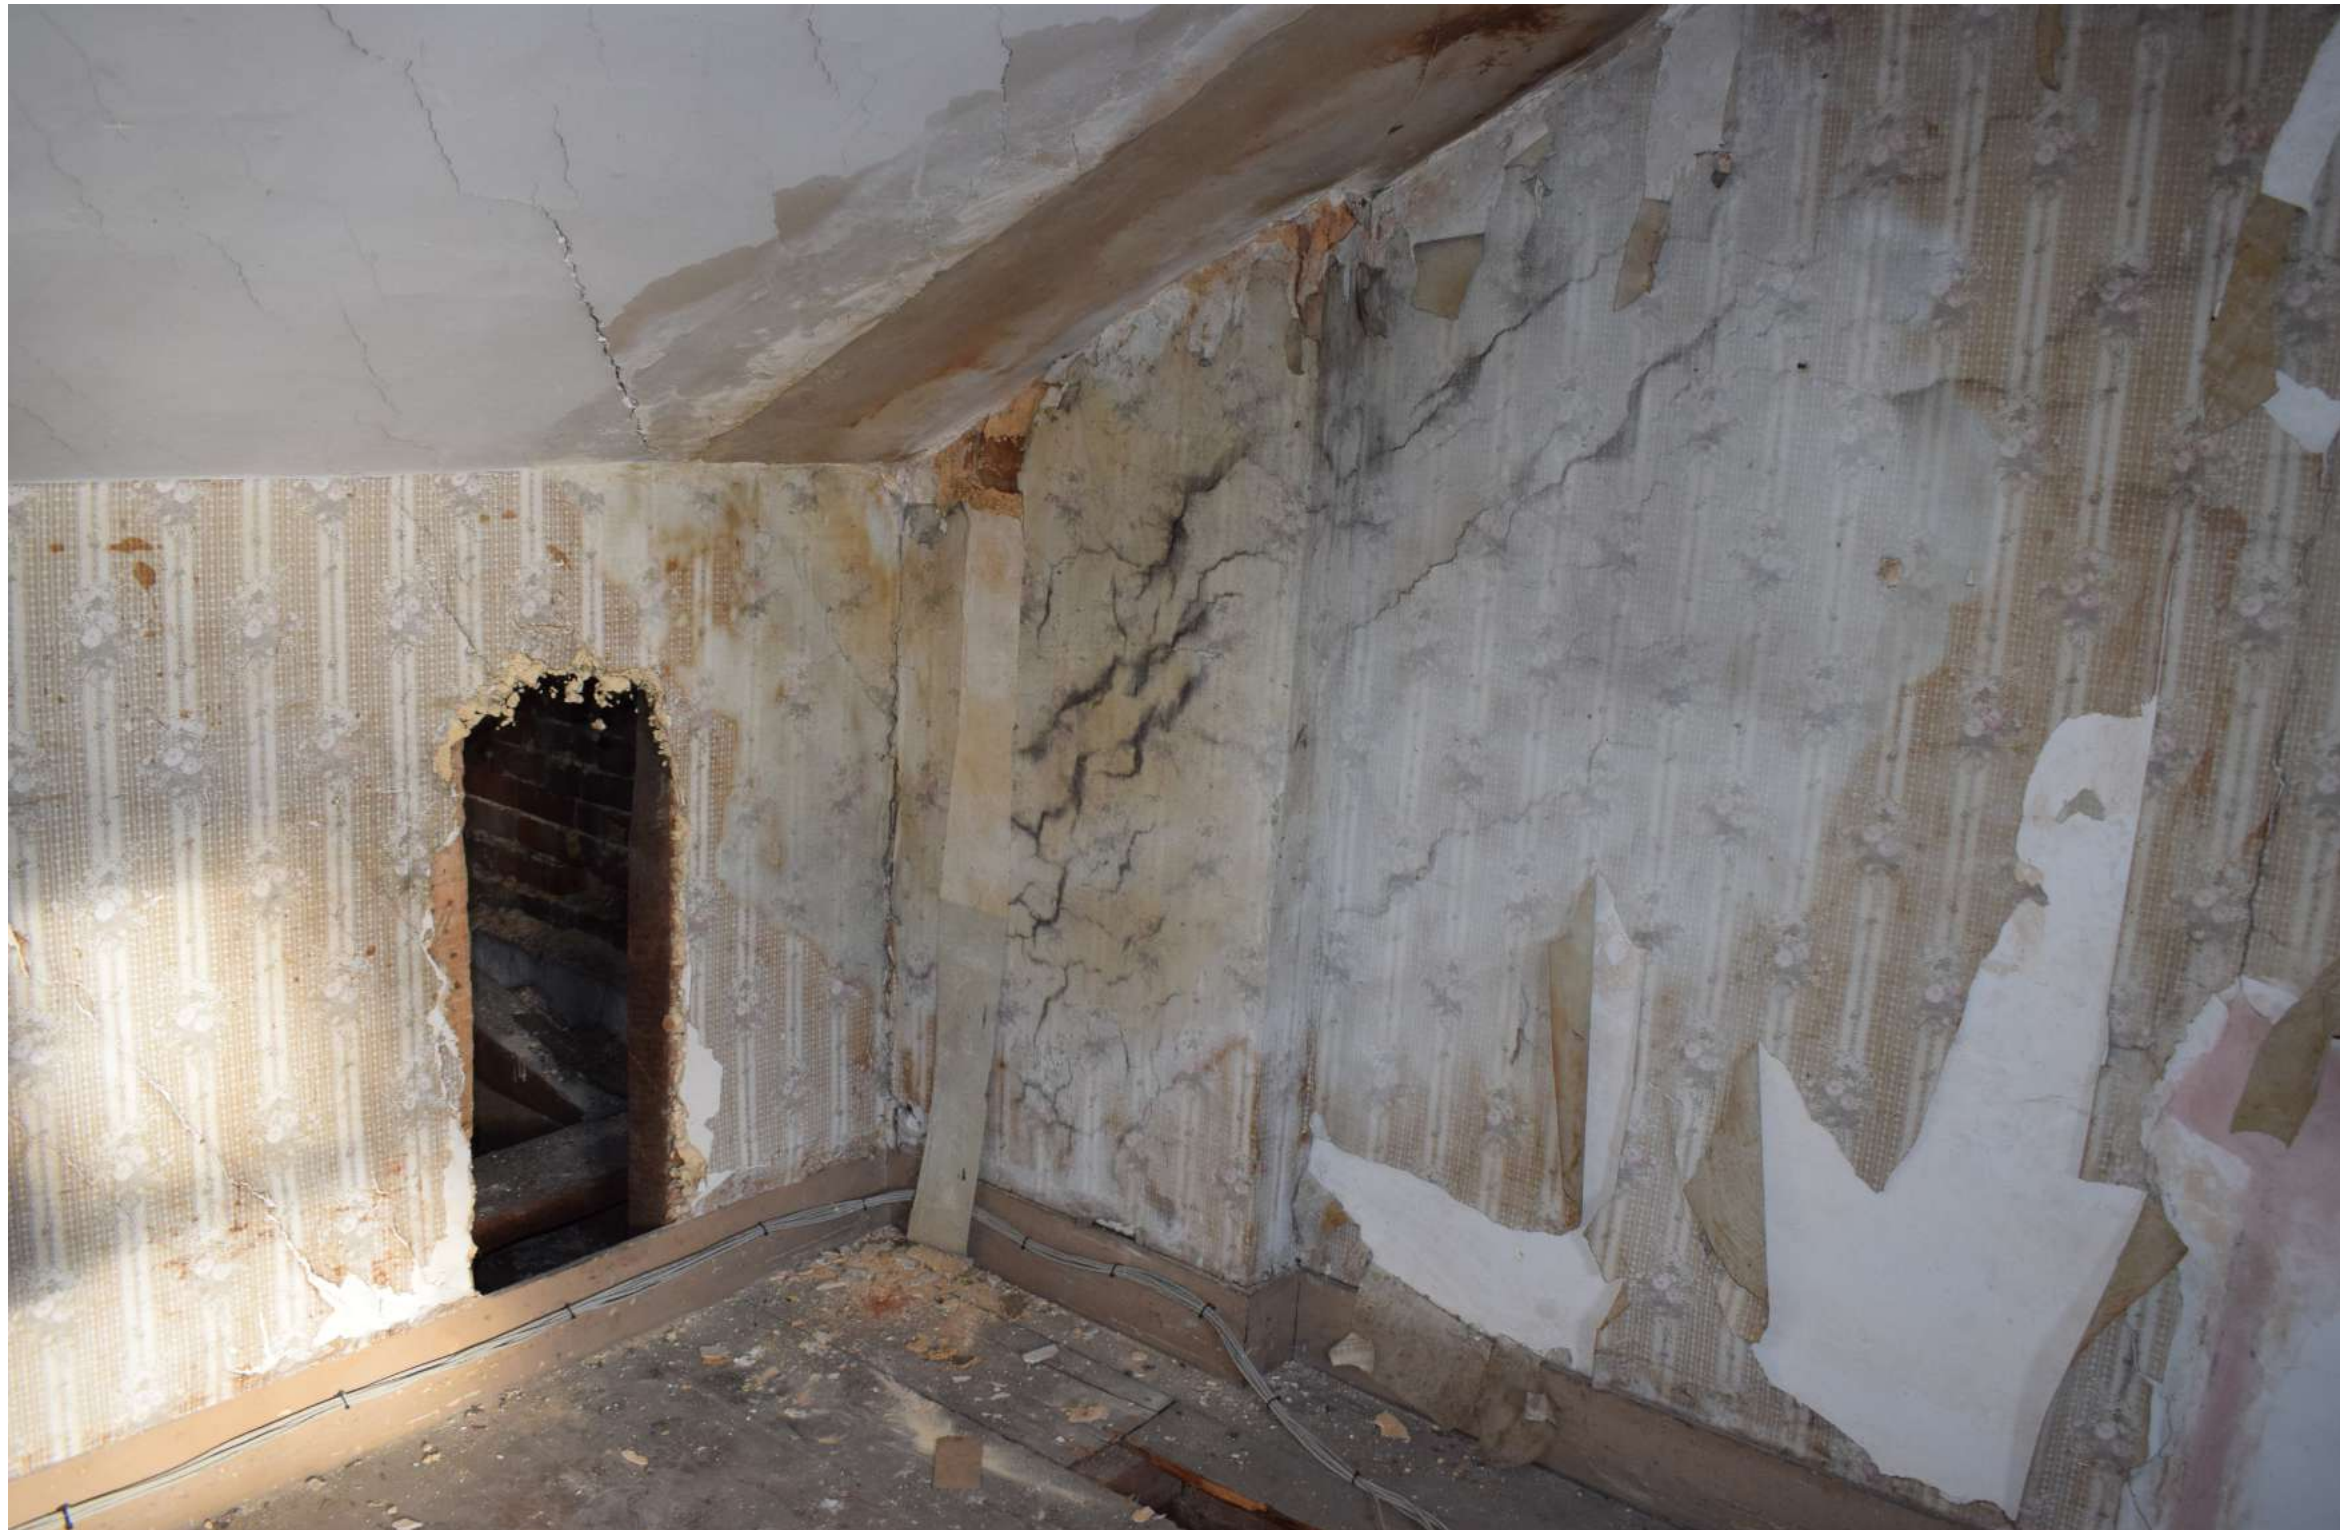
Plate 51

An image of one of the projecting walls the support the chimney flue and stacks above.

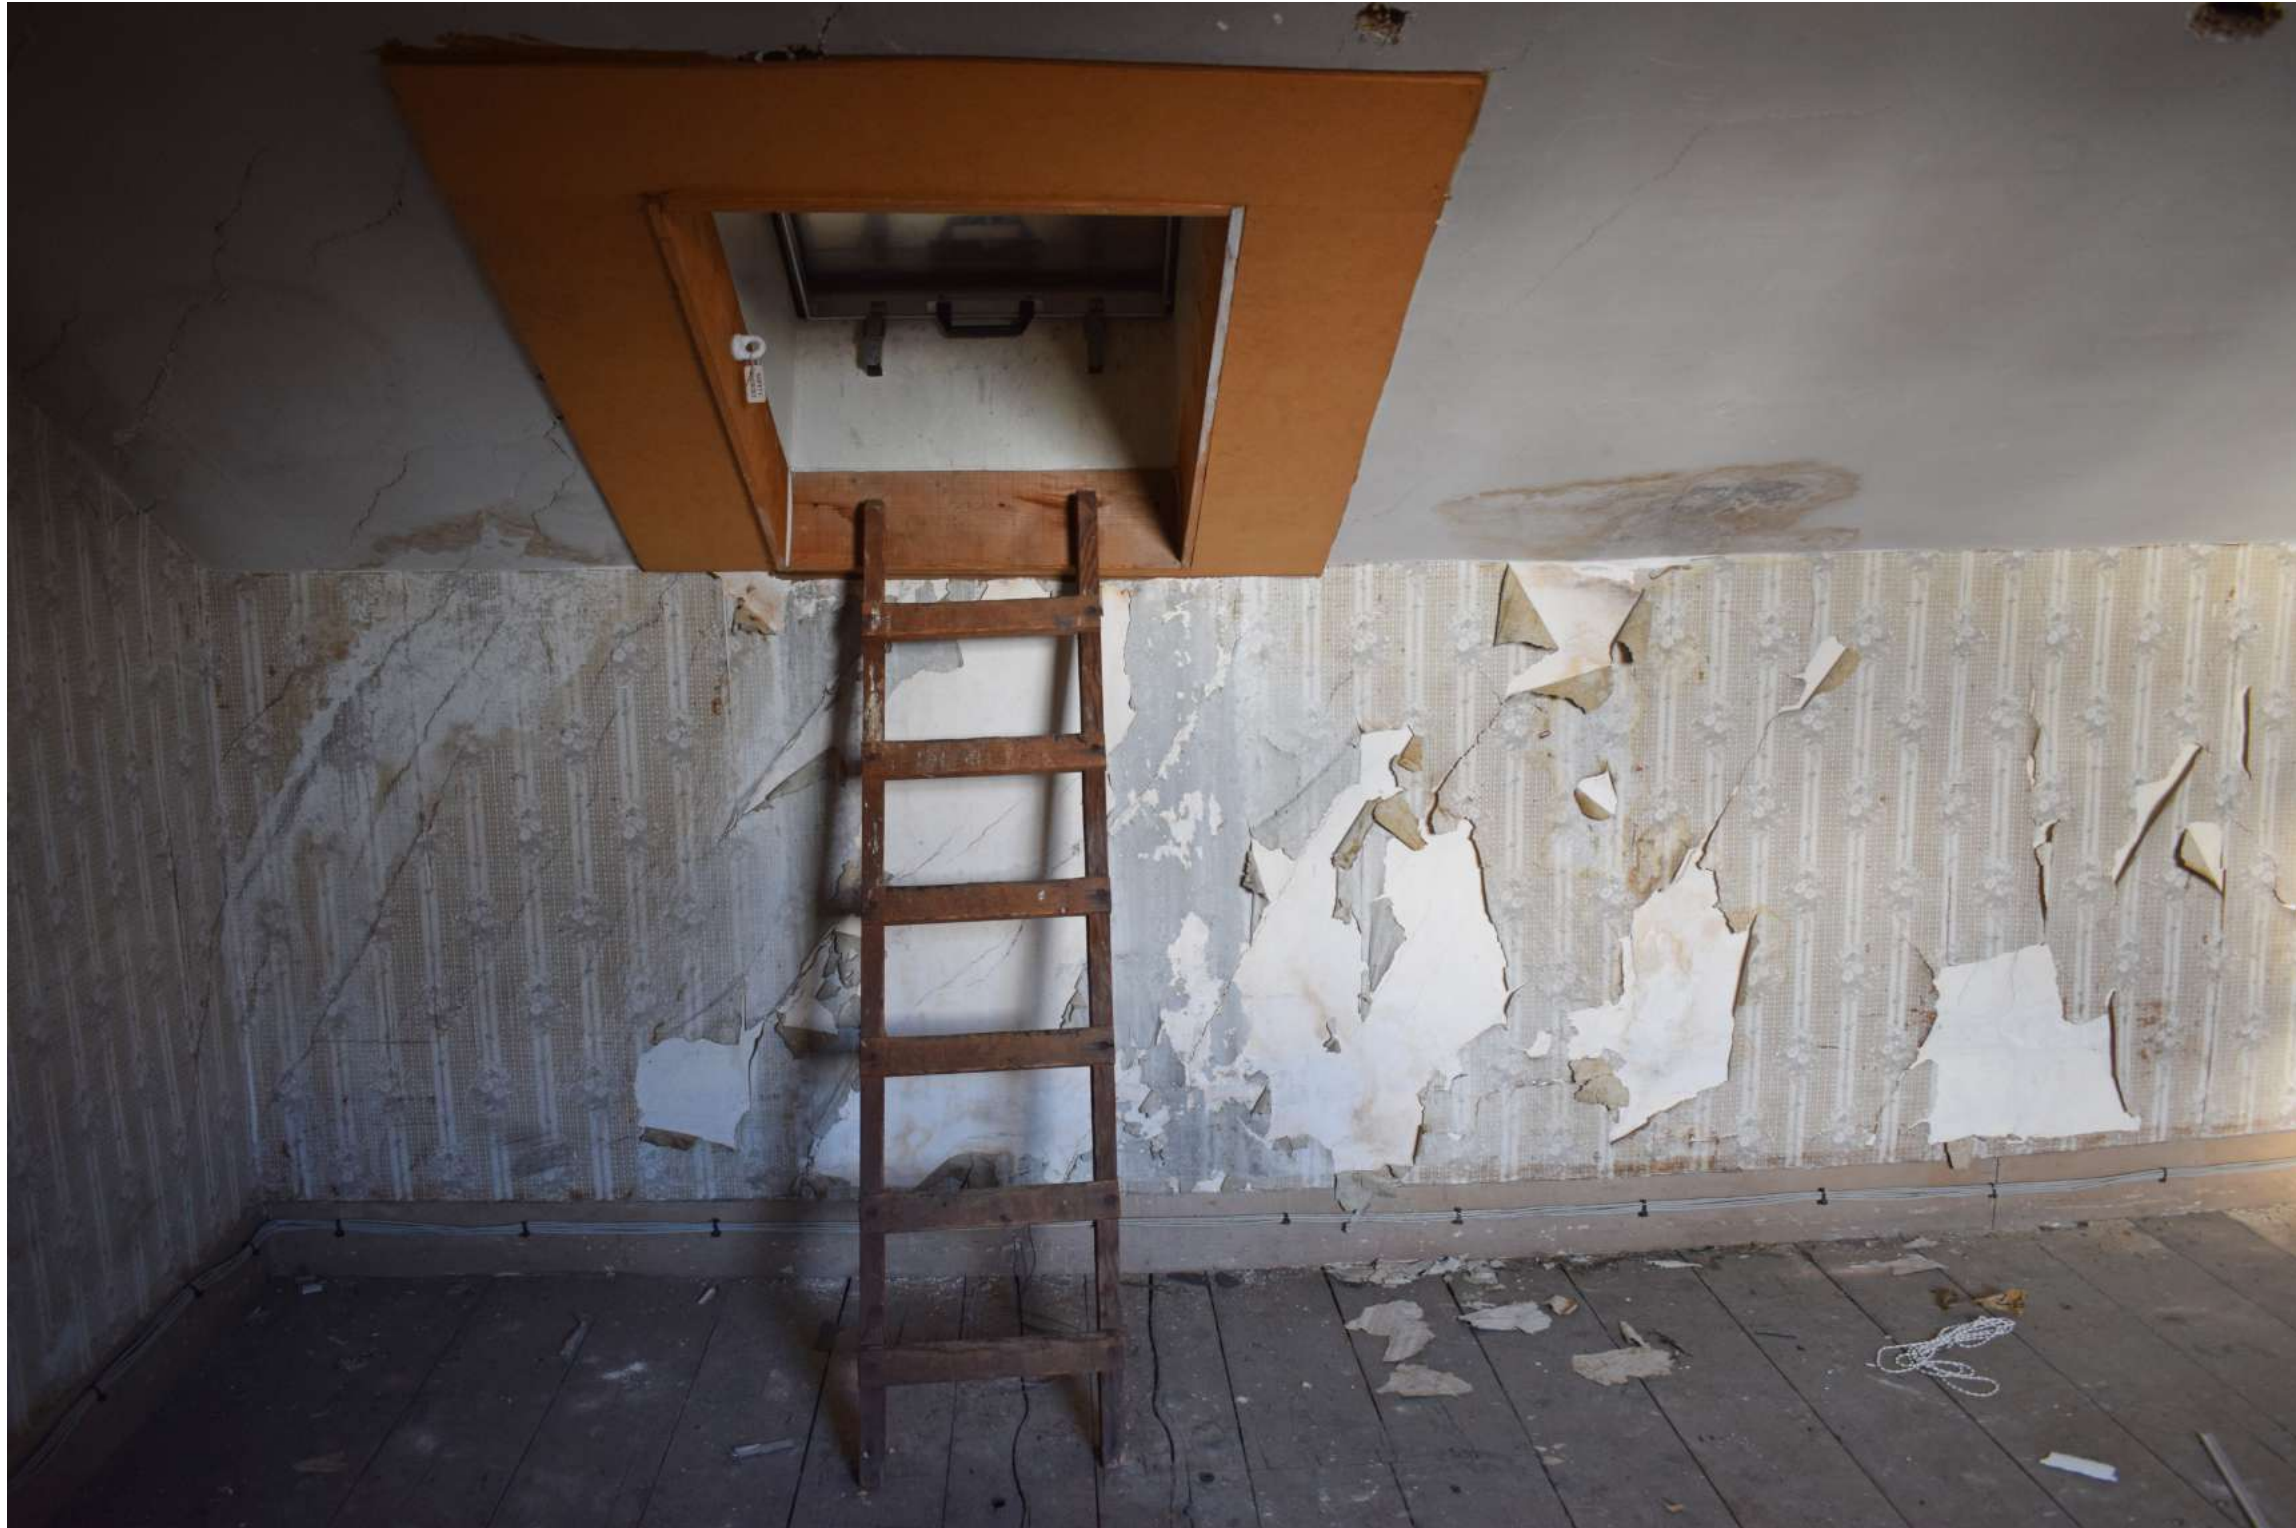
Plate 52

Access point to the roof: An historic ladder has been retained, leading up to a modern escape hatch installation.
