Archway Heritage

# Appendix 11

## Yeomanry House

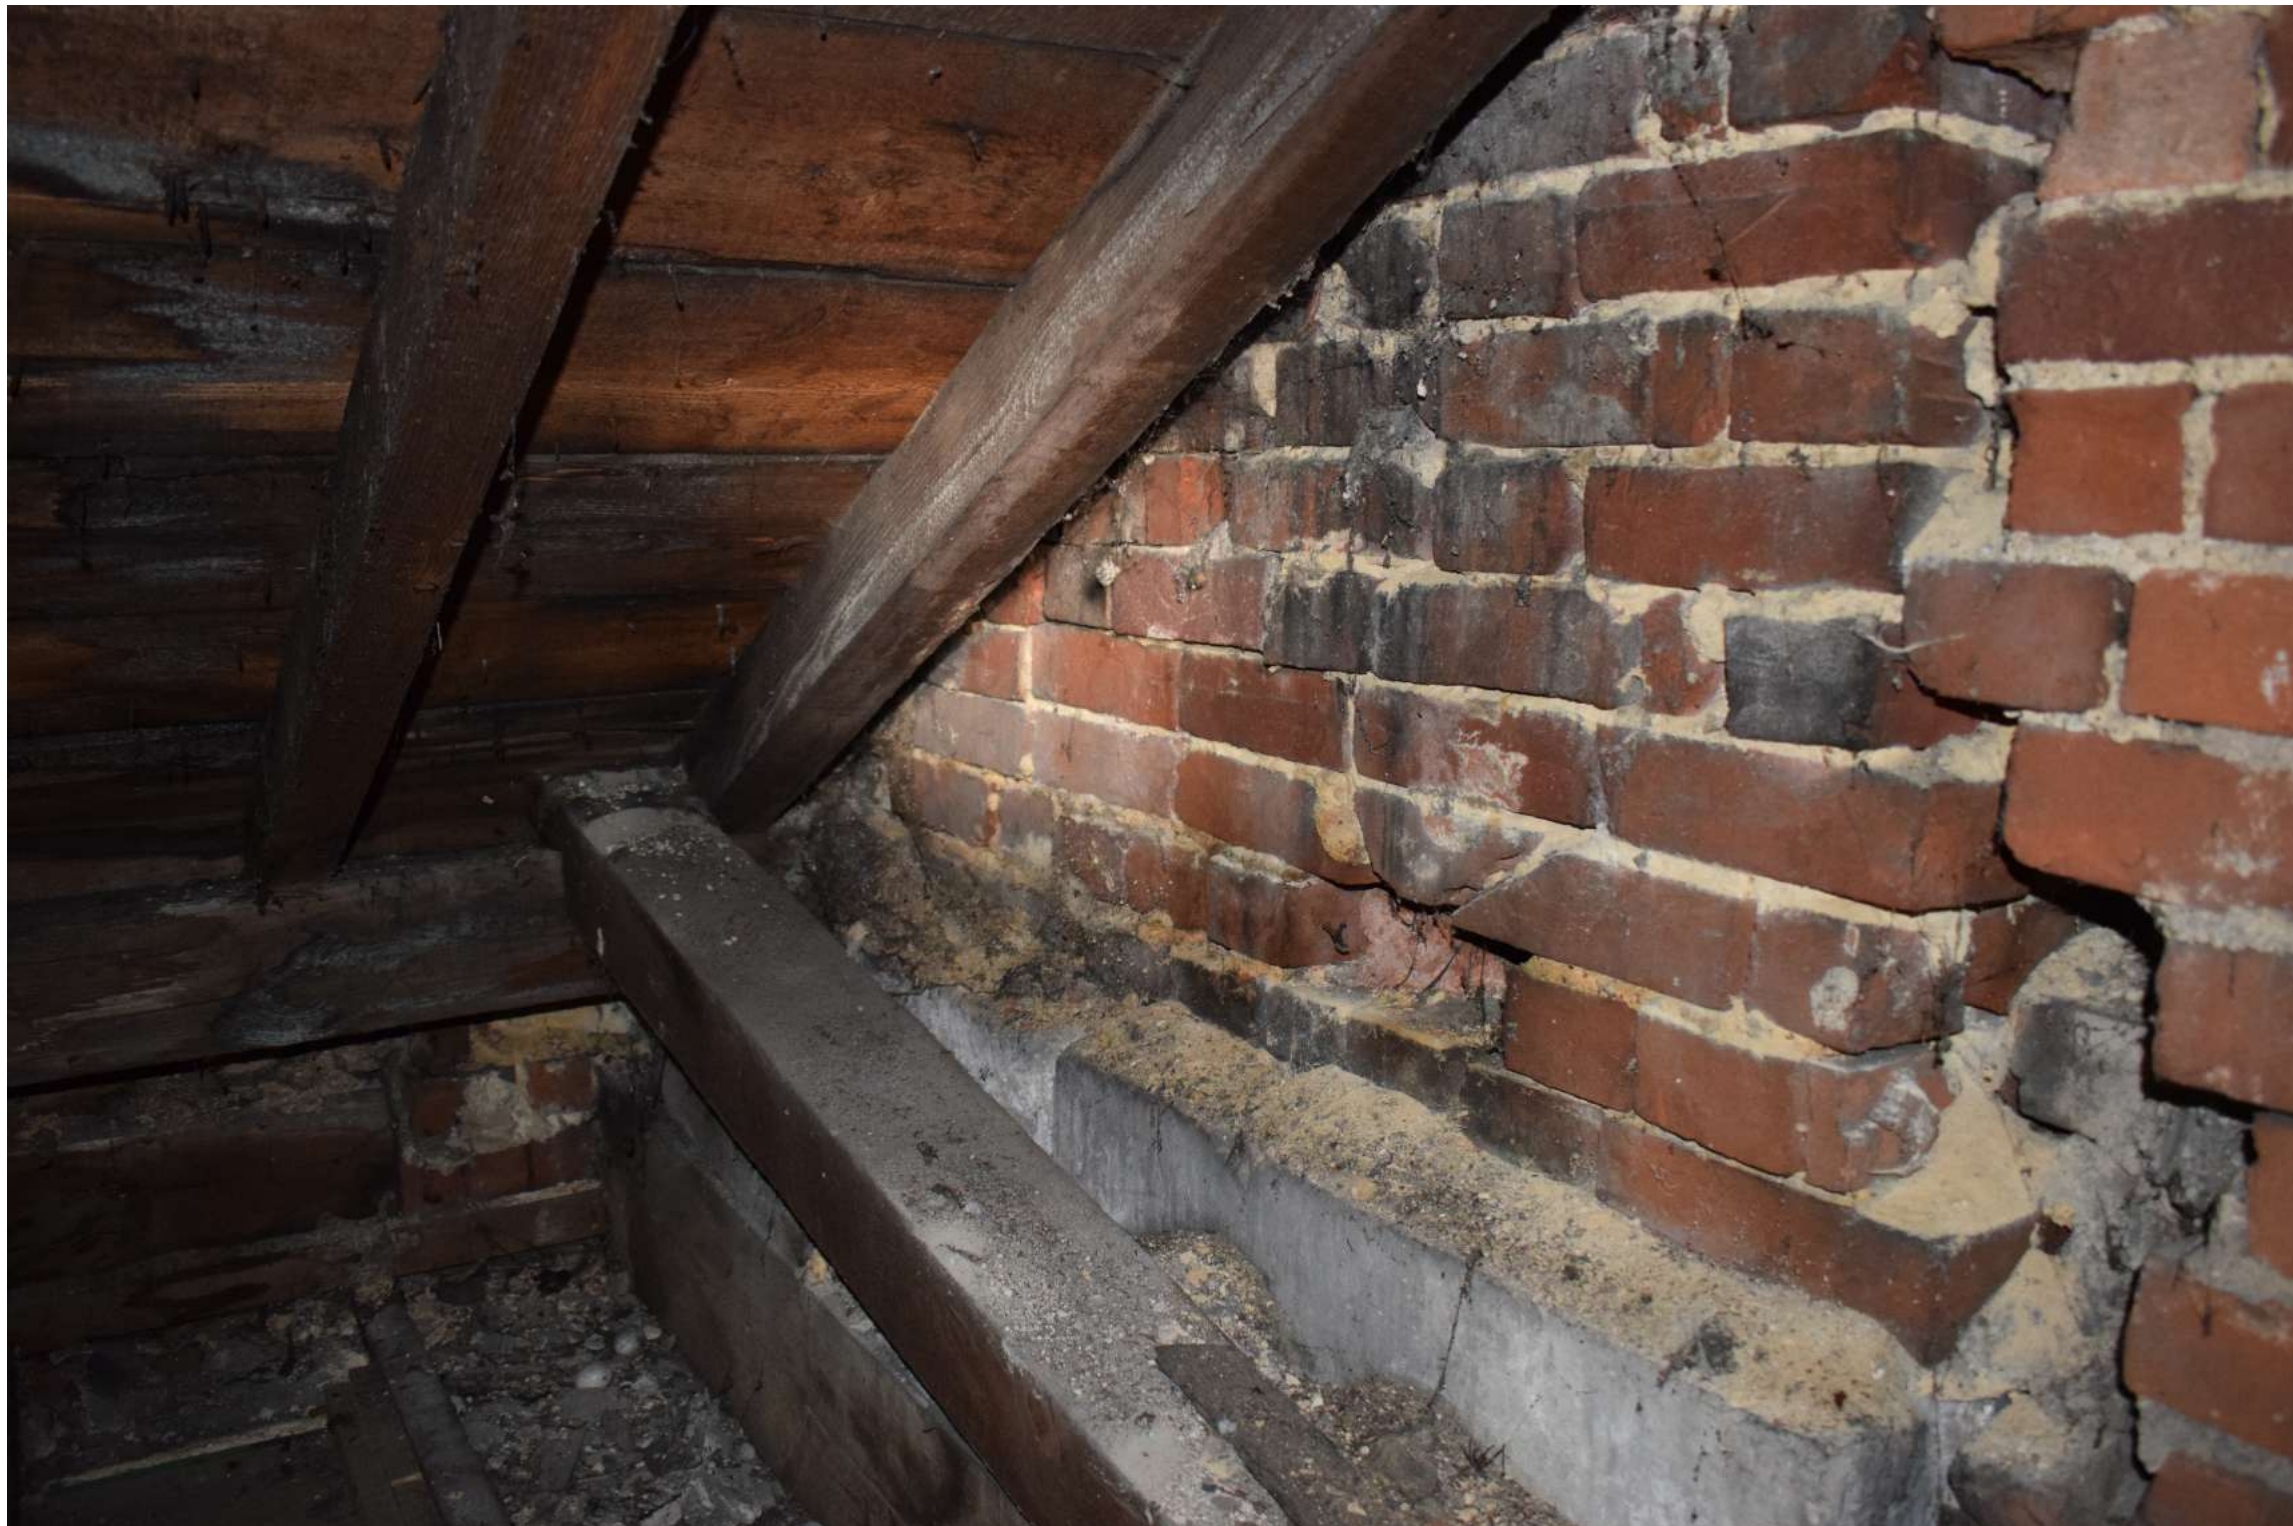
Plate 55

New timber, wood flooring, and historic brick supports for the timbers are visible throughout the roof structure . The existing structural roof timbers are modern and exhibit mould but appear to be in a reasonably good structural state.

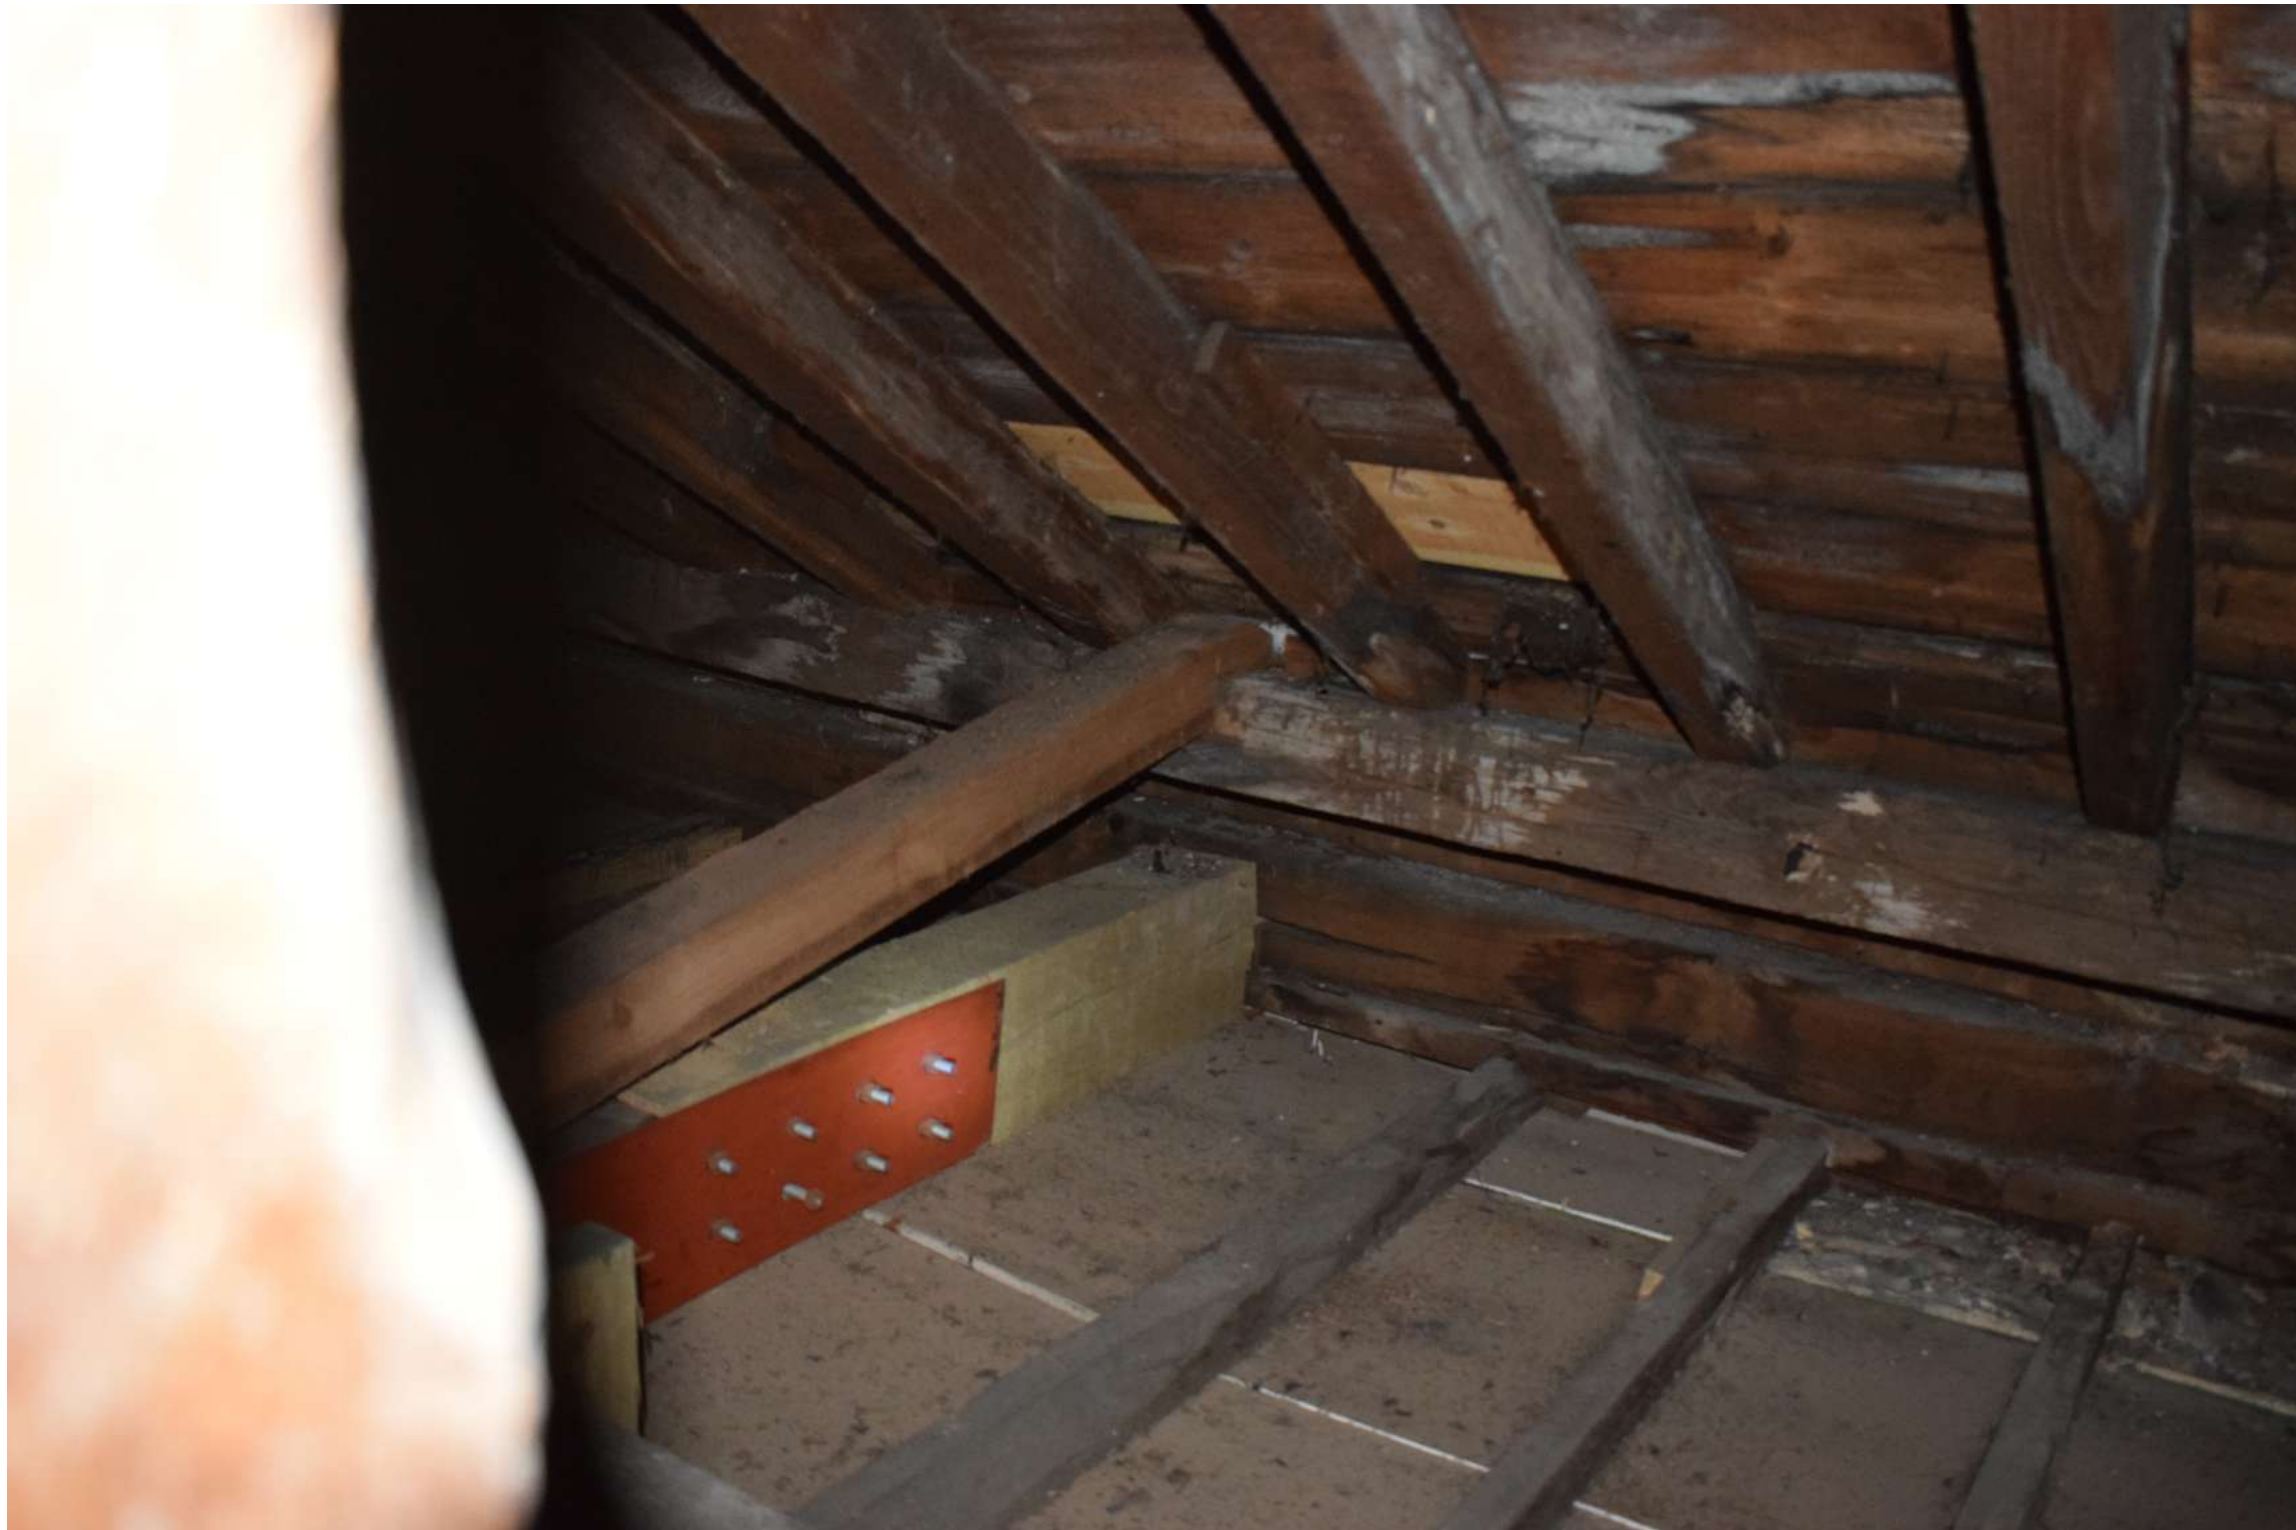
Plate 56

The new roof timbers and a new intervention secured with bolts indicate structural strengthening.

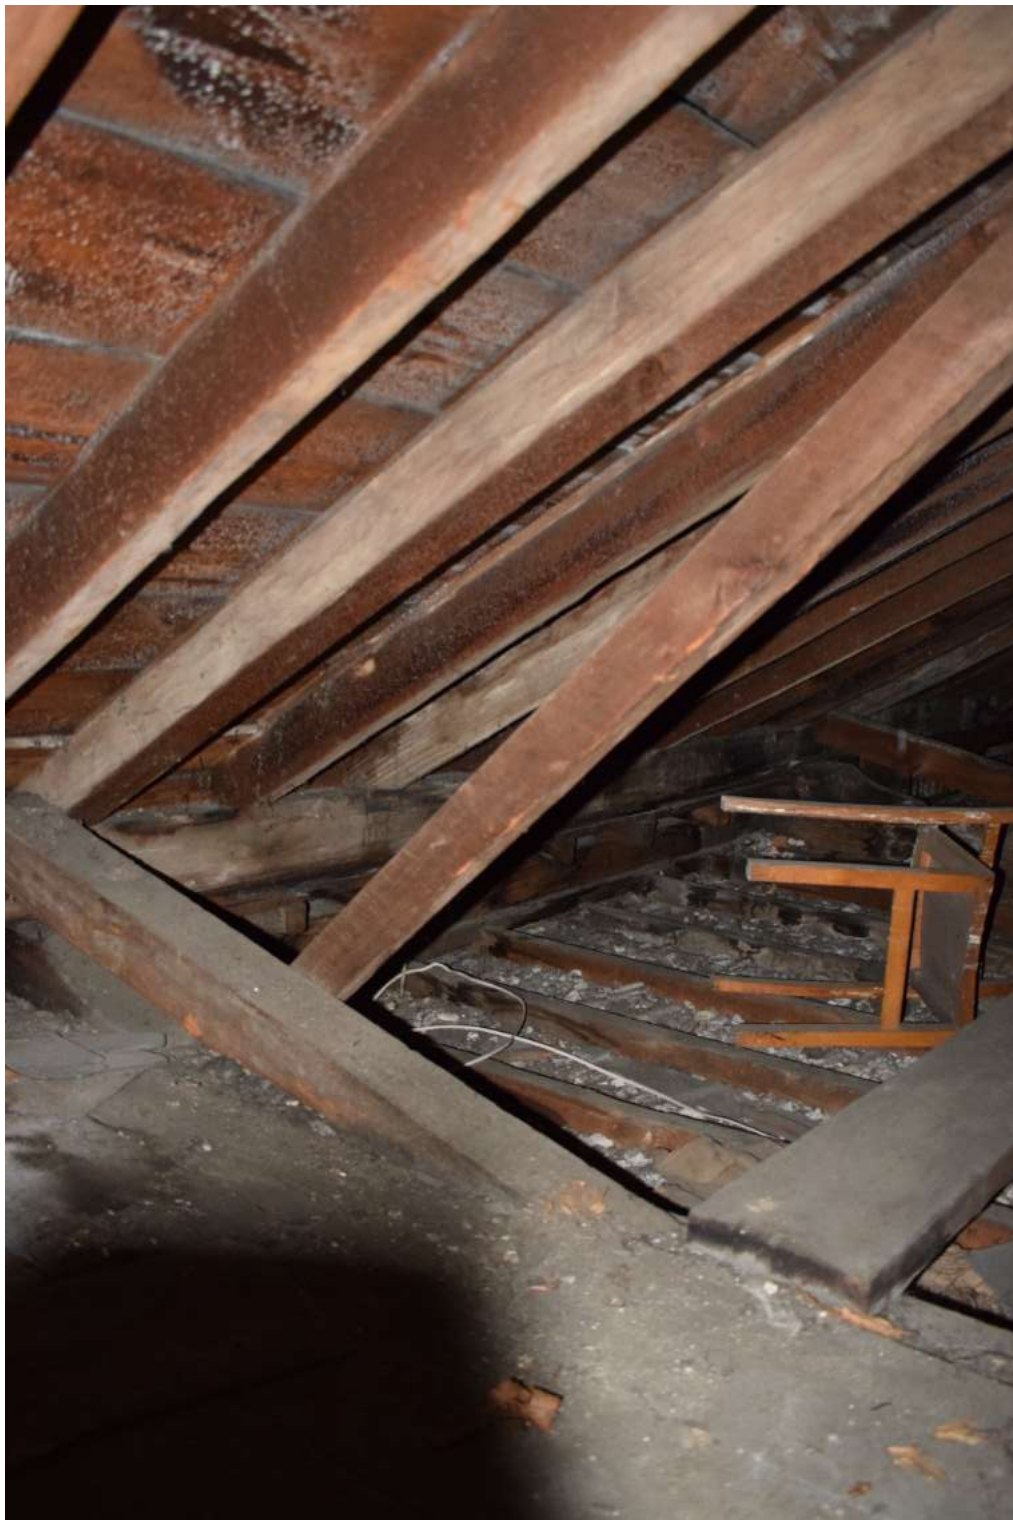
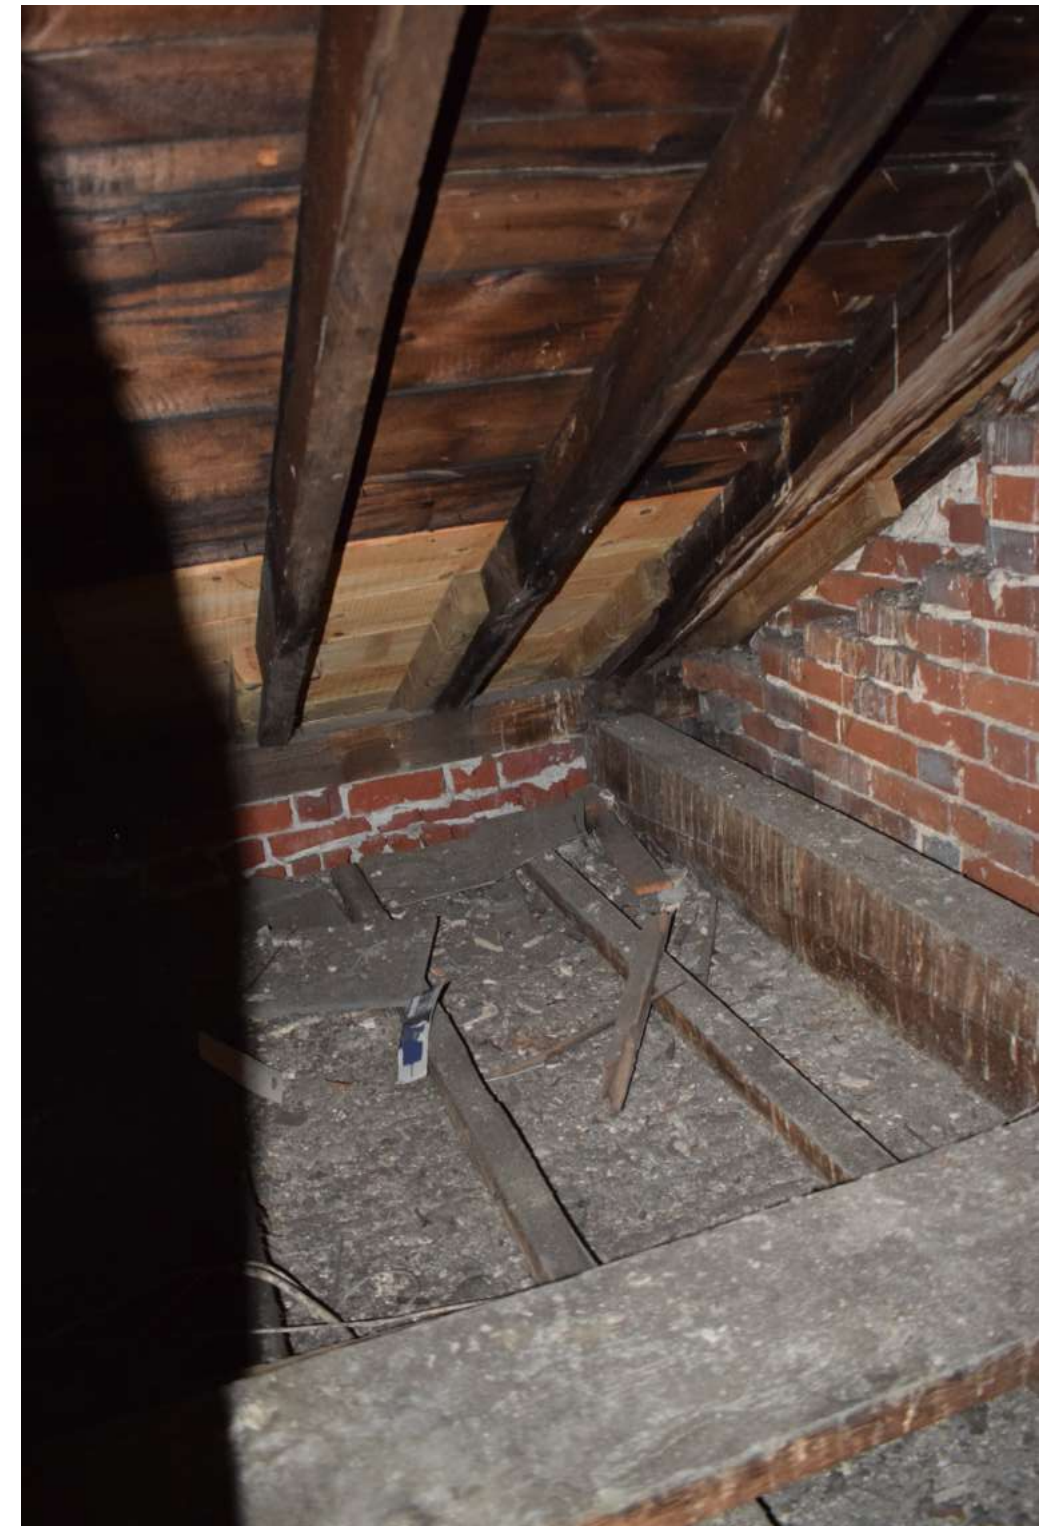
Plate 59

The roof is entirely modern, comprising new timber flooring and contemporary cut timbers. No original timber remains on this side.

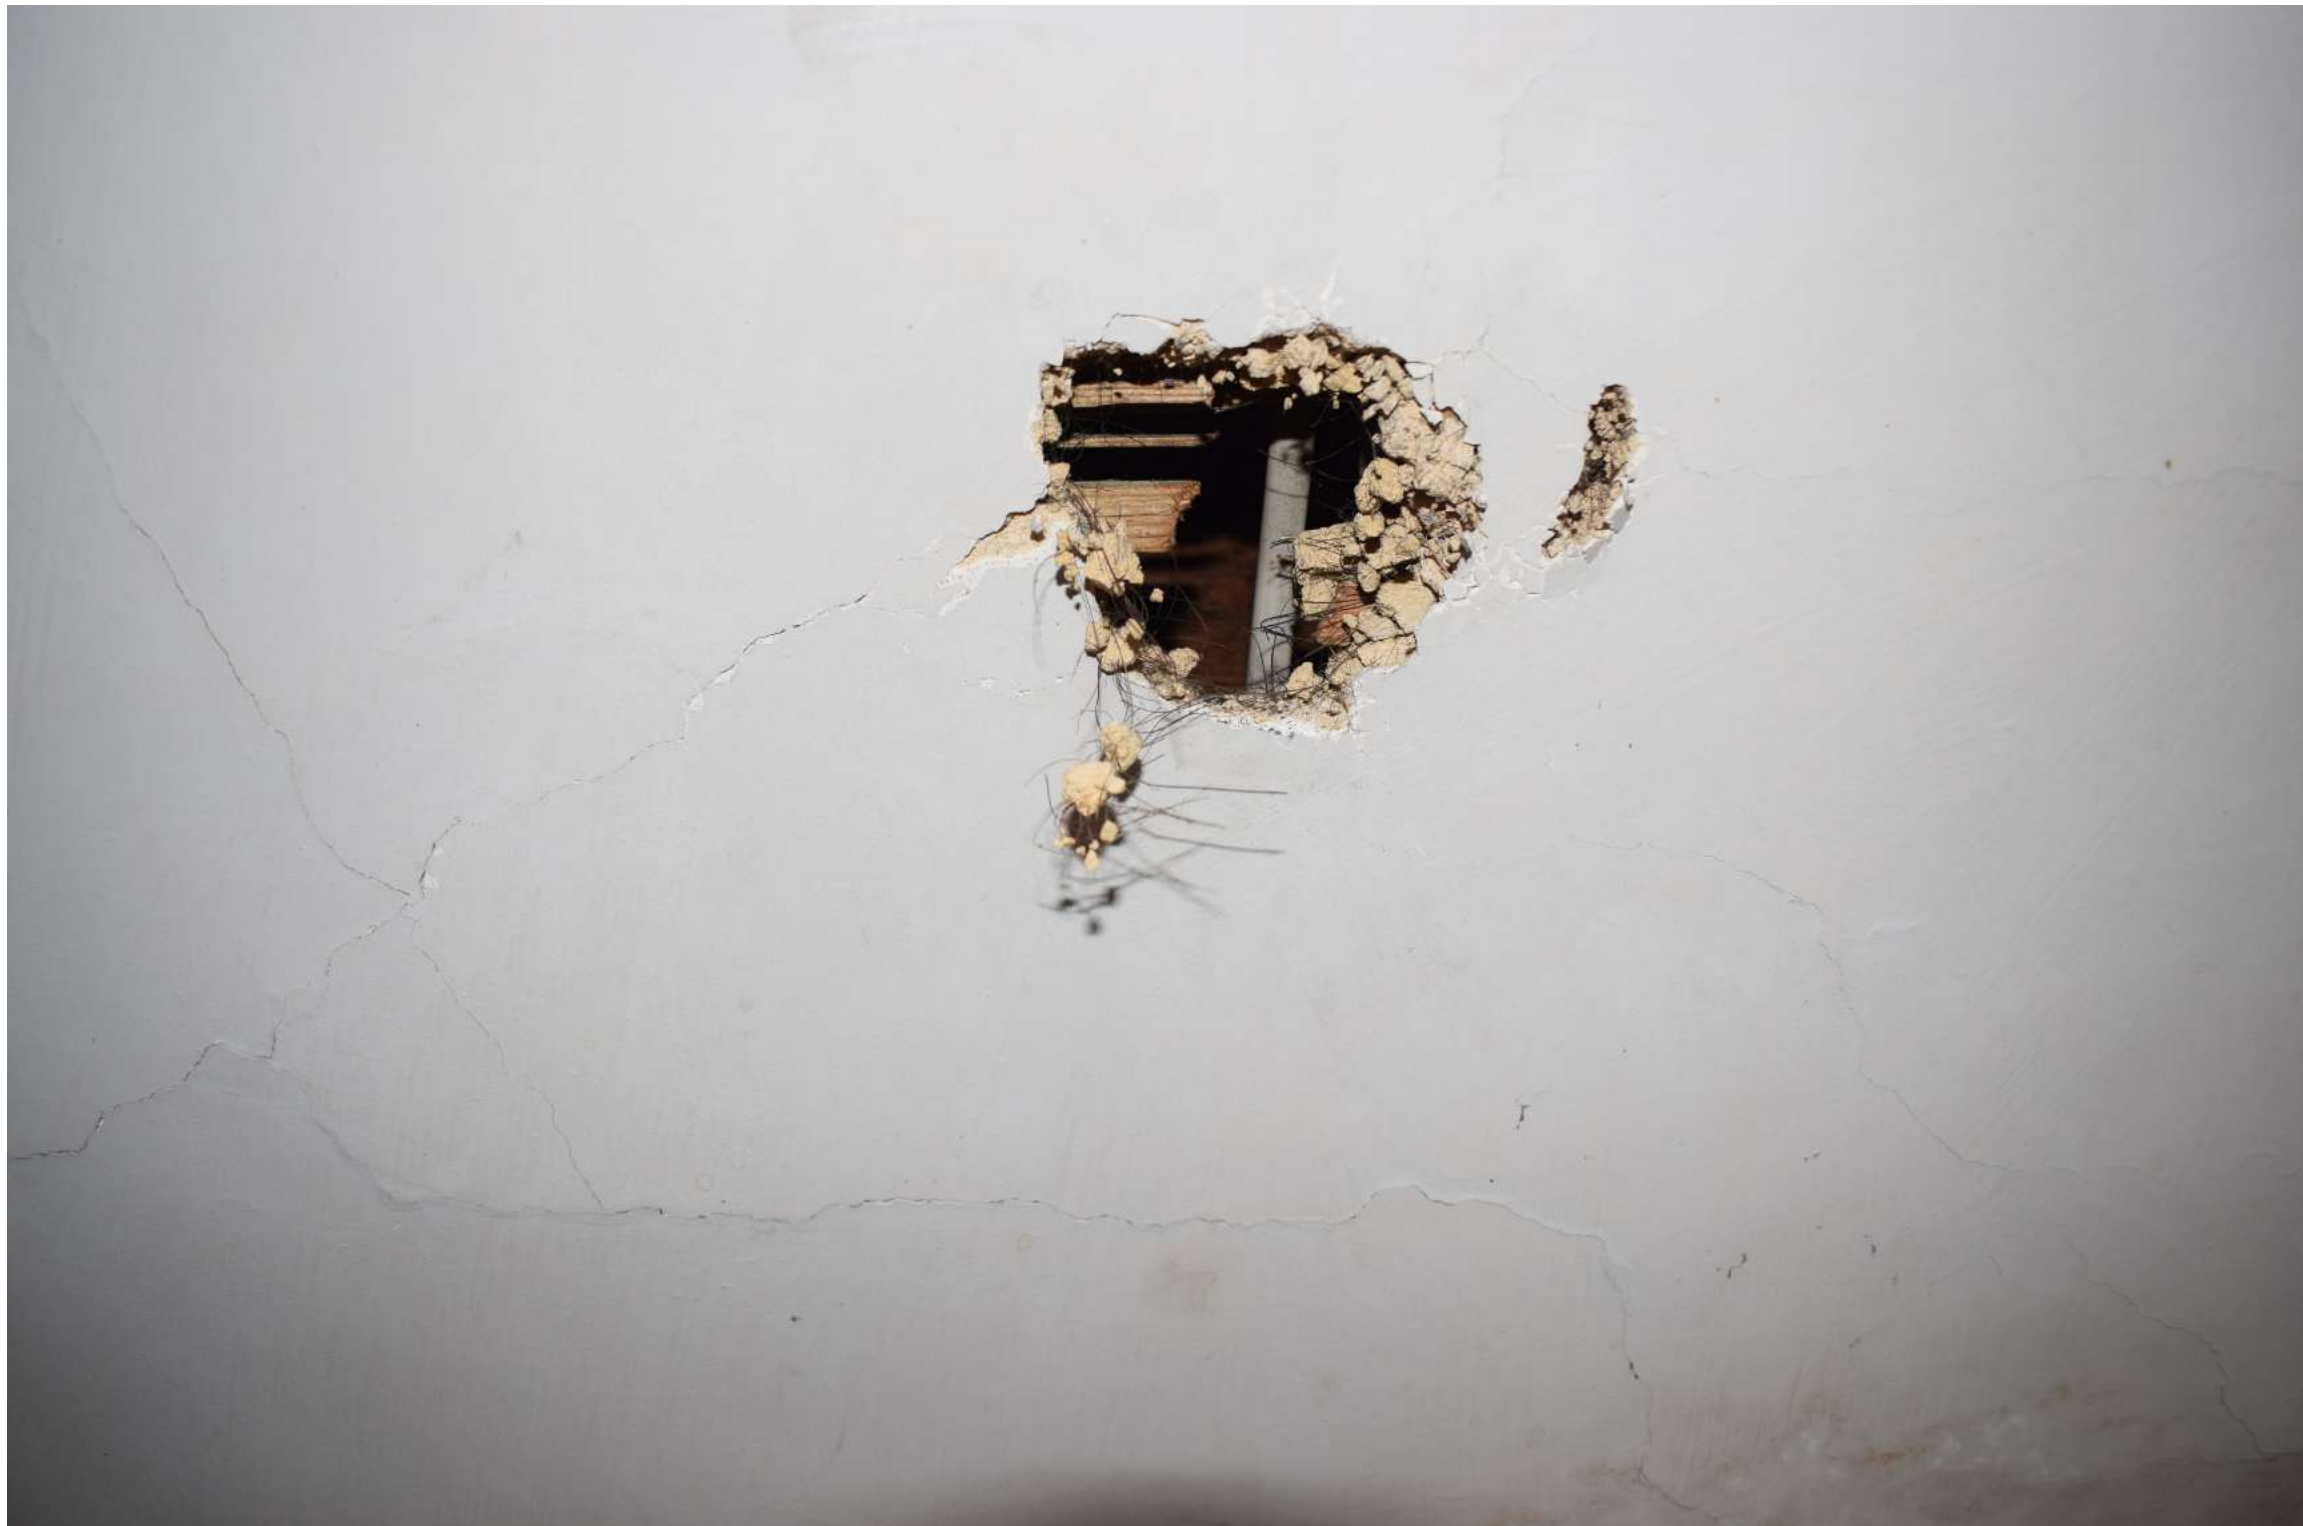
Plate 60

Animal hair is in evidence within the plasterwork.
