Phases 2a and 2b west wing

## Appendix 11

Yeomanry House

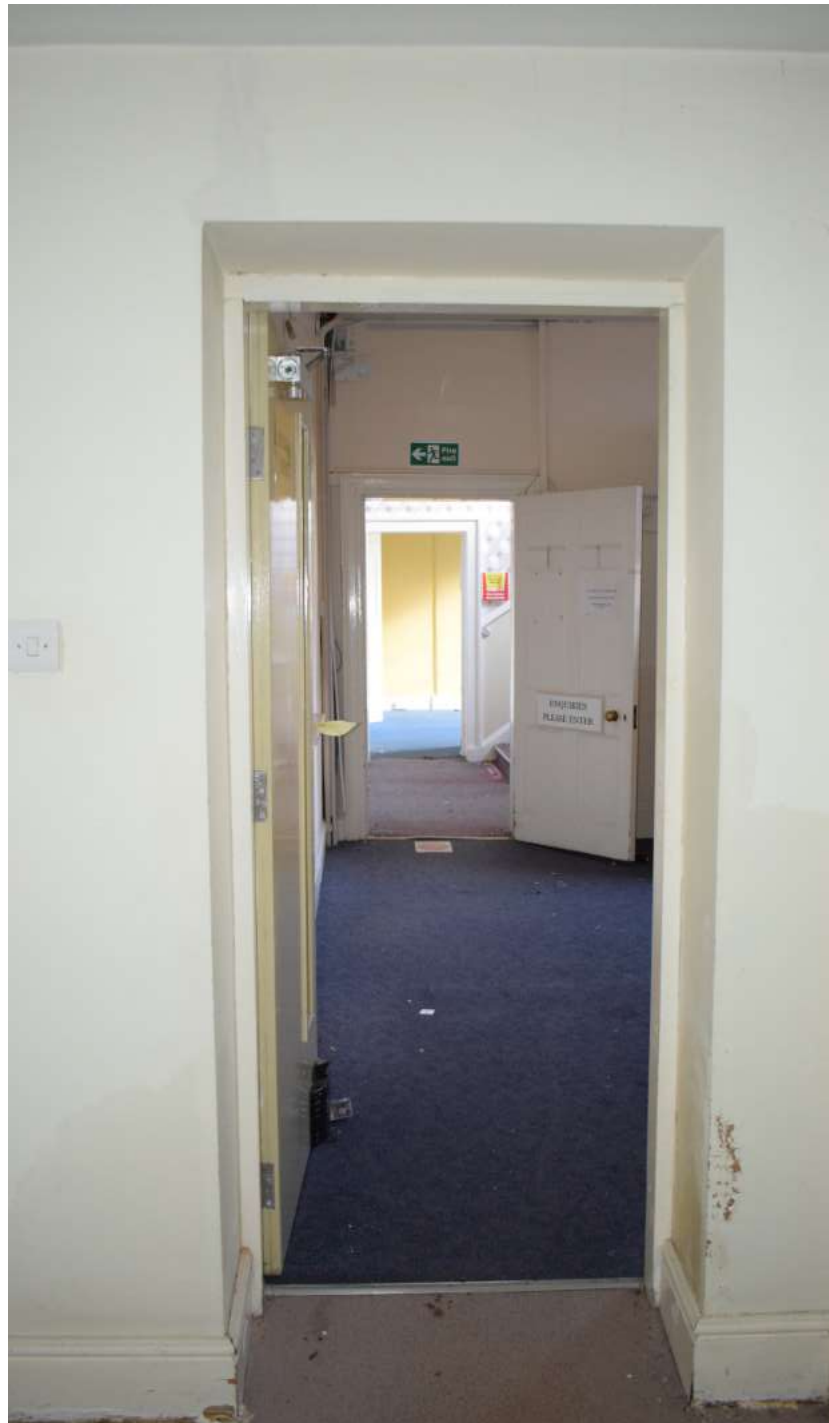
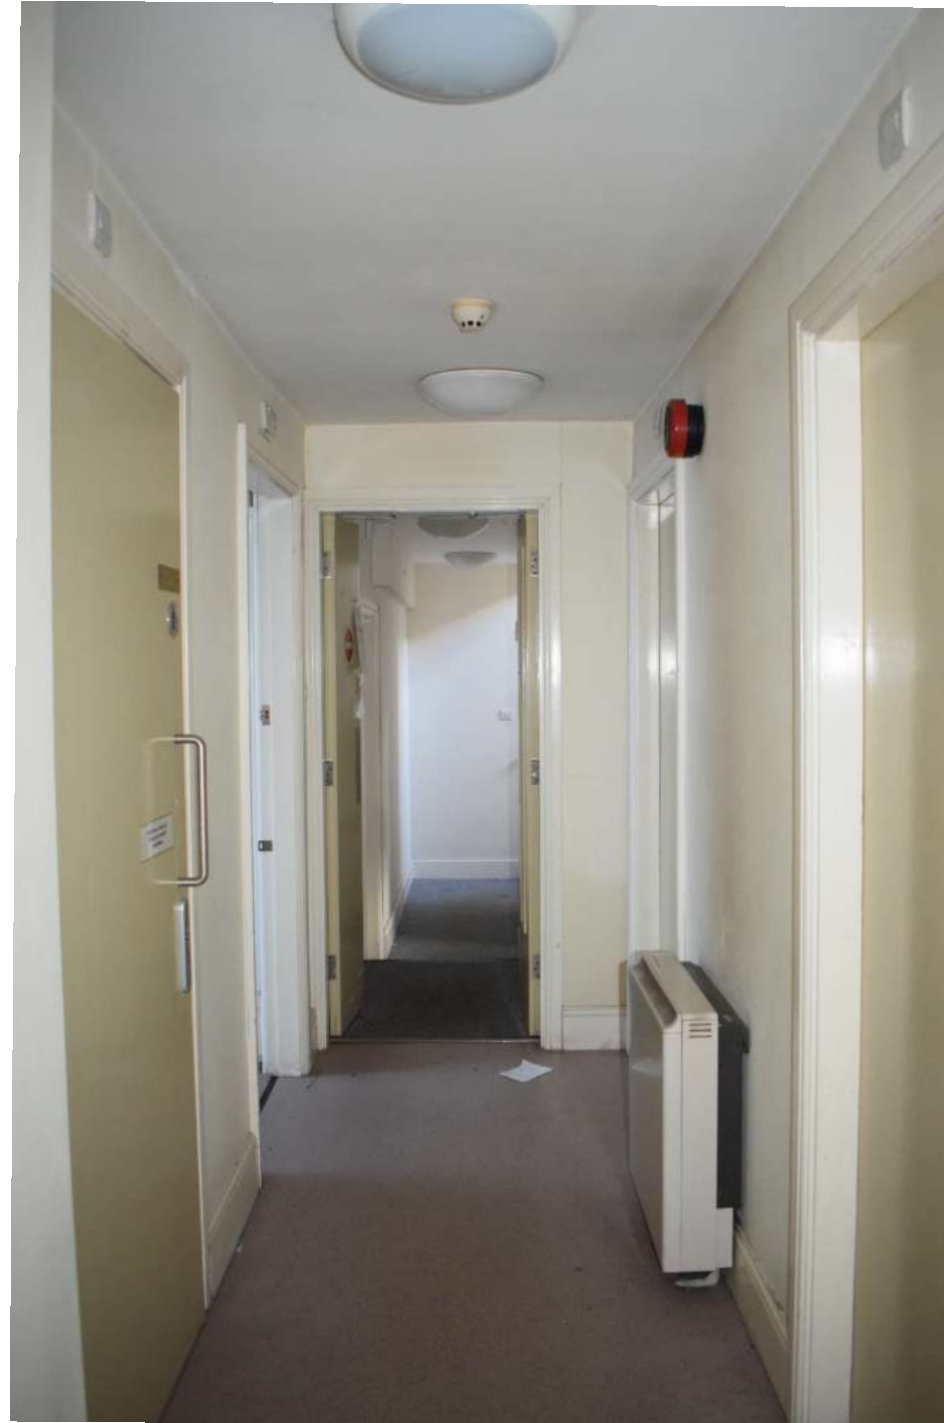
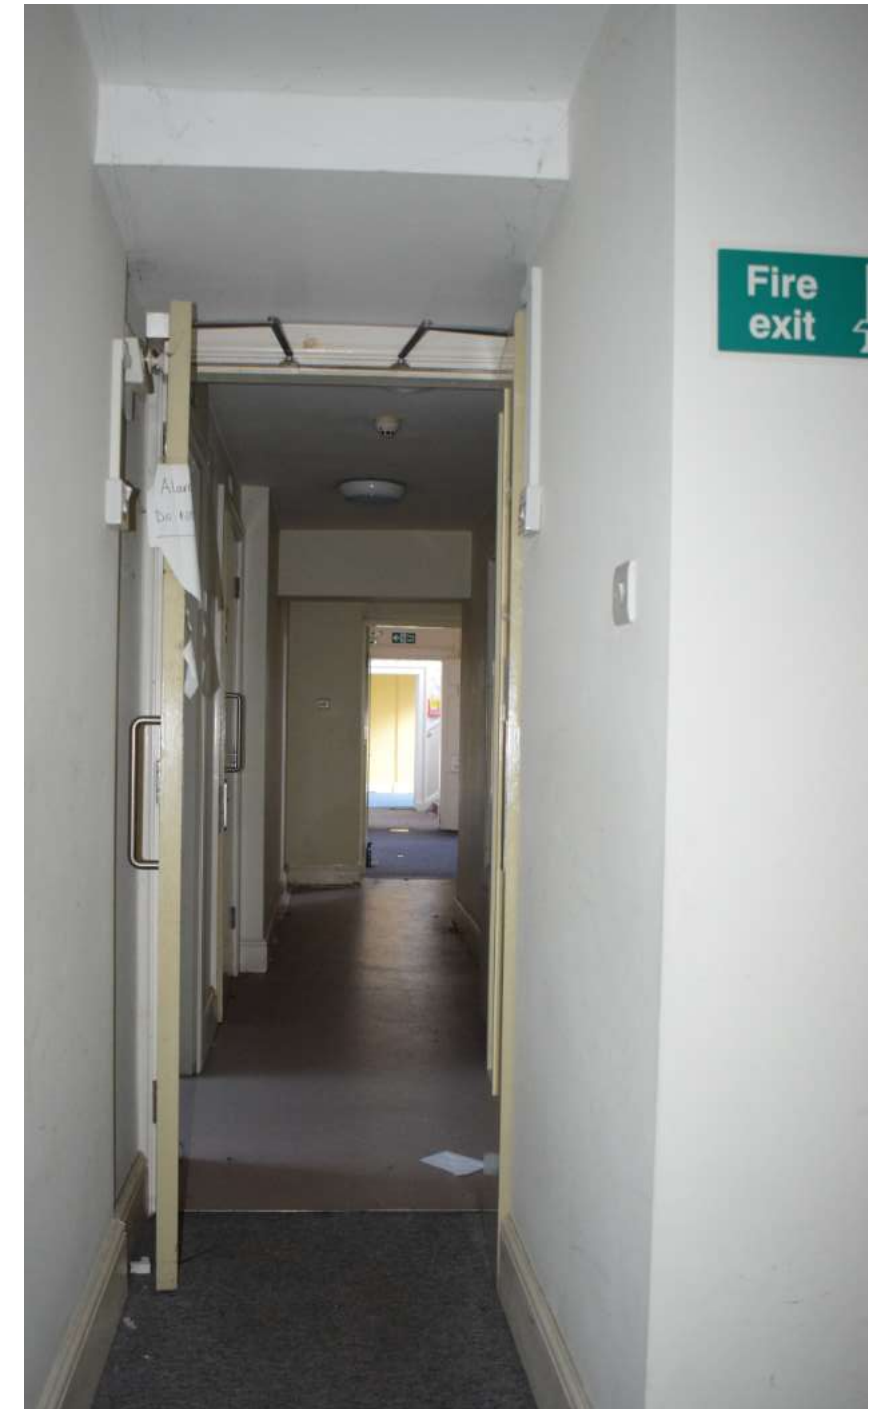
Plate 62

Reconfigured spaces: The reconfigured spaces on the ground floor corridor now feature modern corridors with toilets and a storeroom on either side.

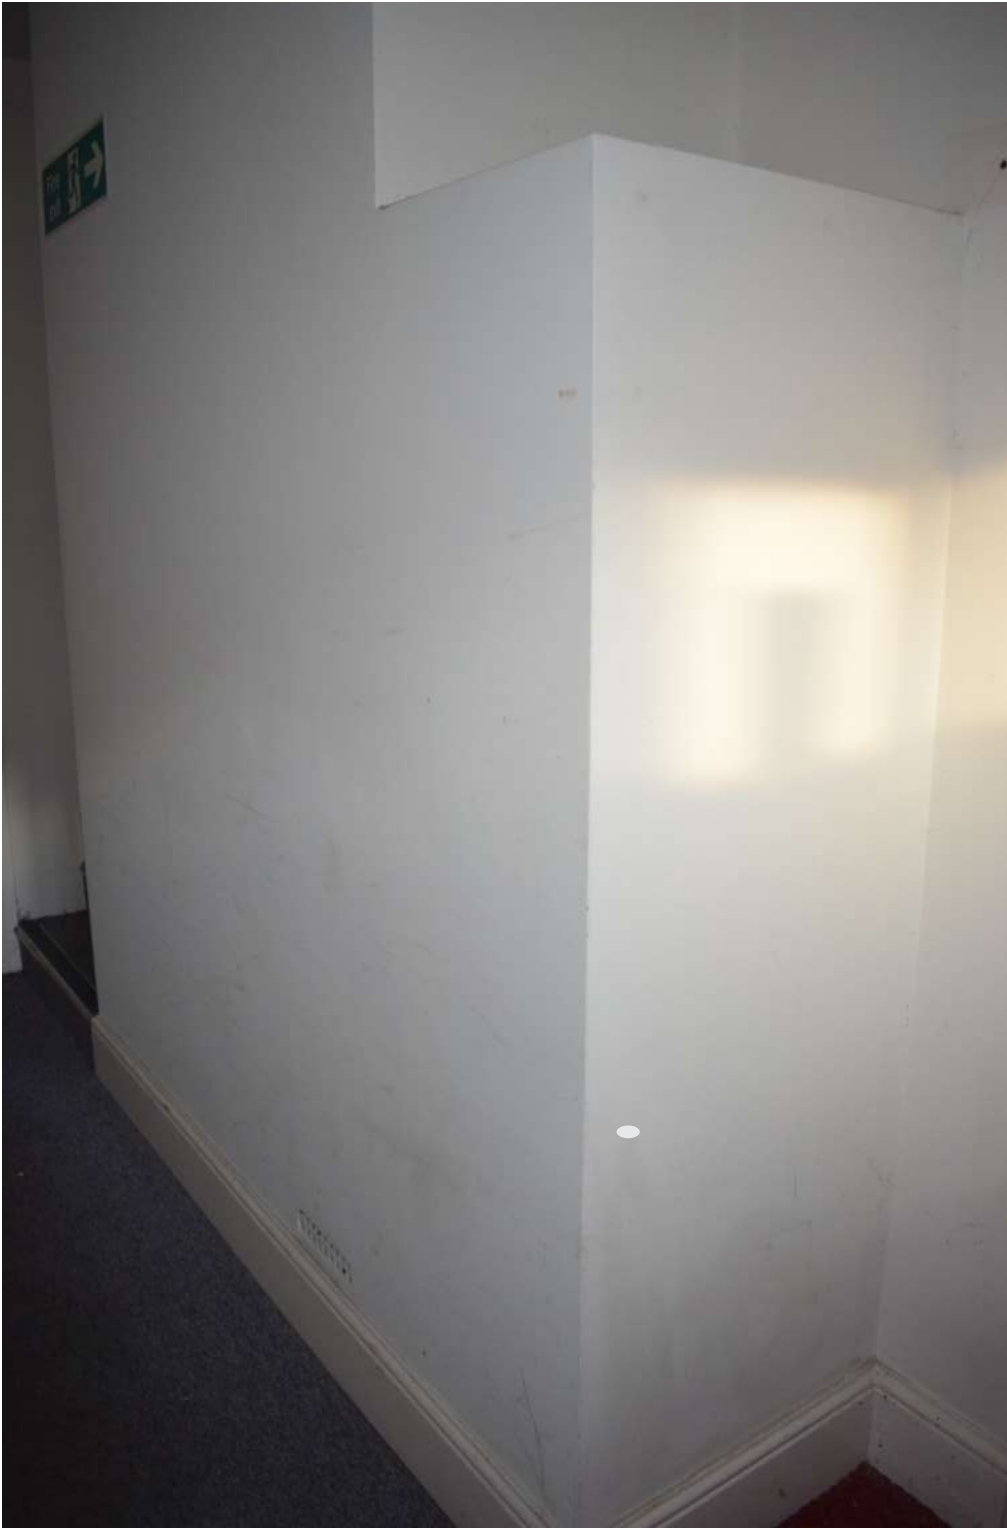
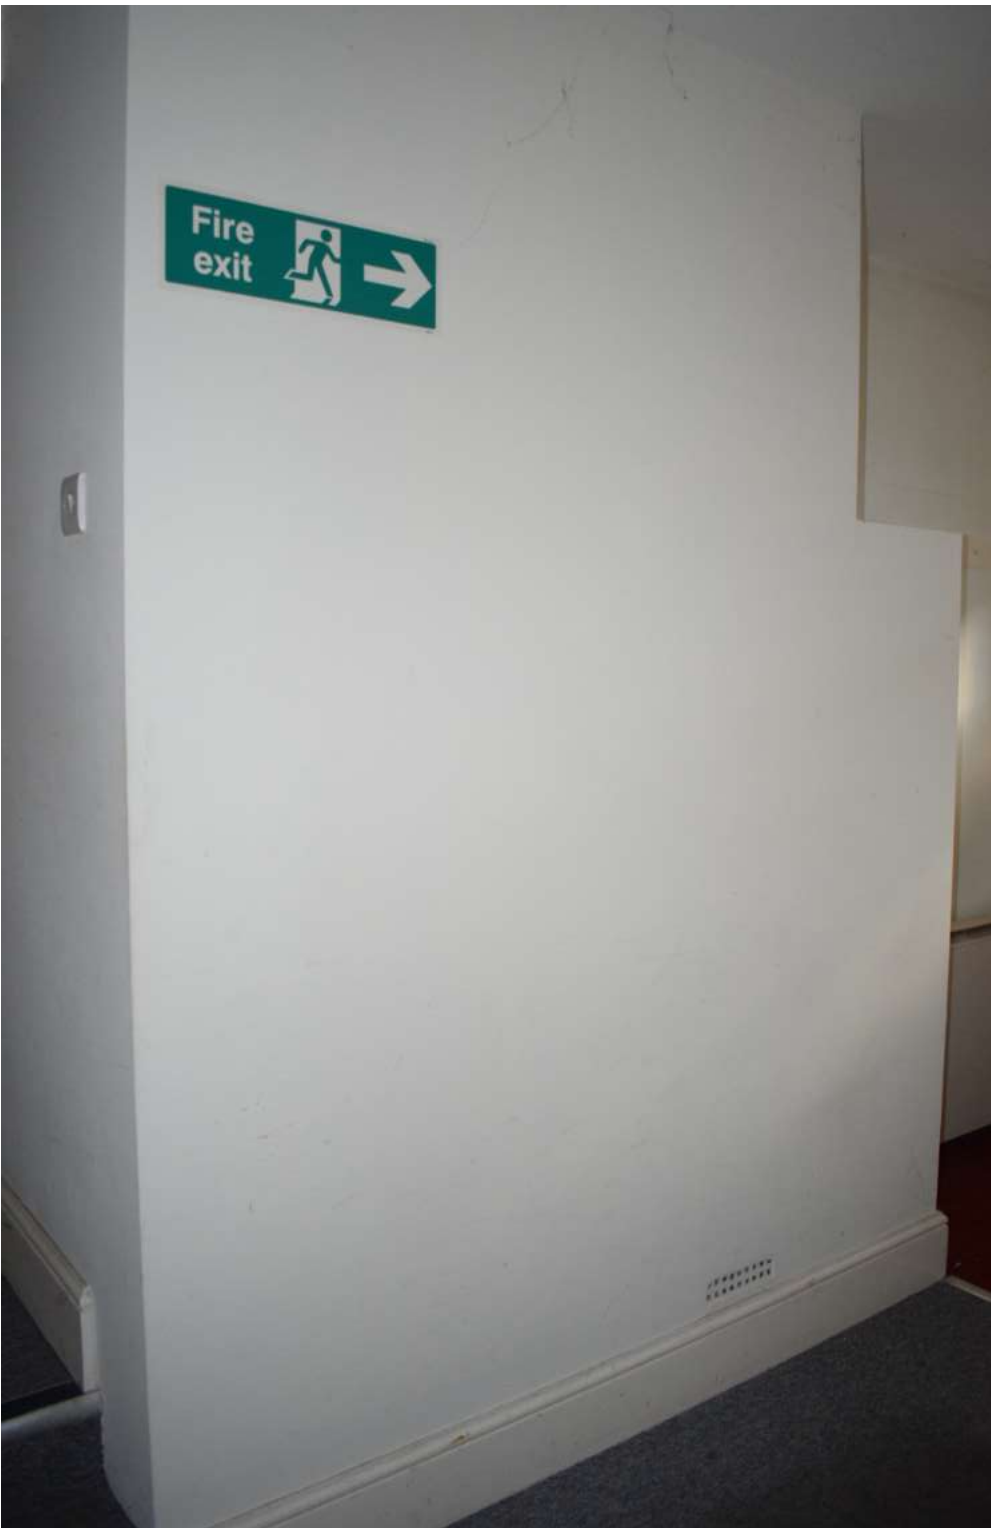
Plate 63

Reconfigured spaces: This image illustrates the reconfigured spaces on the ground floor, where a former, historic fireplace is now located within the corridor by the fire exit.

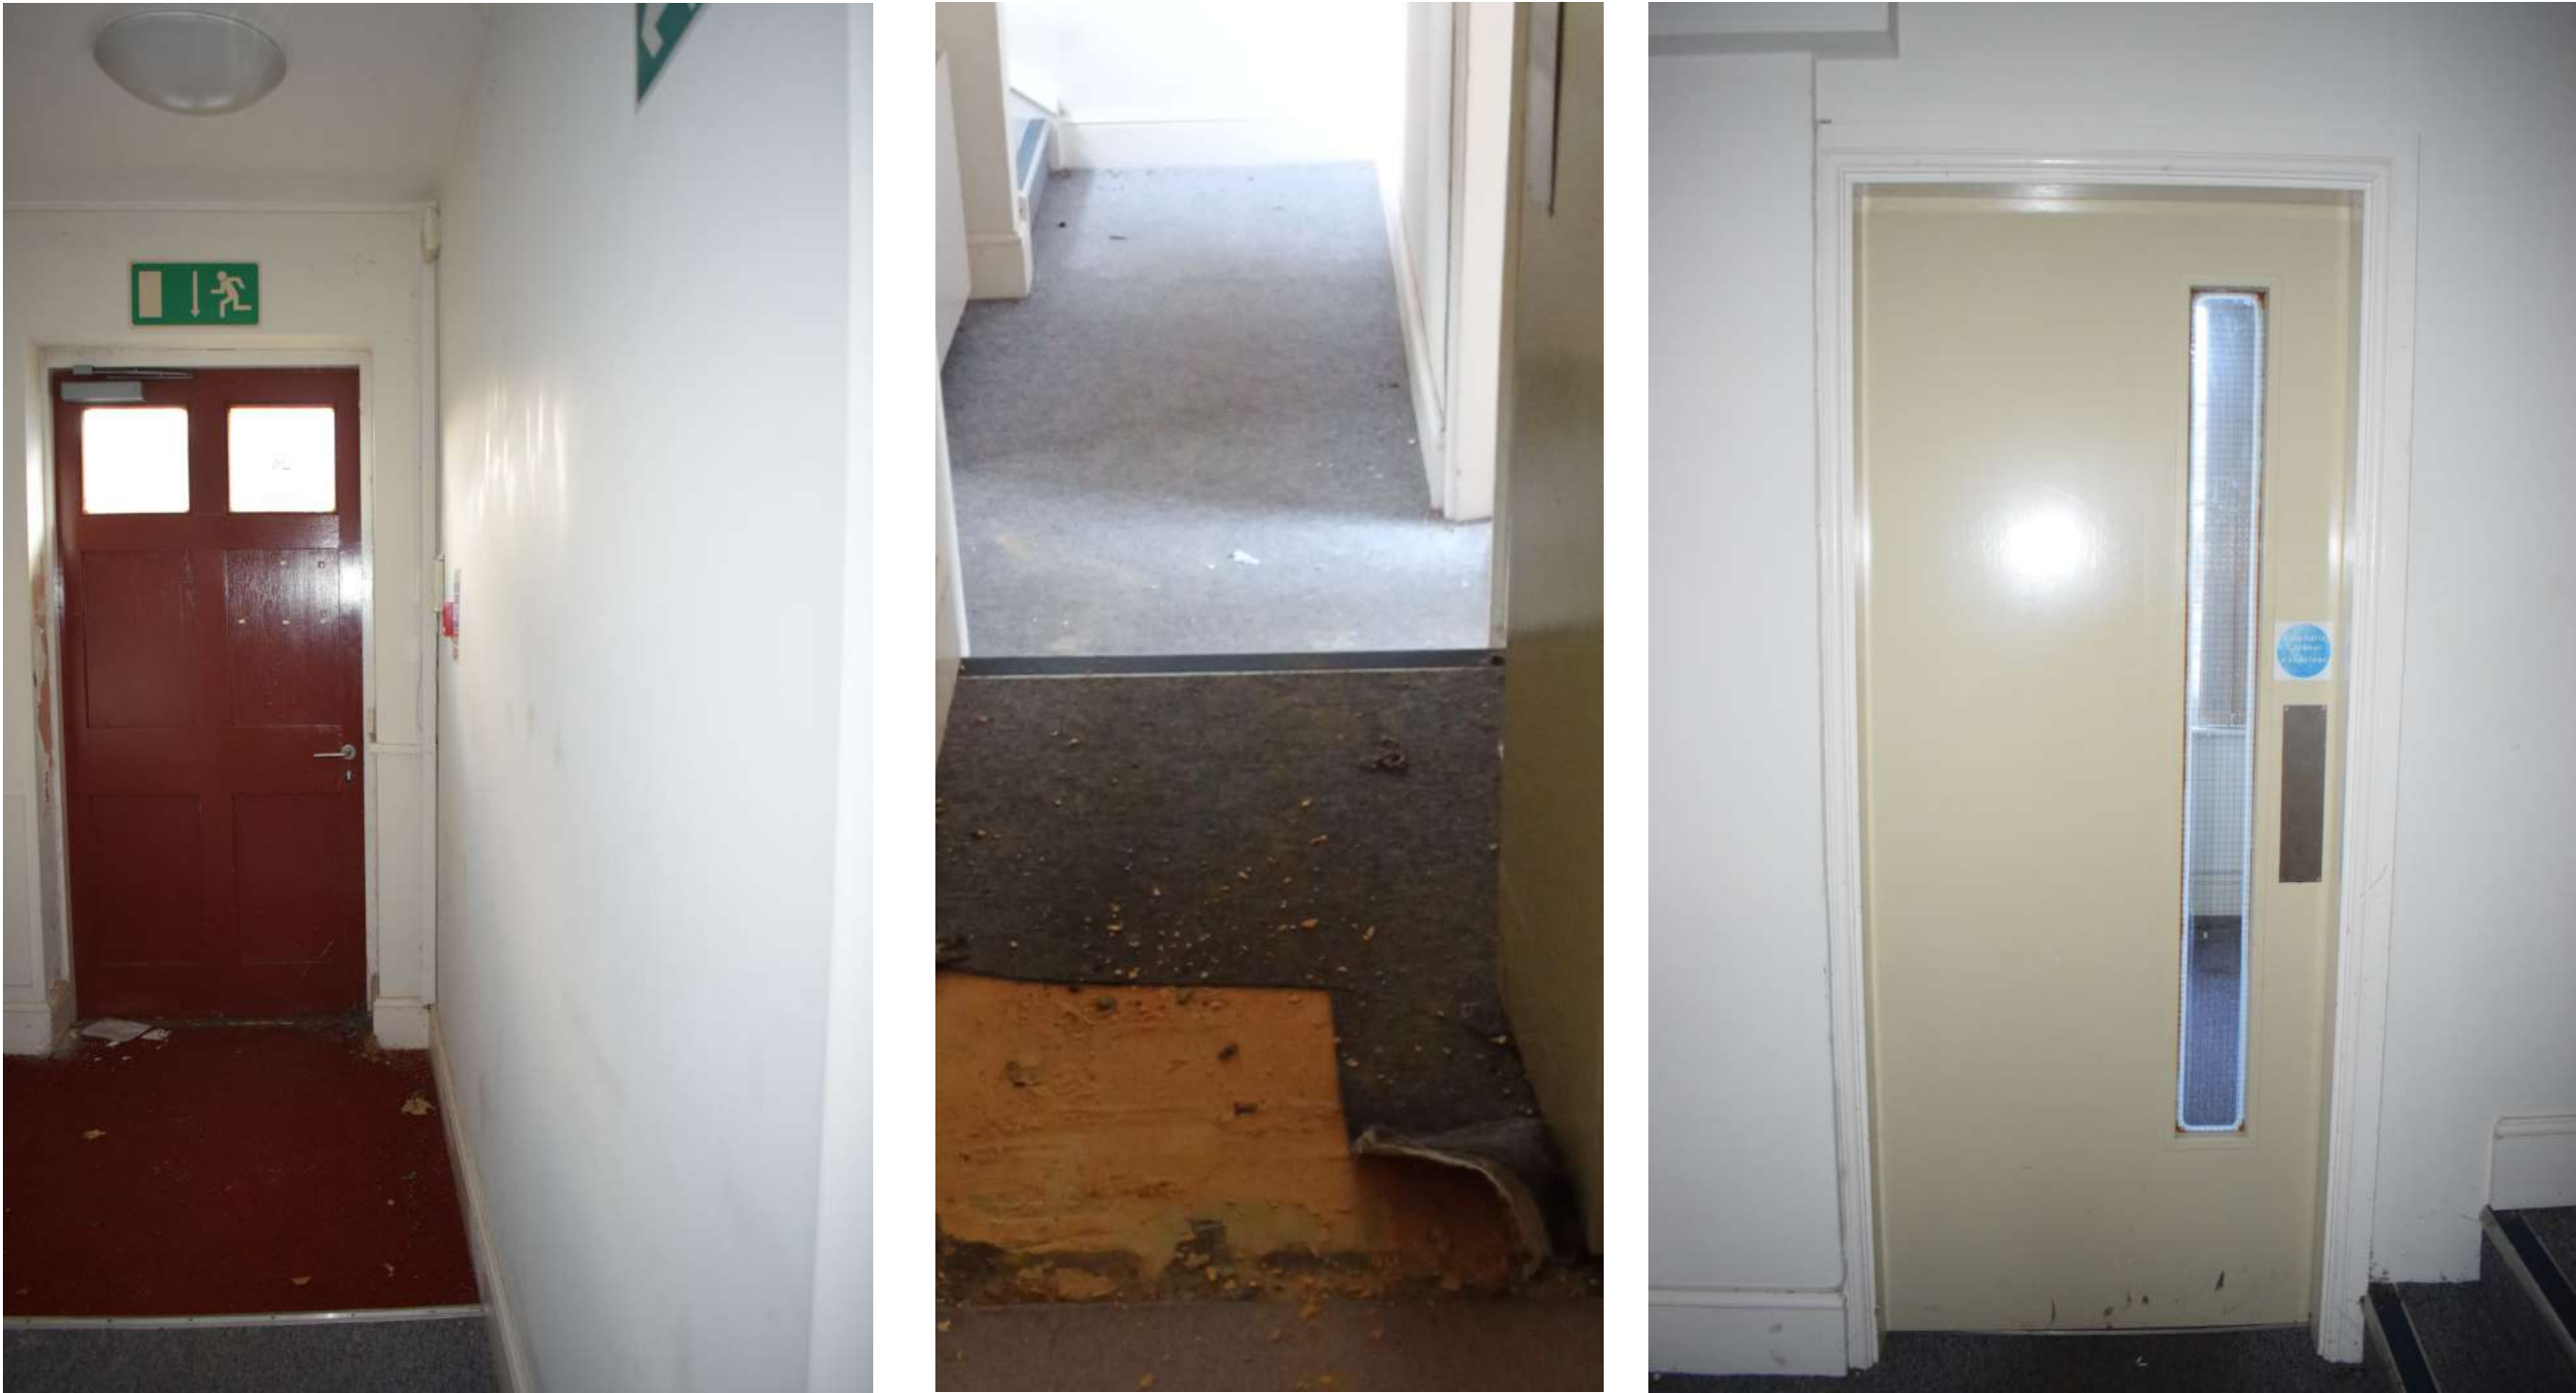
Plate 64  
Reconfigured spaces: This image illustrates one of the reconfigured spaces, and associated fire door exits. Inset: a detail of the solid flooring on the ground floor of Phase 2, due to re-modernisation.

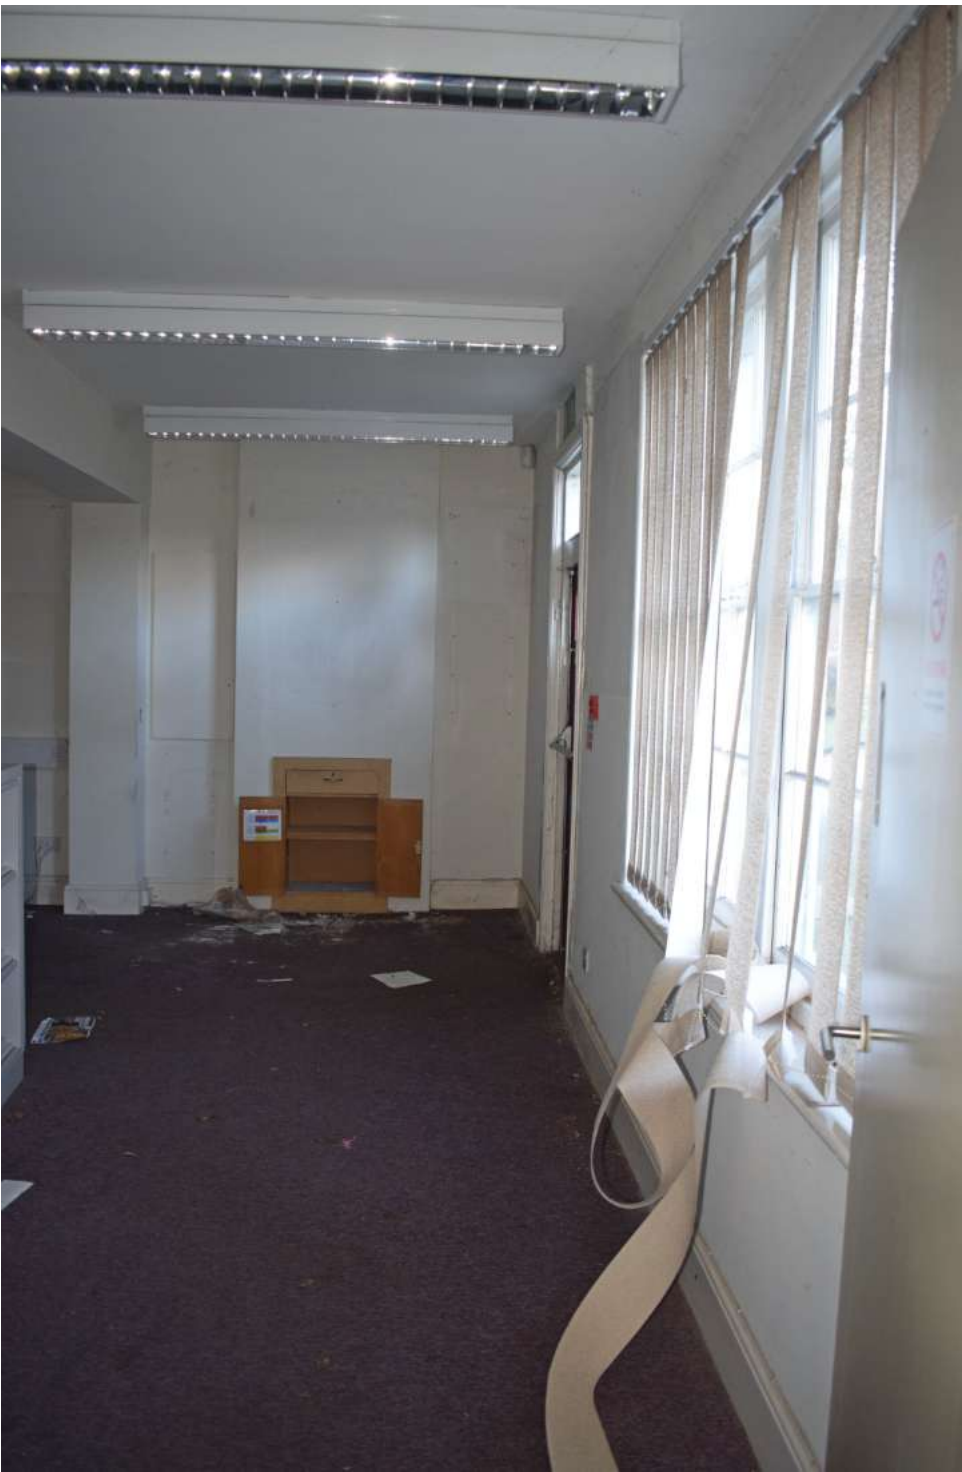
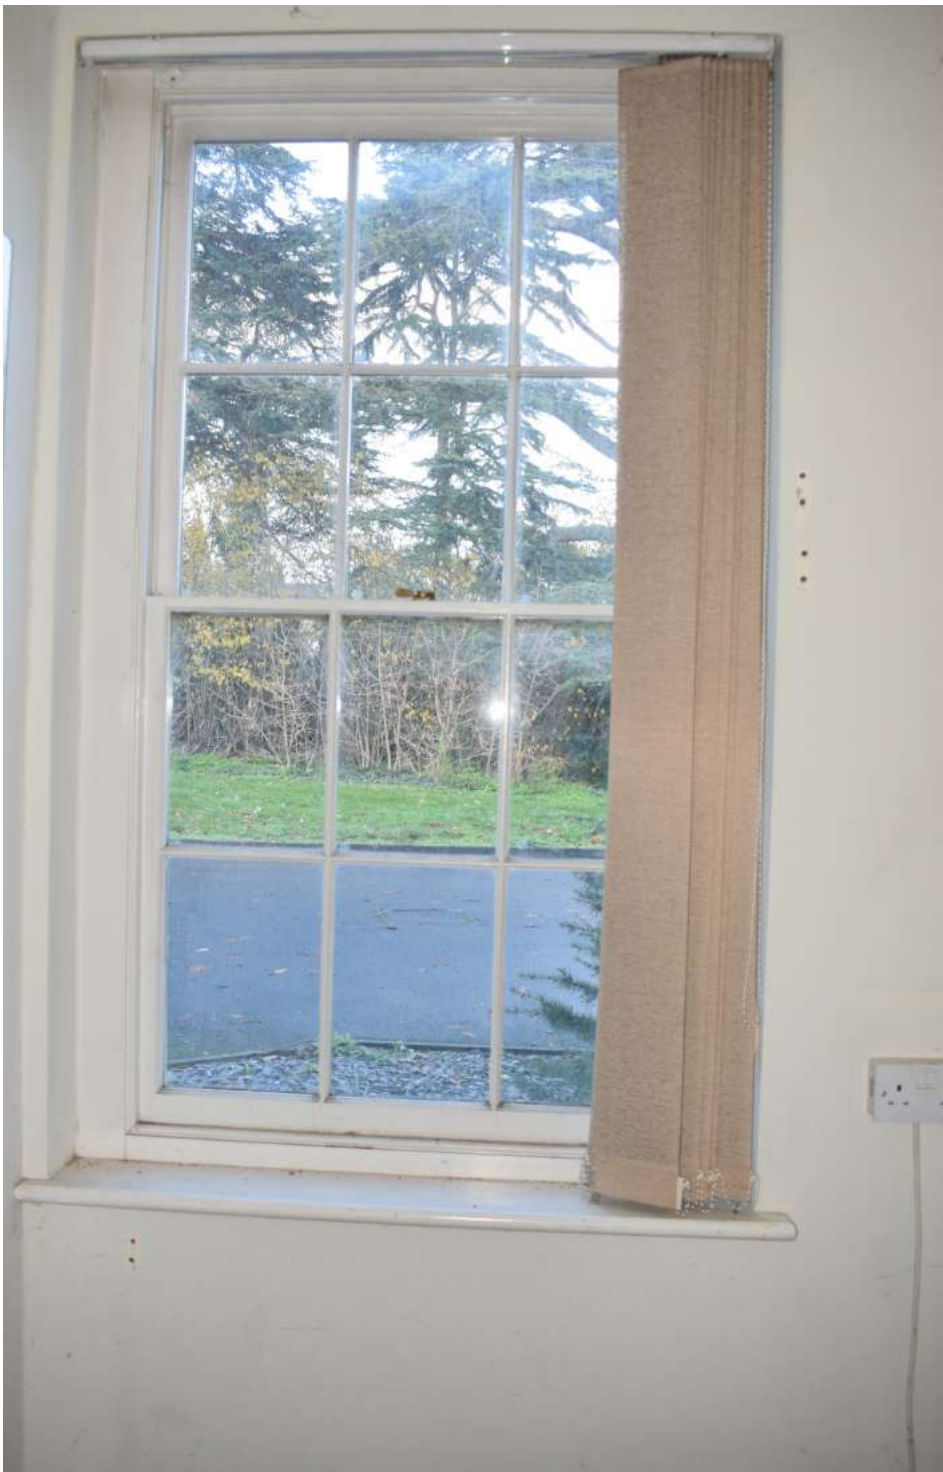
Plate 65

Reconfigured spaces: This image shows one of the reconfigured spaces on the ground floor: a blocked-up fireplace in the Berkshire Family Society Office.

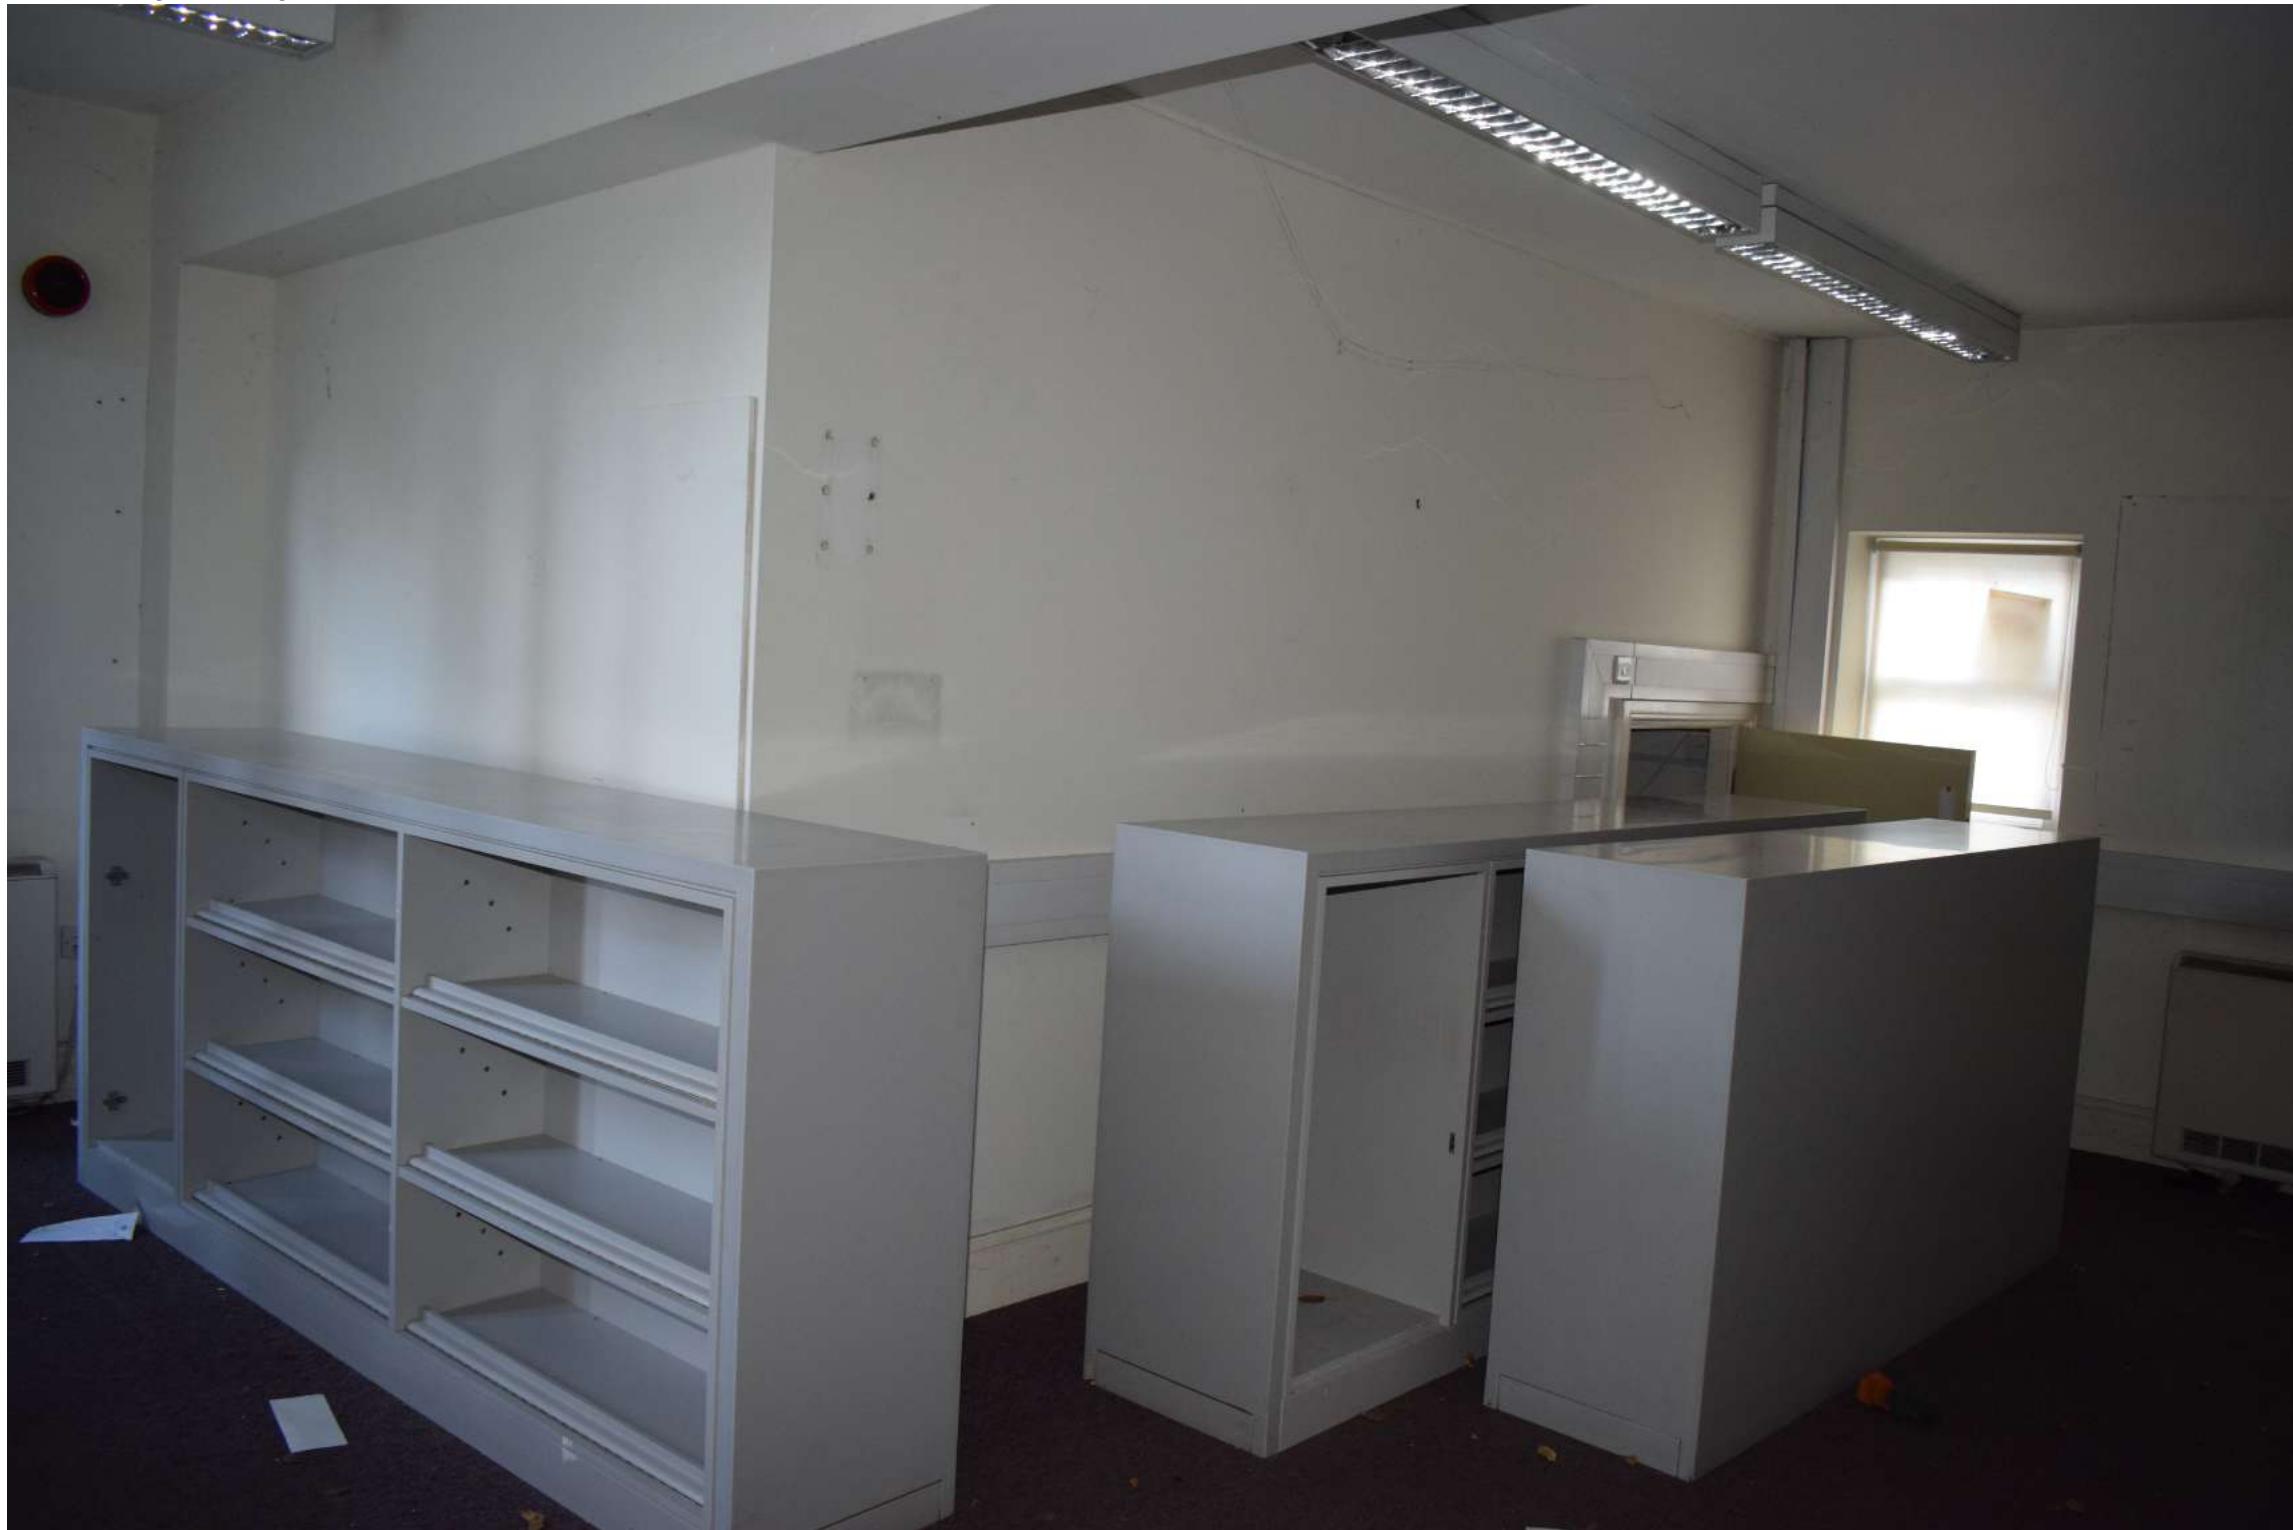
Plate 66

Reconfigured spaces: This image provides a view of the space required for the modern stairwell within the ground floor Berkshire Family Society Office.

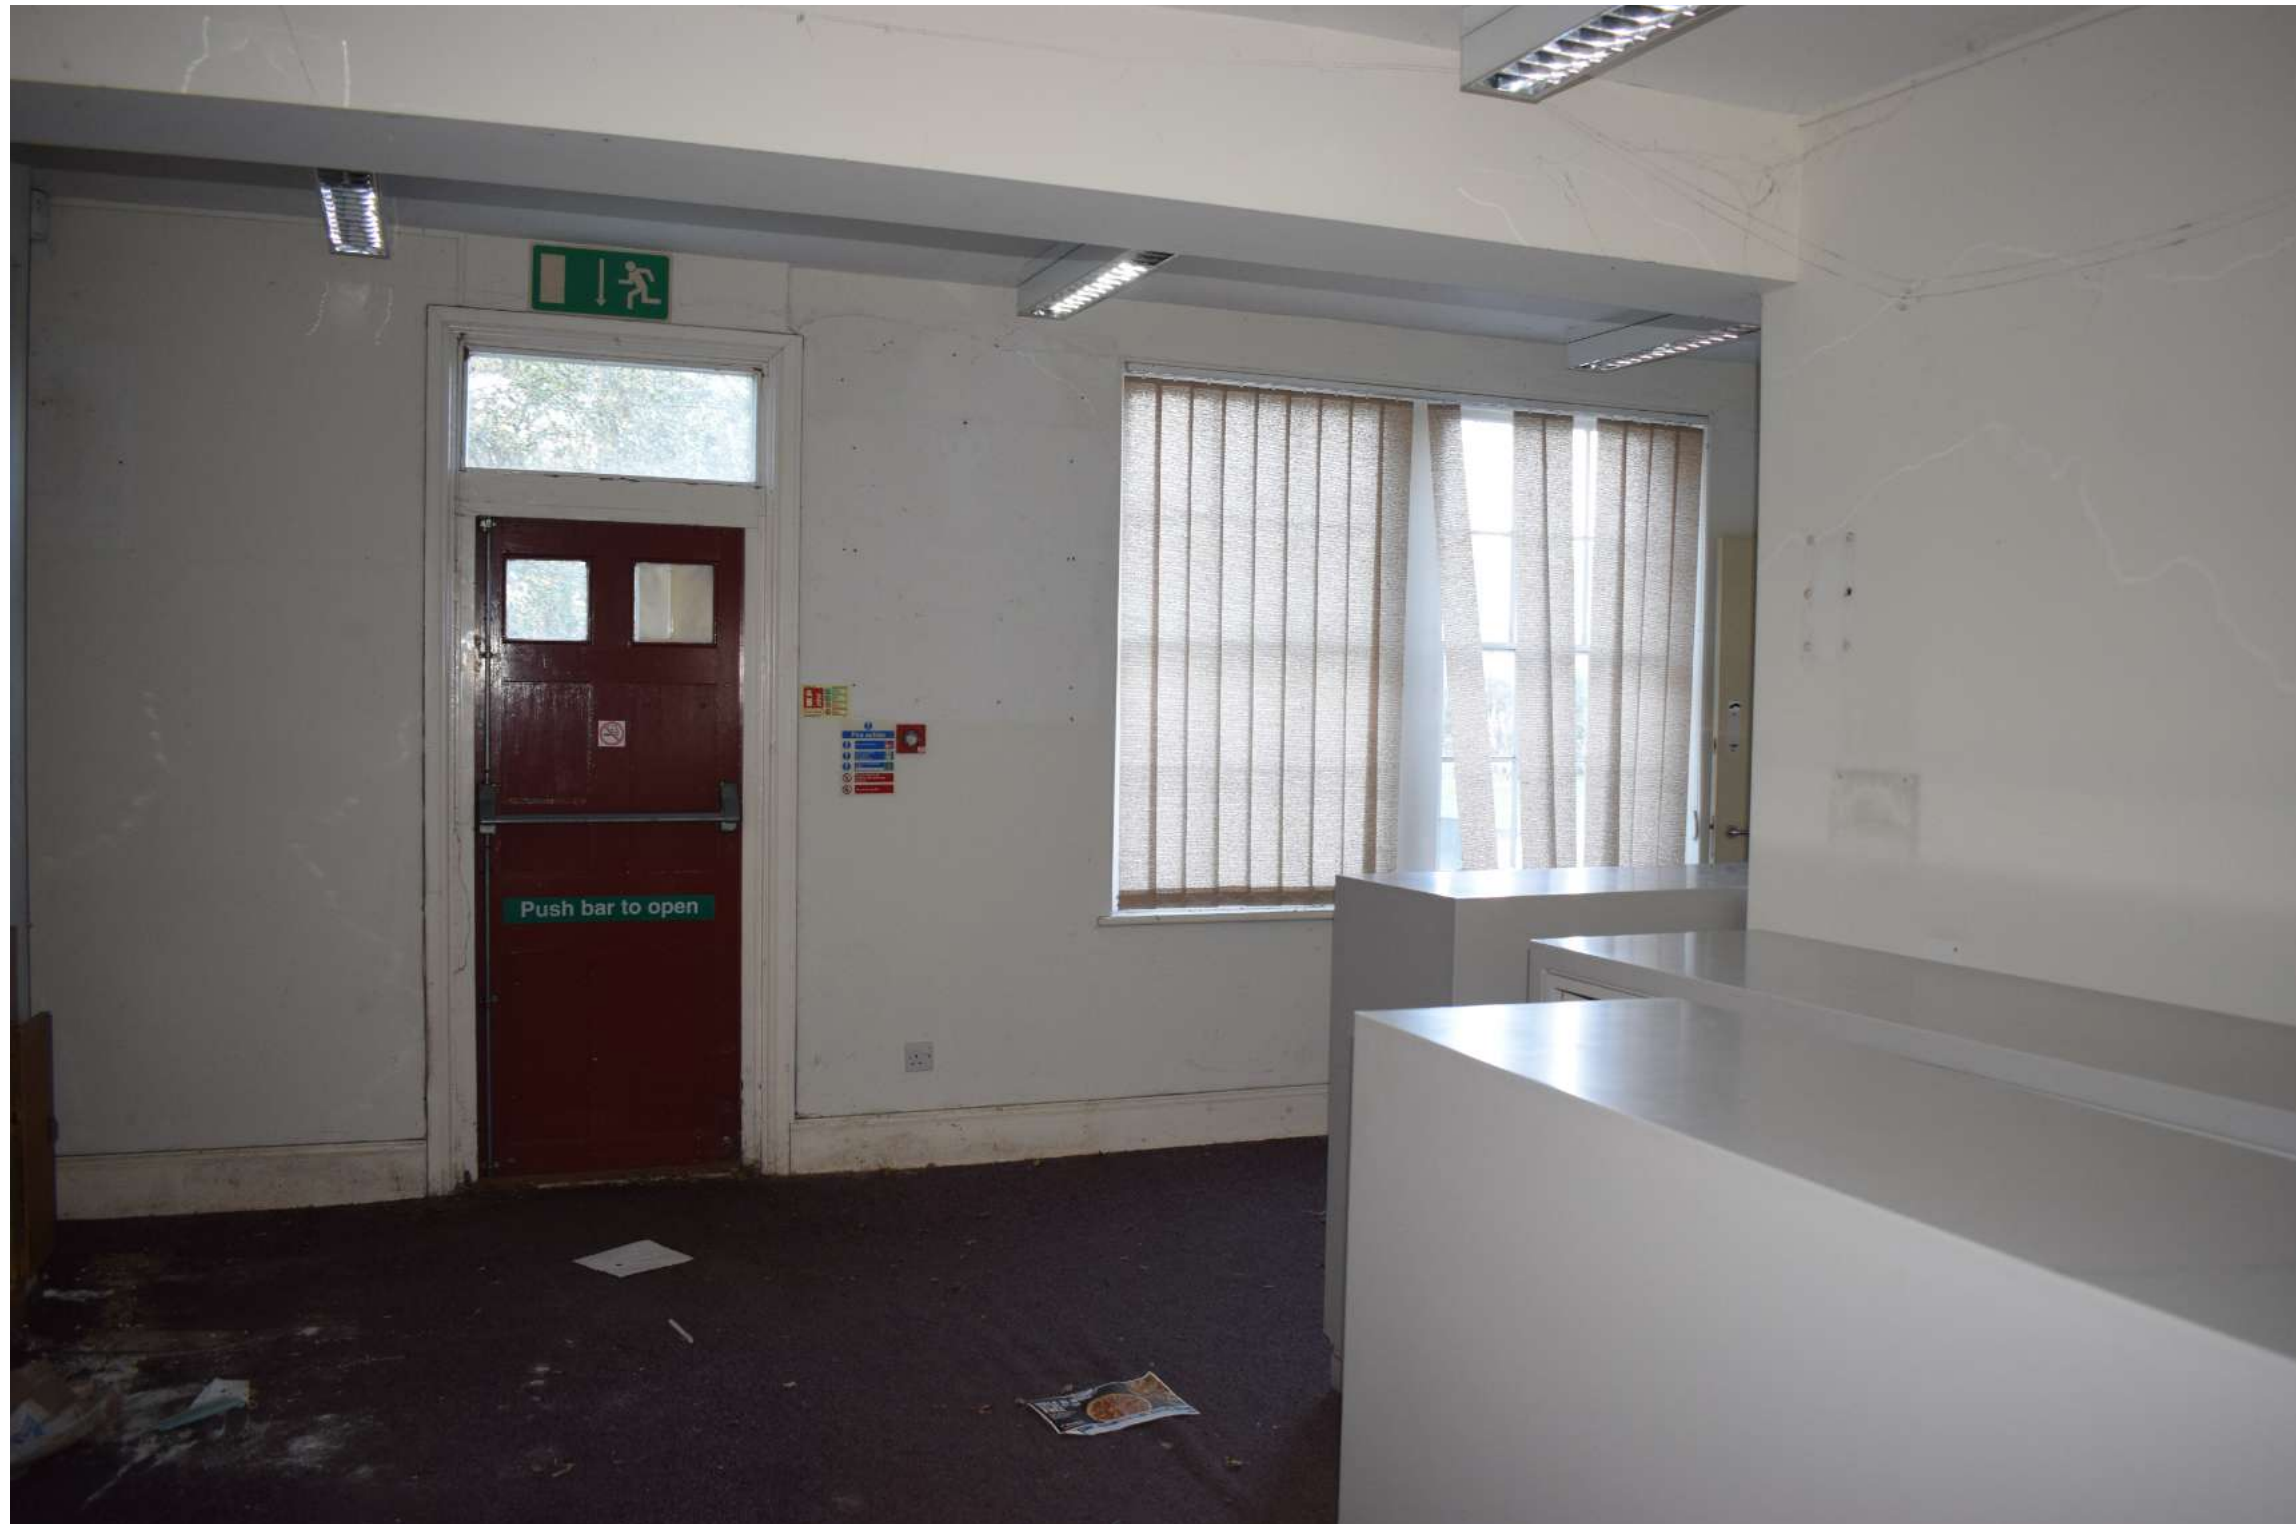
Plate 67

Reconfigured spaces: This image evidences a modern fire exit door and modern window.

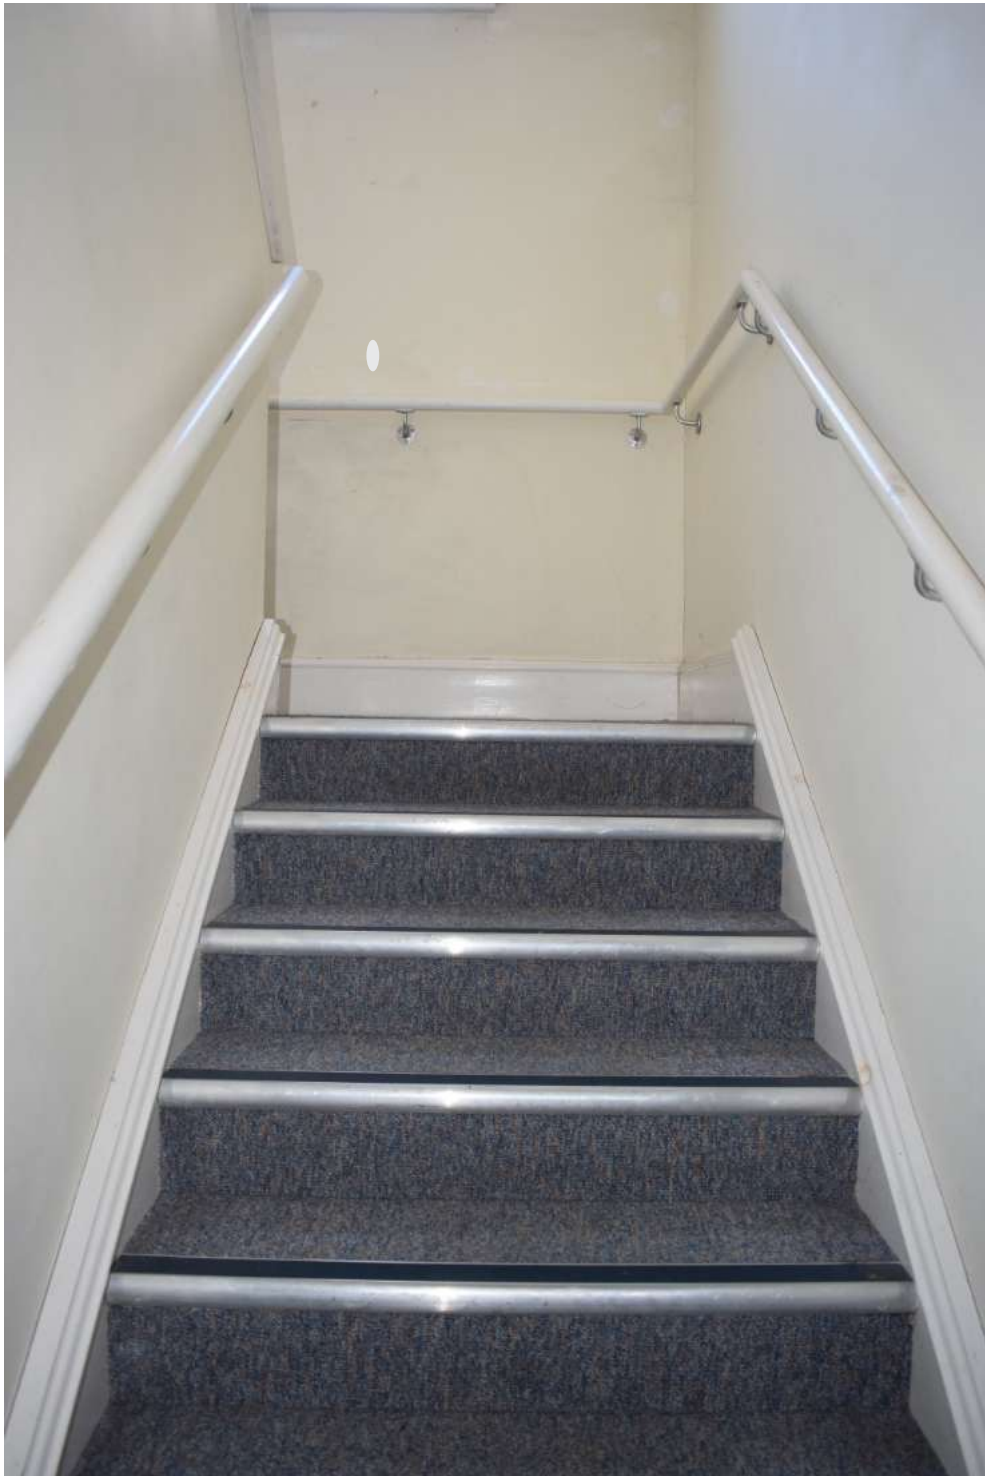
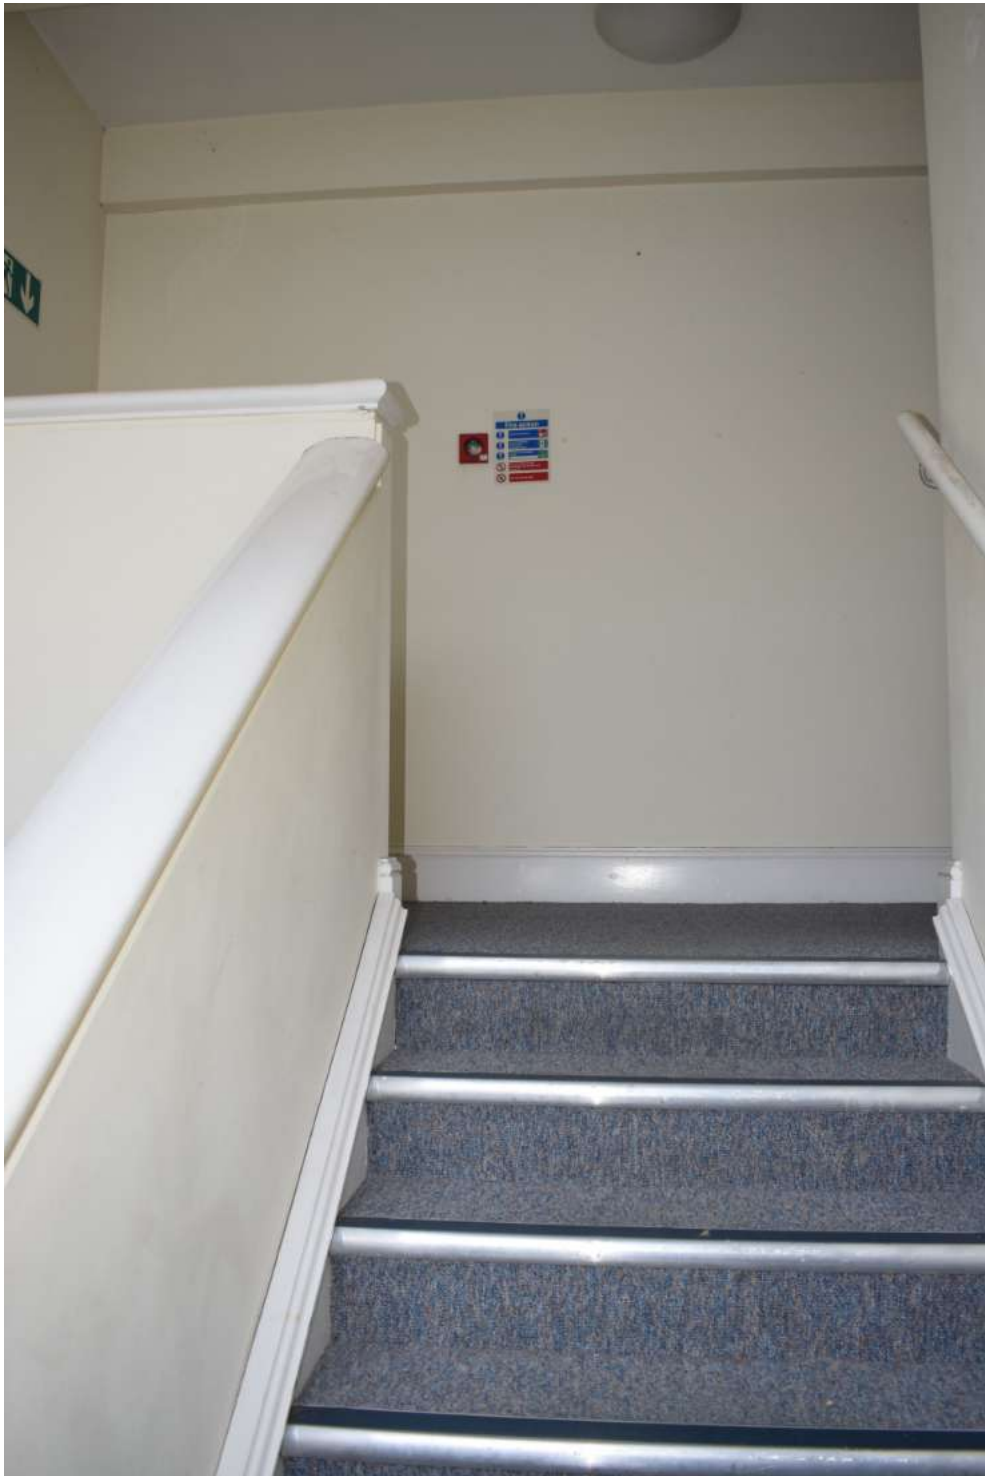
Plate 68

Reconfigured spaces: This image shows the scale and design of the modern stairwell
